# TECHNICAL SERVICE BULLETIN

## Driver Seat Cushion Sagging - Built On Or Before 11-Feb-2021

**24-2394**

19 November  
2024

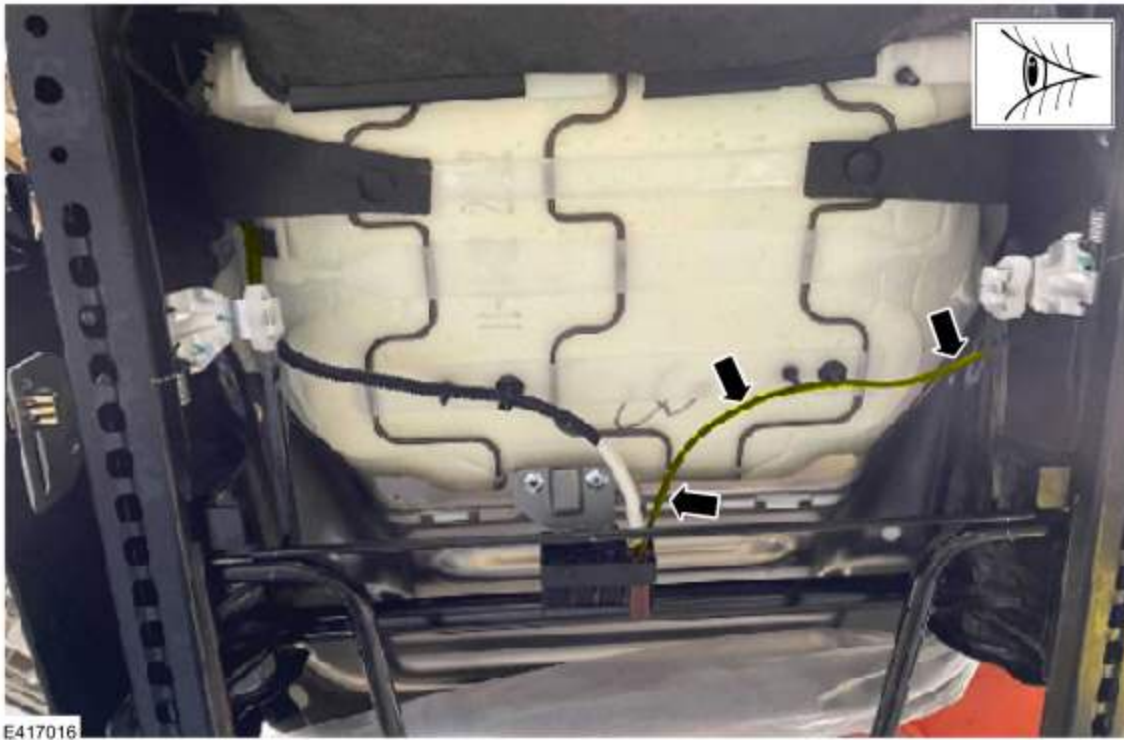
Figure 1

1. Remove the affected driver seat track. Refer to WSM, Section 501-10A, starting with Step 2.
2. Inspect the seat airbag deployment circuit for damage as shown in Figure 1. If damage is present, replace the side airbag. Refer to WSM, Section 501-20B.

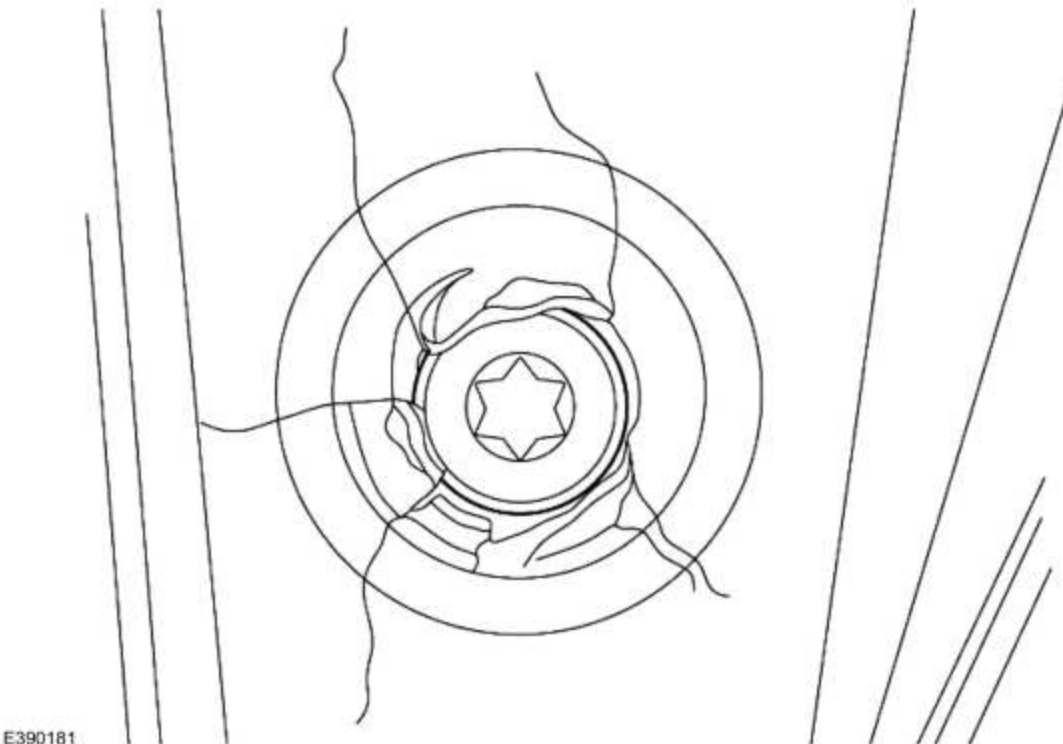
Figure 2

3. Inspect the driver seat track assembly for damage. Is the driver seat track assembly damaged?

**NOTE: Small cracks around the bolt are considered normal. (Figure 2)**

(1). Yes - replace the seat track assembly. Refer to WSM, Section 501-10A Front Seats > Removal and Installation > Front Seat Track. Proceed to Step 5.

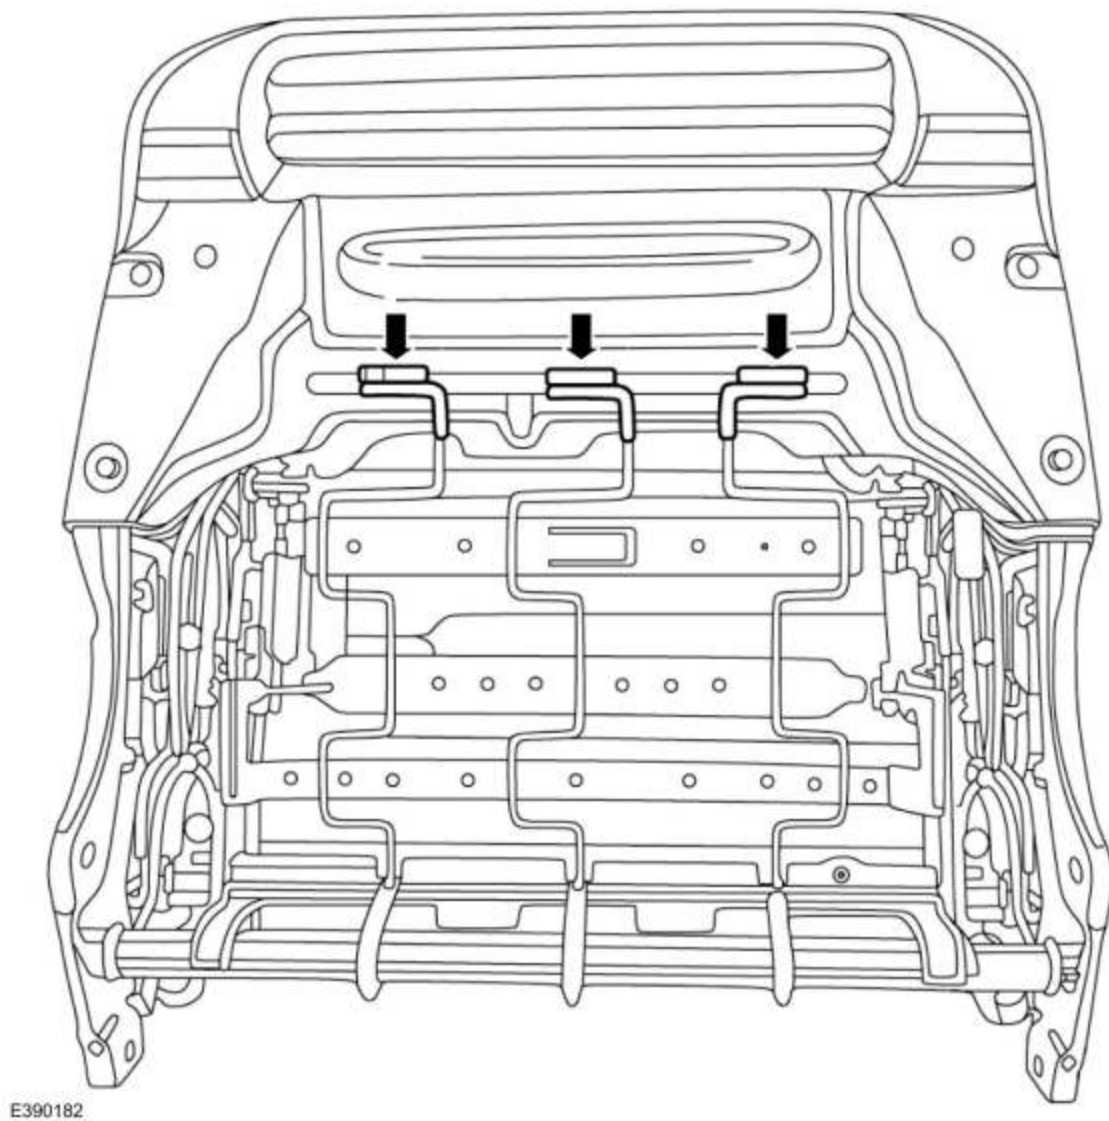
Figure 3

(2). Disengage the 3 suspension mat assembly forward attachments from the cushion pan. (Figure 3)

(3). Remove the suspension mat assembly 3 rearward attachments. The suspension mat assembly has a snap fit on the rear tube. (Figure 3)

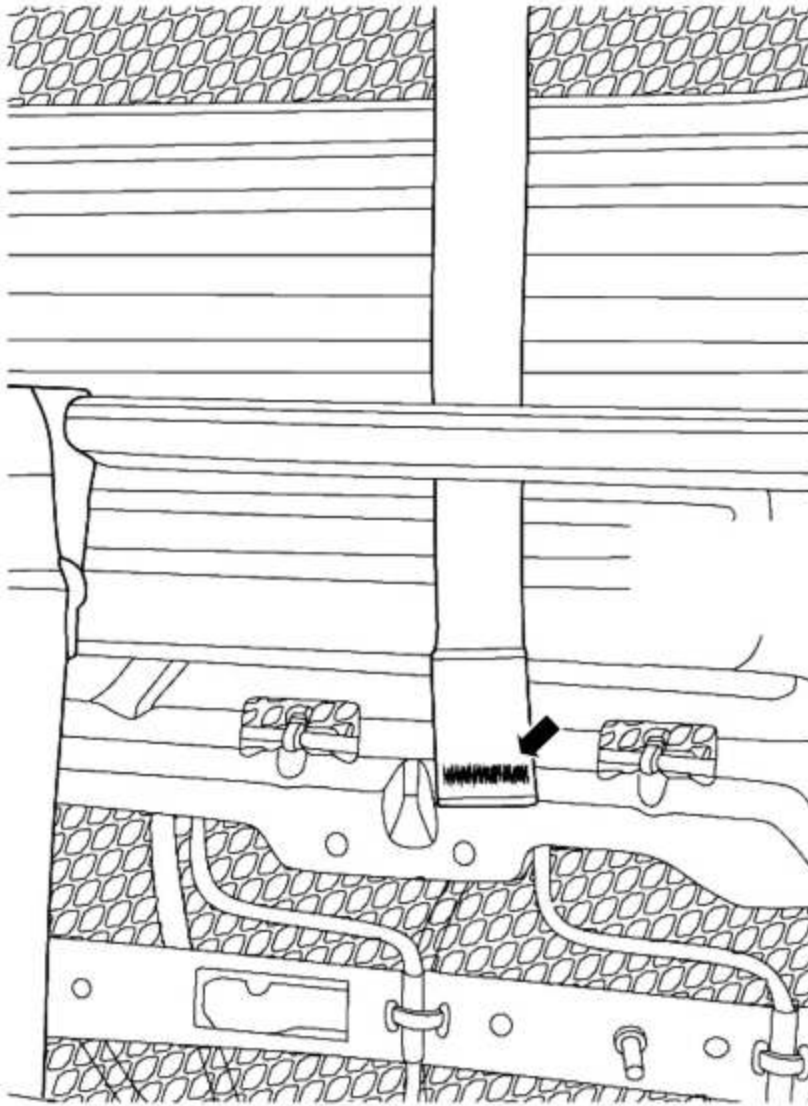
Figure 4

(1). With the red thread visible, route the end of the 1st webbing strap assembly without the metal ring between the cushion pan and the front cross-car tube. (Figure 4)

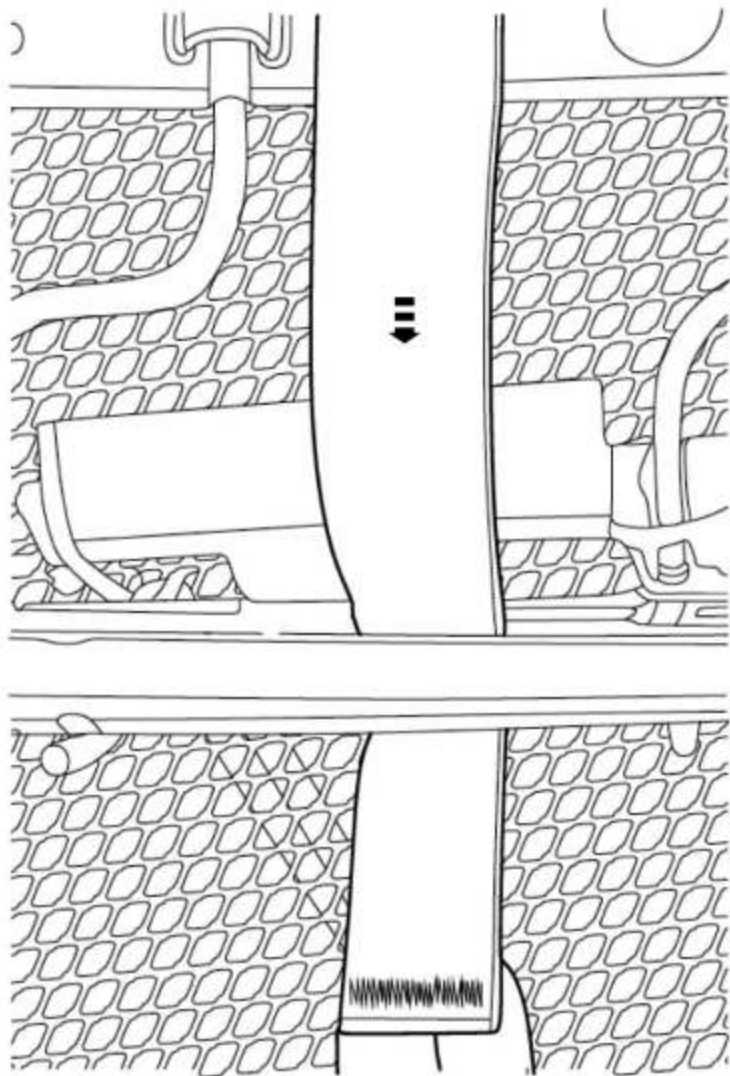
Figure 5

(2). Continue rearward and route the webbing strap assembly between the suspension mat assembly and the rear tube. (Figure 5)

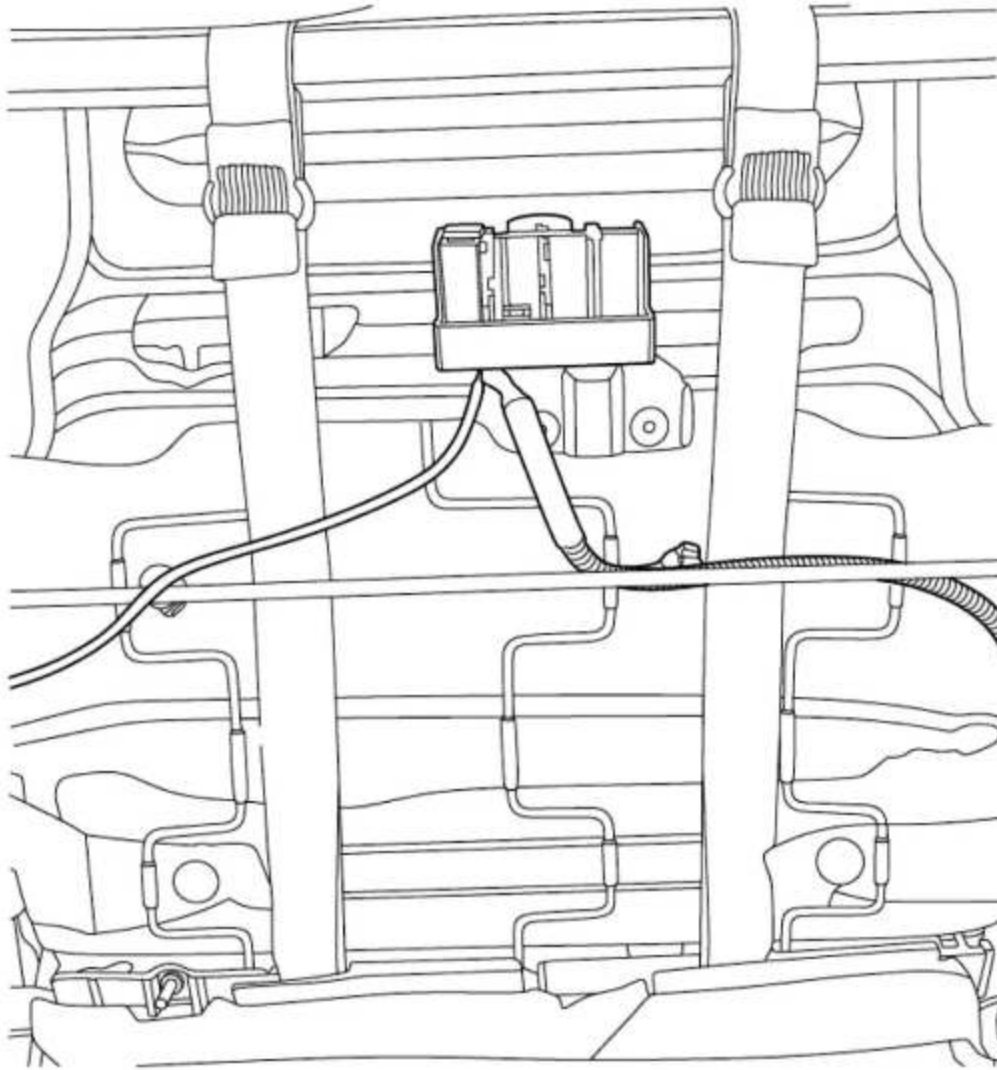
Figure 6

(3). Make sure all electrical harnesses are below the webbing. The final assembly will have the suspension mat on top (closest to the seat cushion), then the webbing straps, and then the wire harnesses on the bottom. (Figure 6)

**NOTE:** Make sure all electrical harnesses hang below the webbing and not between the webbing and suspension mat. When the final assembly is installed in the vehicle, it will have the suspension mat on top (closest to the cushion), then the webbing straps, and then the wire harnesses on the bottom. (Figure 6)

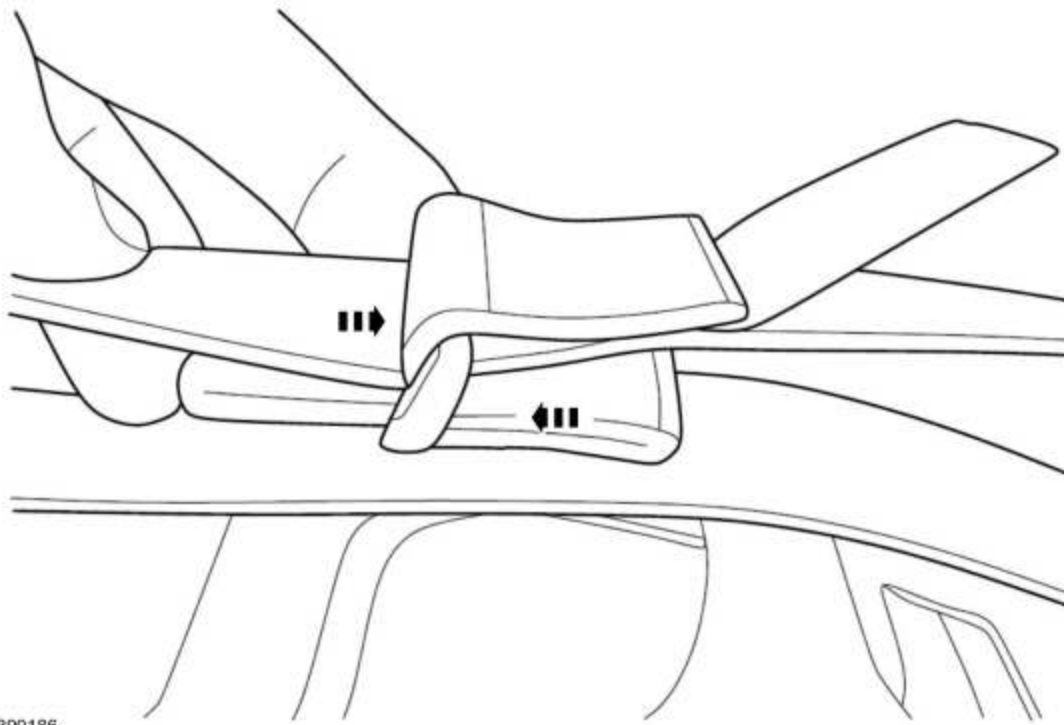
Figure 7

(4). Bring the webbing strap assembly to the metal ring and insert it. After the fold is all the way through the ring, pull the retention fold back and into position. (Figure 7)

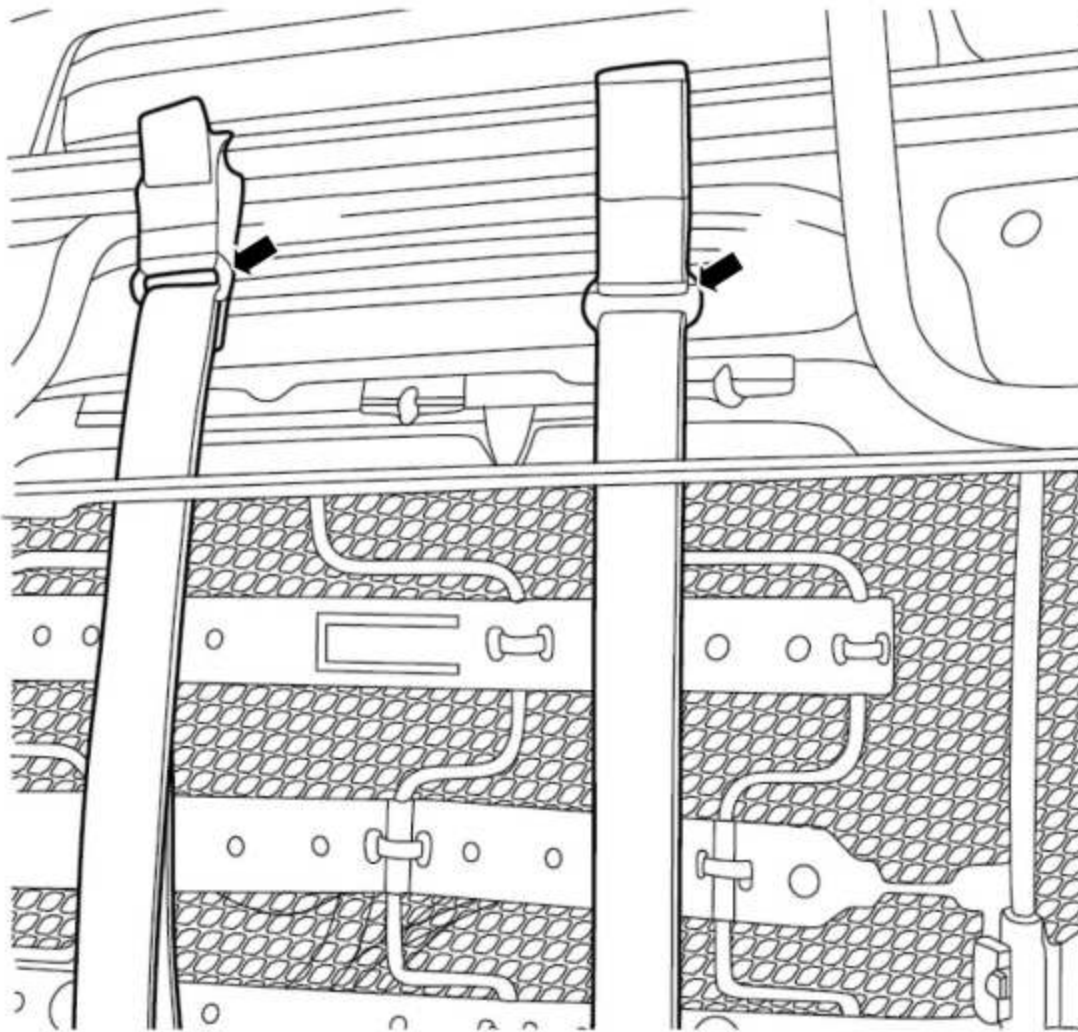
Figure 8

(6). The metal ring should be positioned forward in vehicle. (Figure 8)

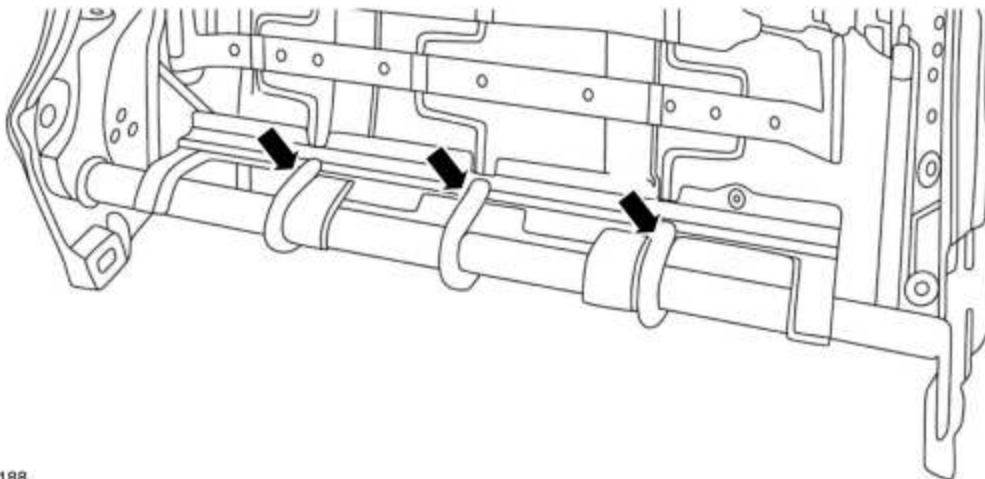
Figure 9

- (1). Locate the suspension mat to the cushion and webbing assembly.
- (2). At the rear tube verify one webbing is located between the left and center suspension attachment and the other is between the center and right suspension attachment. (Figure 9)

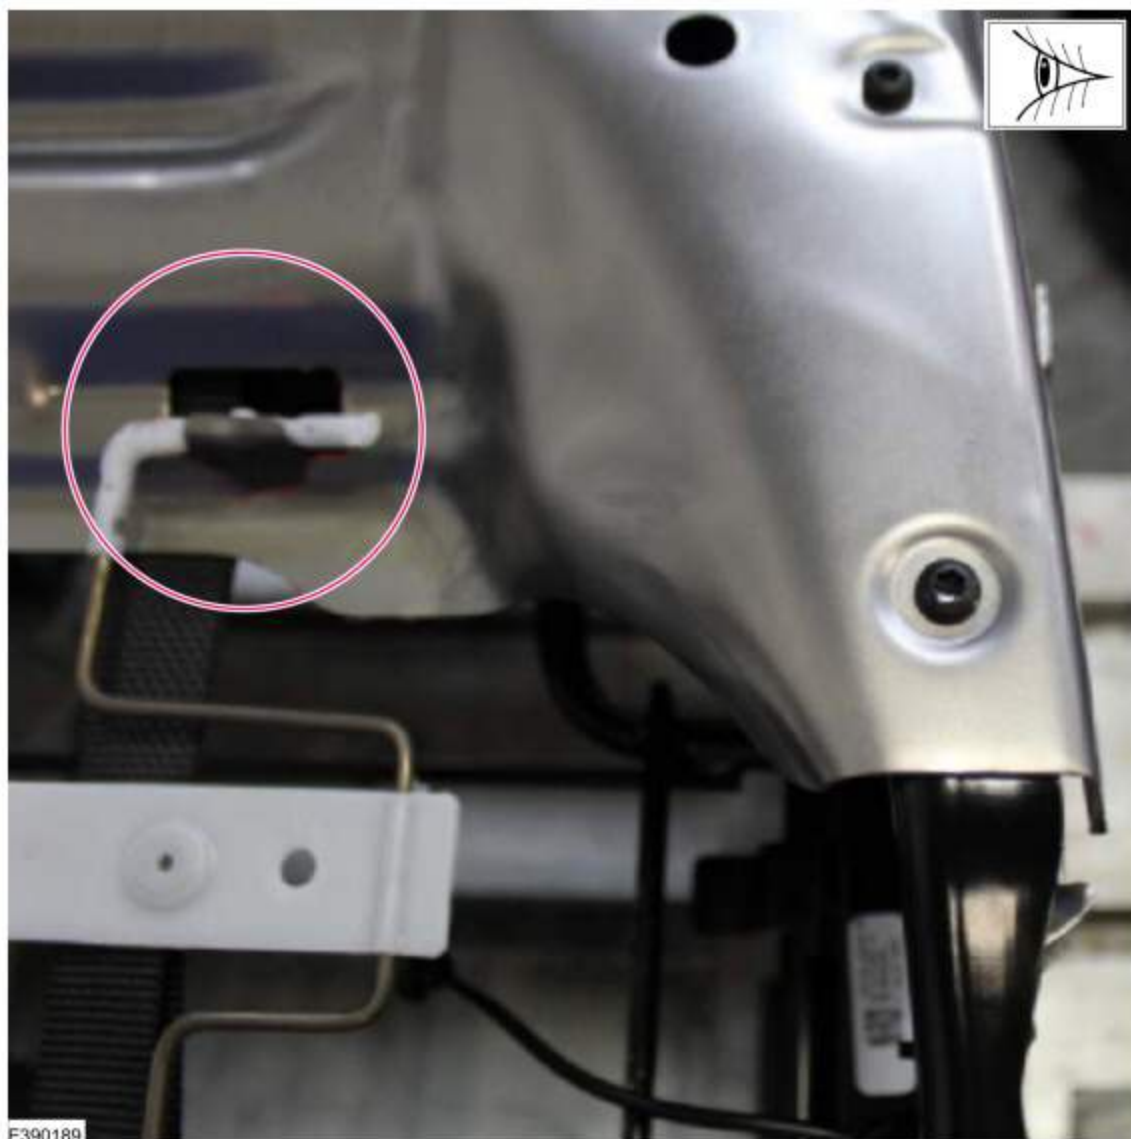
Figure 10

(4). Secure the front of the suspension mat to the retaining tabs on the cushion pan (no tools required). (Figure 10)

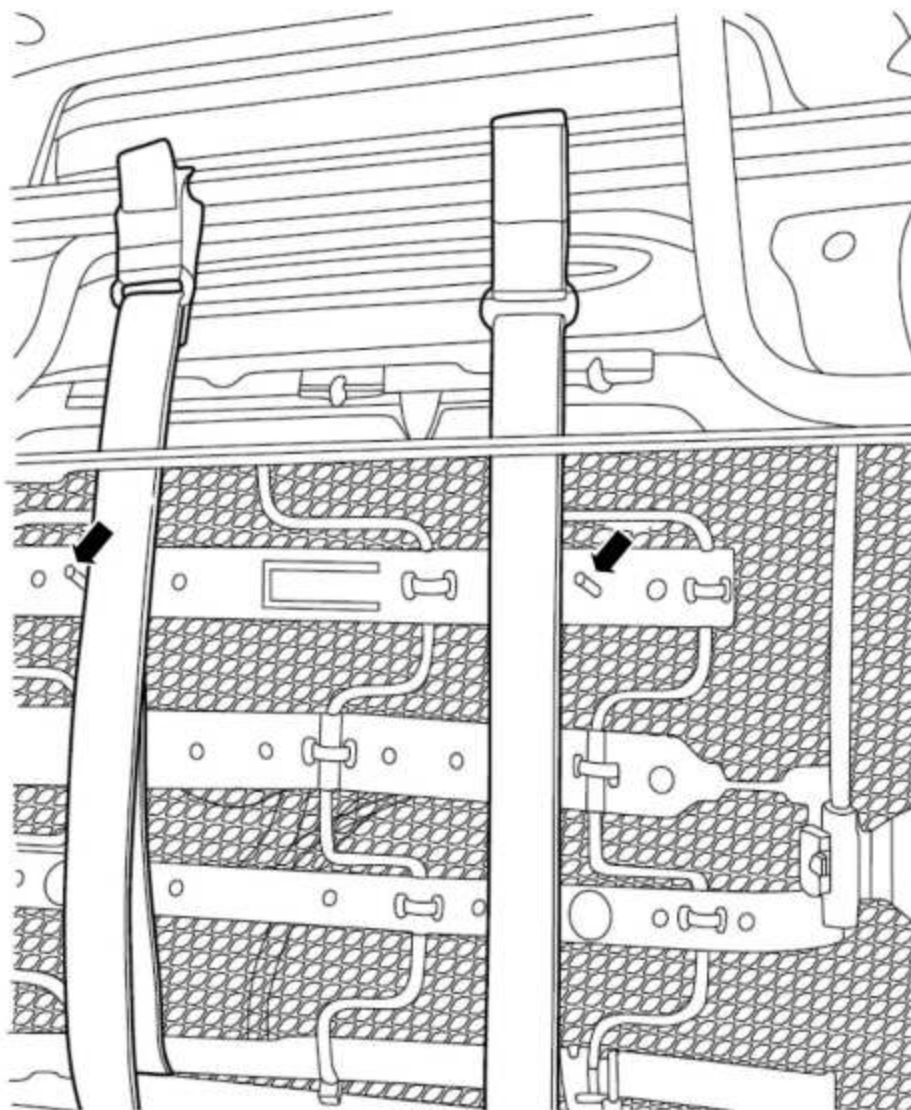
Figure 11

(5). Verify the cross-car position of the webbings. The position should be aligned with the stud on the suspension mat. (Figure 11)

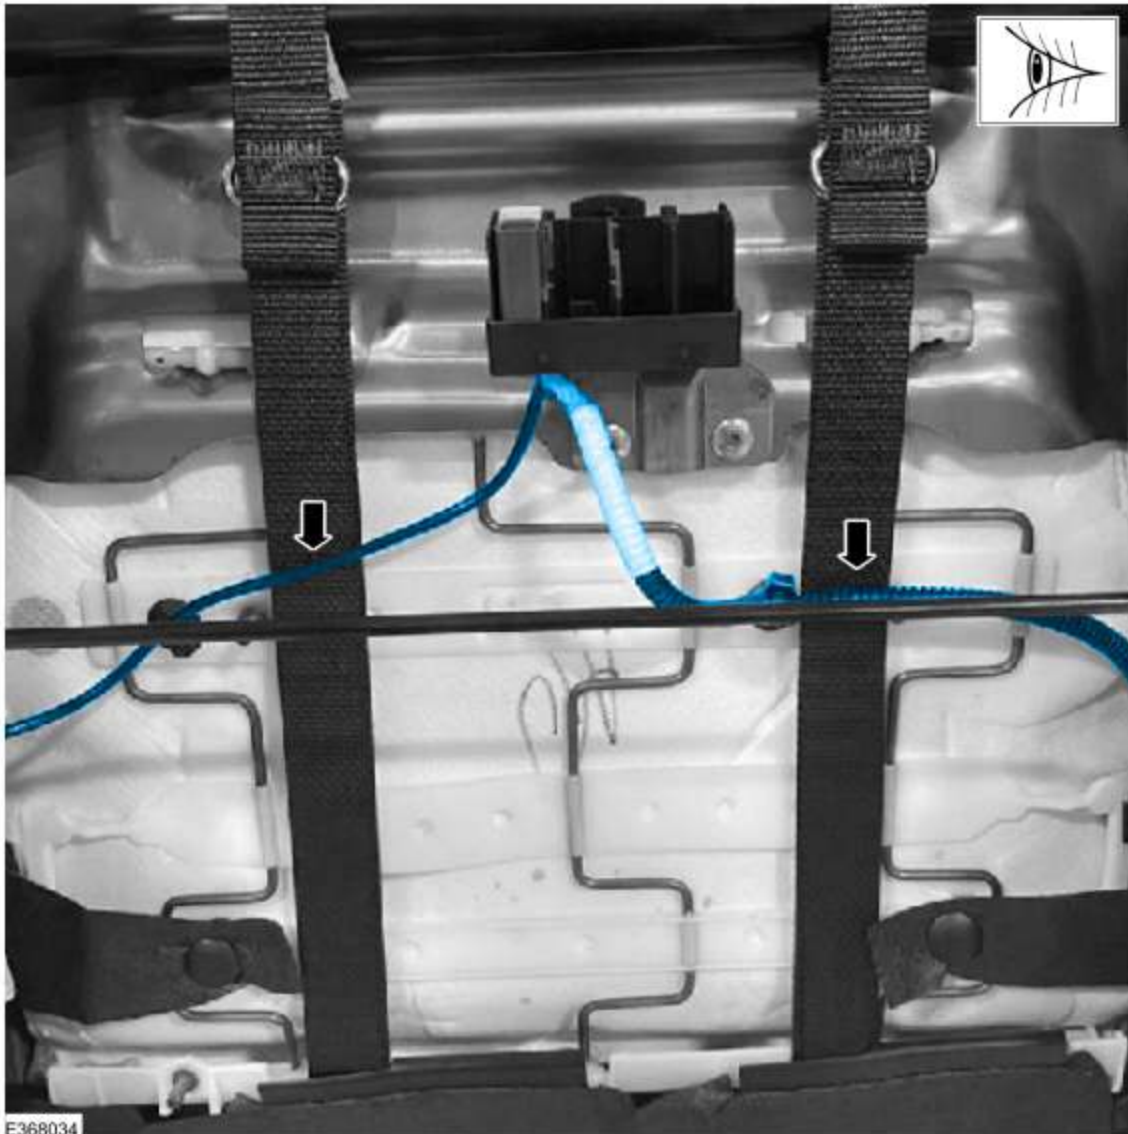
Figure 12

(6). Secure the wire harness(es) to the suspension mat. (Figure 12)

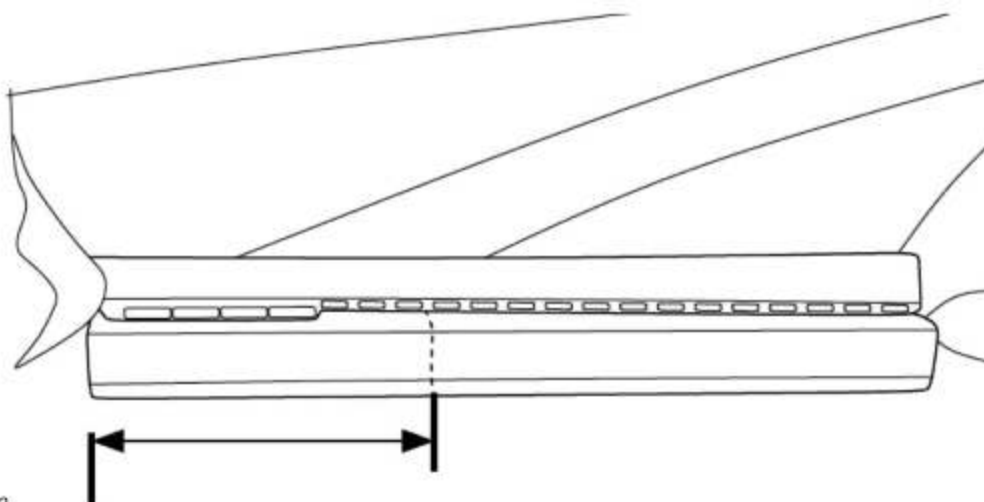
Figure 13

(1). Measure 1 3/4 in. (45 mm) and cut with a knife along the dotted line. (Figure 13)

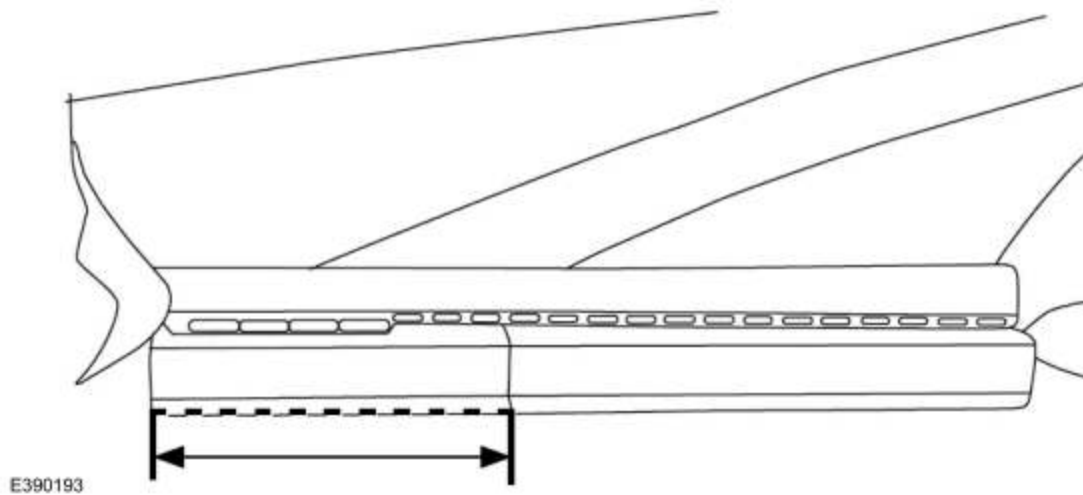
Figure 14

(2). Cut along the dotted line (Figures 14-15), perpendicular to the previous cut, so that the portion of the J retainer in Figures 16 and 17 can be removed.
