## Technical Service Bulletin

**24-01-020H**

**SONATA  
(DN8/DN8A)**

**SUBJECT:** ECU UPDATE & CHECK VALVE/FUEL TANK INSPECTION AND REPLACEMENT (SERVICE CAMPAIGN 9B1)

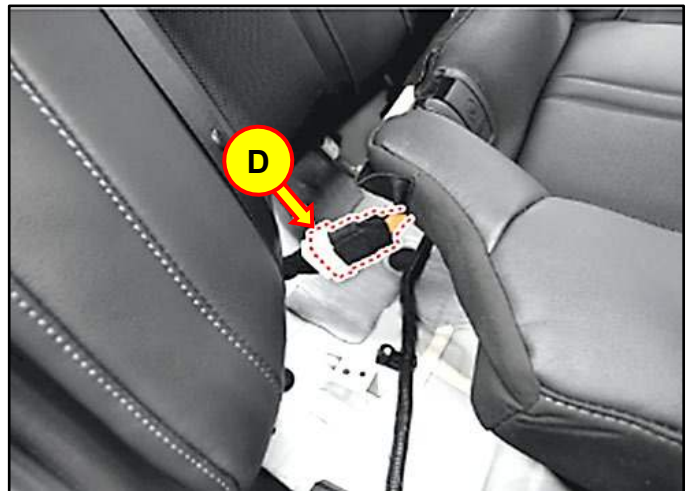
4. Disconnect the rear seat heater unit connector if equipped (D).

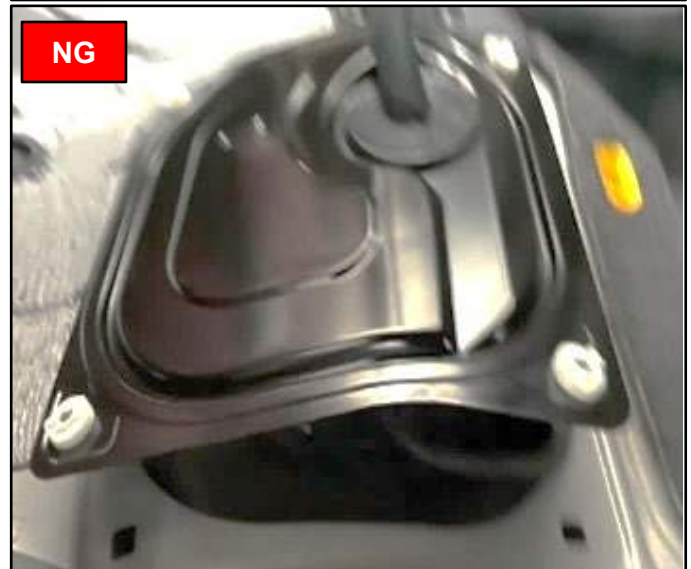
5. Inspect the fuel pump service cover (E).

- If a gap is **NOT** present (**GOOD**):
  - Replace the check valve.
  - Proceed to **step 8**.
- If a gap **is** present (**NG**)
  - Open RA Techline Case.
  - Continue to **step 6**.

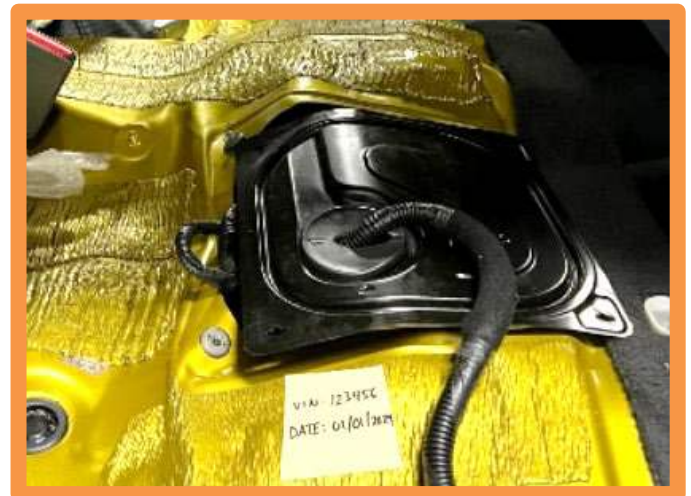
Using STUI, take a photo of the gap in the fuel pump service cover, with the last 6 digits of the VIN and the date of repair on a piece of paper.

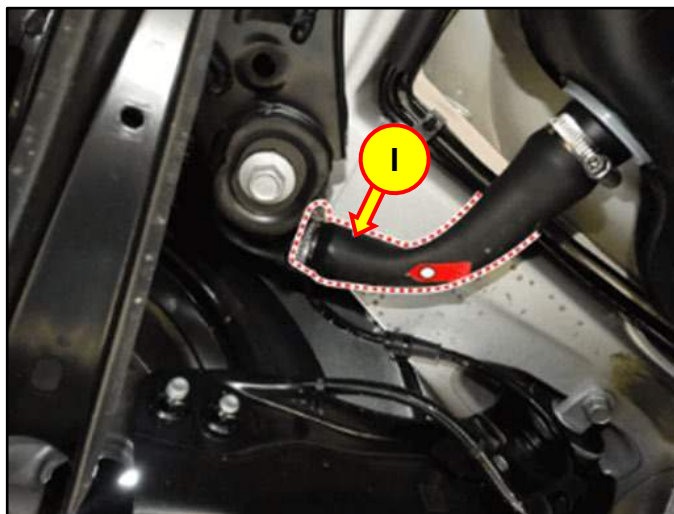
Remove the side under cover (H).

12. Disconnect the fuel filler hose (I).

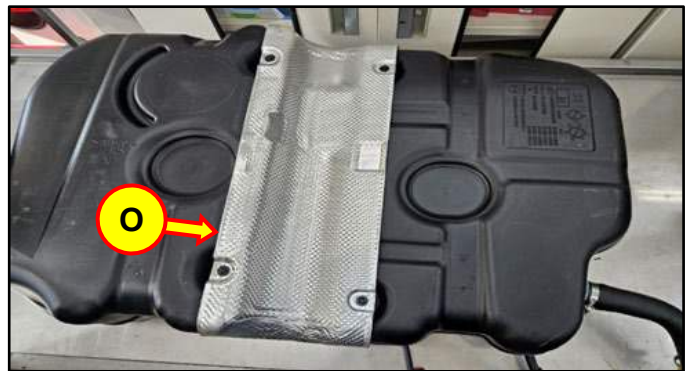
16. Remove the fuel tank band (M) and then the fuel tank (N) from the vehicle.

Replace fuel tank bands during installation.

Attach the fuel tank heat protector (O) supplied to the new fuel tank.
