# Technical Service Bulletin

## 93 e-tron GE electric drive motor leak P0AA600

93 24 29 2073858/4 November 7, 2024. Supersedes Technical Service Bulletin Group 93 number 24-25 dated October 24, 2024 for reasons listed below.

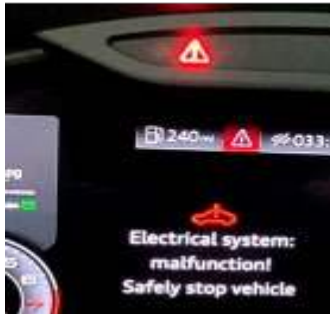
- A Drive System/Electrical System Malfunction message (Figure 1) appears in the in the instrument cluster; the warning may not be present at the time of inspection.

*Figure 1. Warning lamp associated with message.*

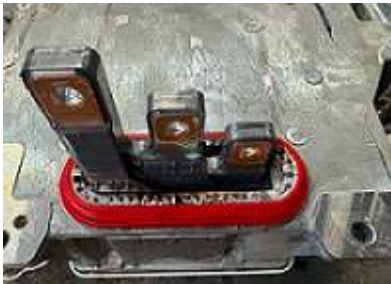
1) Corrosion on the high-voltage system connection for power and control electronics for electric drive (Figure 4).

*Figure 4: Corrosion on high-voltage system connection for power and control electronics for electric drive.*

**The power electronics for electric drive must not necessarily be replaced if the electric drive motor is leaking (refer to images 4 and 5).**

**In this case, the power and control electronics for electric drive must not be replaced.**

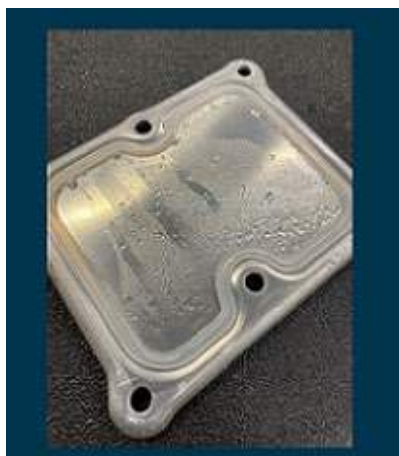
2) Condensation on high-voltage system connection cover (Figure 5).

*Figure 5: Condensation on high-voltage system connection cover.*
