## Technical product information

| <b>Topic</b> | Rotating display/screen - Fault diagnosis - Mechanical malfunction DTC B140107 is evident within 005F |
| <b>Brand</b> | Bentley |
| <b>Transaction No.</b> | 2075532/2 |

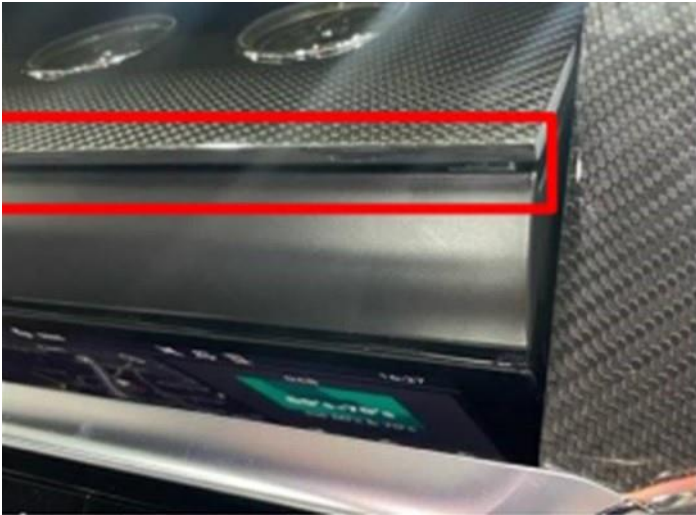
Figure 1

4) Figures 1 and 2 show an example of the display clocks and/or dials fascia unclipped)

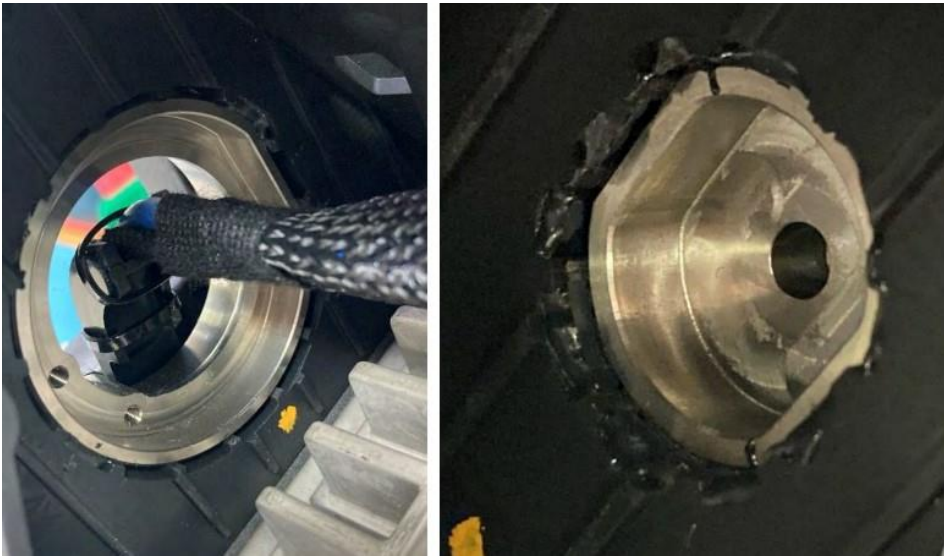
7) Bearing displacement check

- **HINT:** Referring to Figures 4 and 5, if there is a large gap on one side of the fascia panel and a small gap on the opposing side or a report of clashing with driver fascia or clunking the operative should check to confirm the bearings of the unit have not displaced as shown in Figure 6
