| <b>HYUNDAI</b><br><b>Technical Service Bulletin</b> | GROUP<br><b>CAMPAIGN</b> | NUMBER<br><b>25-01-001H</b> |
| | DATE<br><b>JANUARY 2025</b> | MODEL(S)<br><b>SONATA<br/>(DN8/DN8A)</b> |
| <b>SUBJECT:</b> ECU UPDATE & CHECK VALVE/FUEL TANK INSPECTION AND REPLACEMENT (SERVICE CAMPAIGN 9B1) | | |

**Description:** Certain 2021-2023MY Sonata (DN8) and 2020-2022MY Sonata (DN8A) vehicles may have DTC P0451 stored in the ECU. Follow this bulletin to inspect the check valve, fuel pump cover and fuel tank, and update the ECU. If necessary, replace the check valve and/or fuel tank based on inspection results. The ECU Upgrade contains a revised DTC P14EE00 which supersedes P0451.

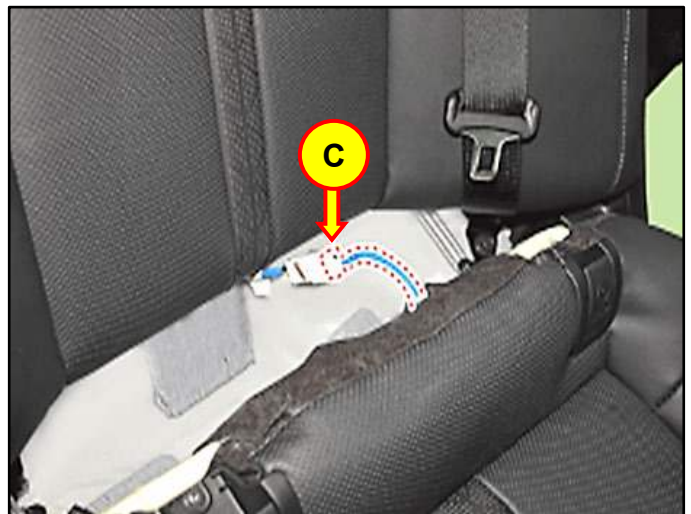
3. Disconnect the rear seat heater connector if equipped (C).

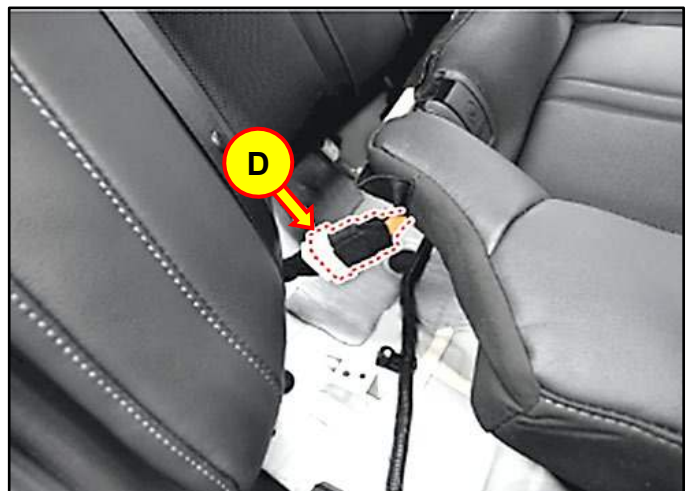
4. Disconnect the rear seat heater unit connector if equipped (D).

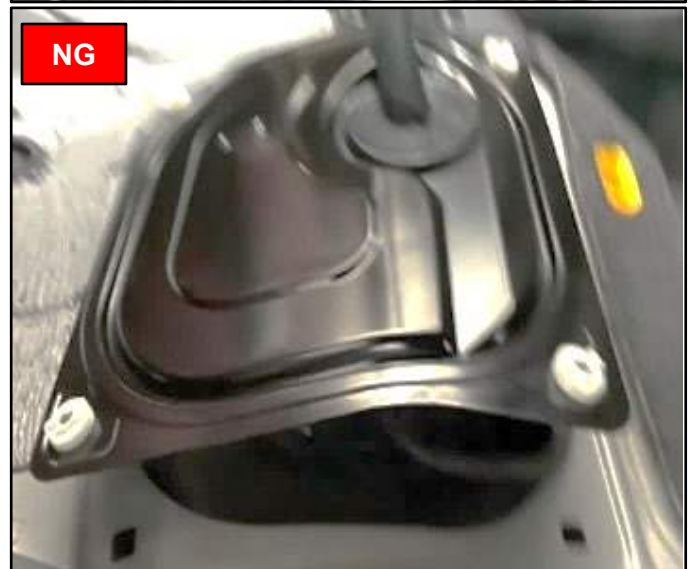
5. Inspect the fuel pump service cover (E).

- If a gap is **NOT** present (**GOOD**):
  - Replace the check valve.
  - Proceed to **step 8**.
- If a gap **is** present (**NG**)
  - Open RA Techline Case.
  - Continue to **step 6**.

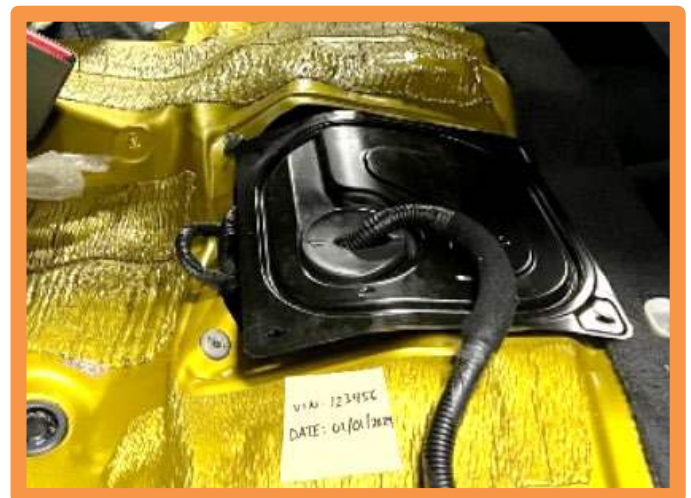
Using STUI, take a photo of the gap in the fuel pump service cover, with the last 6 digits of the VIN and the date of repair on a piece of paper.

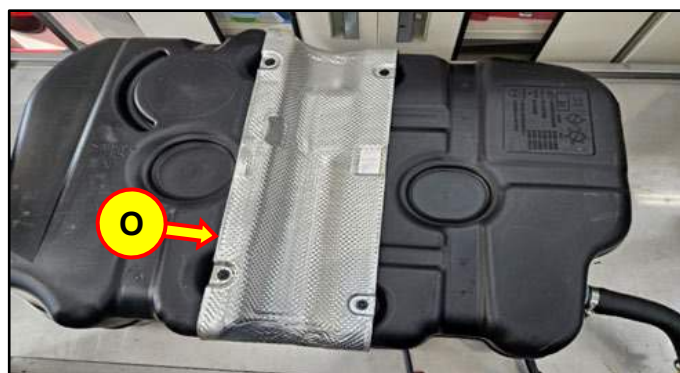
16. Remove the fuel tank band (M) and then the fuel tank (N) from the vehicle.

Replace fuel tank bands during installation.

Use a siphon pump to transfer fuel to supplied tank.

Attach the fuel tank heat protector (O) supplied to the new fuel tank.
