Technical Service Bulletin

01 MIL on (DTC P0456 or DTC P0442 (EVAP emission control system leak detected))

01 14 65 2035519/4 February 4, 2014. Supersedes Technical Service Bulletin Group 01 number 14-58 dated January 14, 2014 for reasons listed below.

Model(s)	Year	VIN Range	Vehicle-Specific Equipment
Q7	2013 - 2014	All	Not Applicable

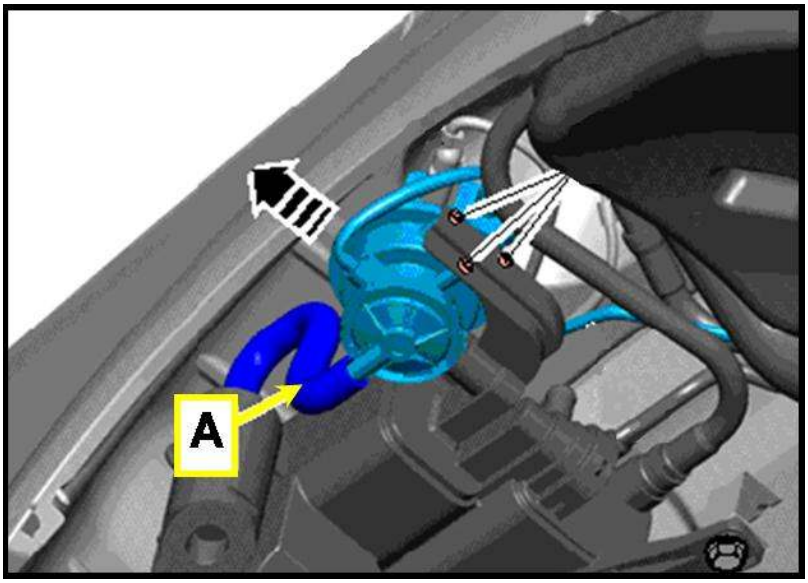
***Figure 1**. Hose leading to LDP air filter (A).*

***Figure 2**. Tool -3094-, hose clamps.*

1. Visually inspect the EVAP system for any loose connections or damaged parts. If found, repair the loose connections and/or replace the damaged parts.
2. Pressurize the EVAP system using the KLI9210 Smoke/Pressure test:
   - Clamp off the hose that leads to the LDP air filter (Figure 1). Use hose clamps up to 25 mm diameter (Figure 2).
   - Pressurize the EVAP system to 12 inch/water (30mbar), and check pressure loss over time.
