Bulletin No.: PI0931

Service Bulletin

Subject: Service Engine Soon (SES) Light On with DTCs P0171, P1101, and/or P0101 Set

Models: 2013 Buick Verano

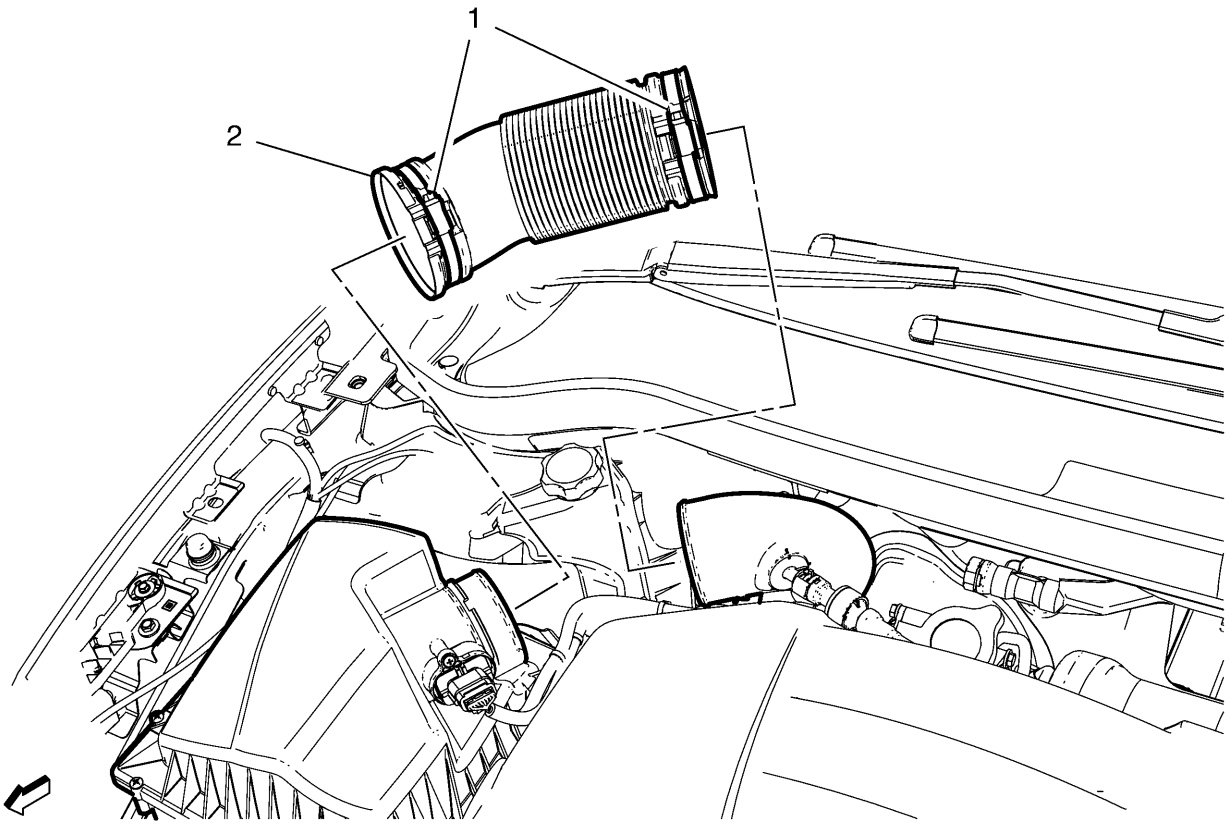
Some customers may comment that the service engine soon (SES) light is on. Upon further inspection, the technician may find P0171, P1101 and/or P0101 stored in history.

This condition may be caused by loose clamps on the air cleaner duct (1) as shown in the illustration above.

Inspect both clamps on the air cleaner outlet duct to ensure that the clamps are secured tightly.
