SERVICE BULLETIN

APPLICABILITY: 2017MY Legacy and Outback 2.5i Premium Models with EyeSight

NUMBER: 07-121-17

SUBJECT: DTC B2902

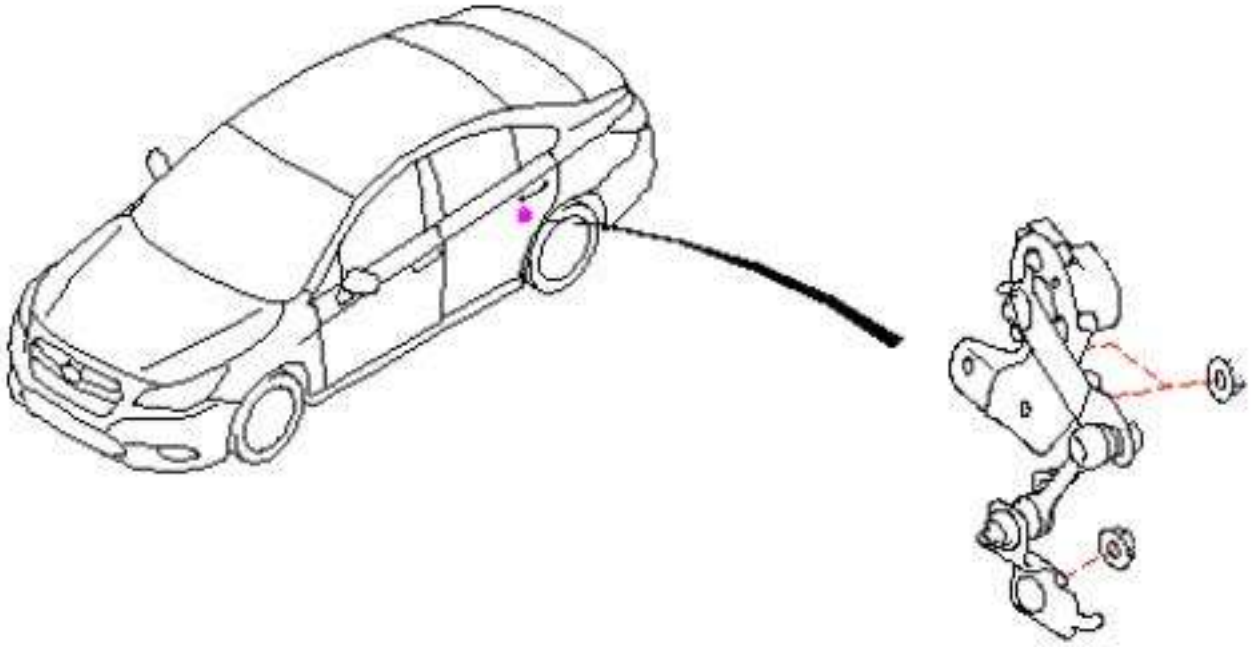
The part number for the correct specification headlamp control module is **84051AL080**.

If DTC B2902 is stored in the Headlight Control System, confirm using the VIN and the Subaru Electronic Parts Catalog whether or not the vehicle should be equipped with the Headlamp Leveler sensor. If the vehicle is not equipped with the Headlamp Leveler Sensor, install the new (84051AL080) module. If equipped with the sensor, diagnose the DTC as per the applicable Service Manual.
