GROUP	MODEL
	Engine	**2011-2012MY Sportage (SL) Turbo**
	NUMBER	DATE
	130 (Rev 1, 01/17/2014)	**July 2013**

TECHNICAL SERVICE BULLETIN

SUBJECT: ECM UPGRADE – REFLASH AND EWGA ADJUSTMENT PROCEDURE (SA 149)

This issue number is SA149.

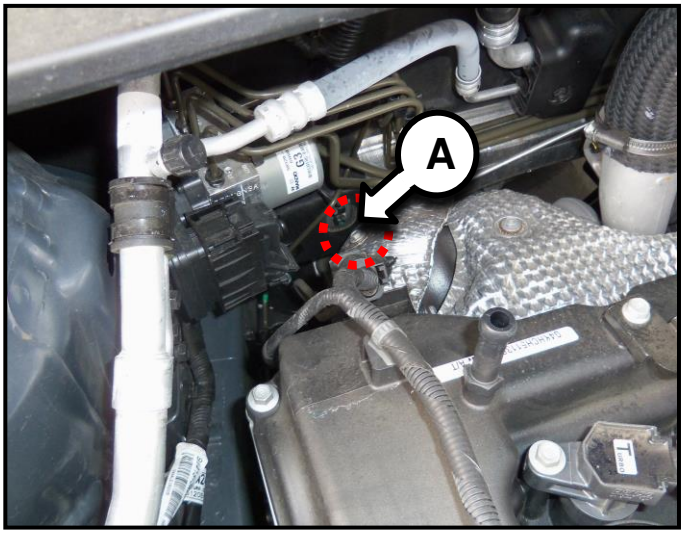
On some Sportage (SL) vehicles, produced from May 1, 2011 to January 1, 2012, the Malfunction Indicator Light (MIL) may illuminate with DTC P2562 and/or P2565. Inspect the voltage value for boost pressure actuator position control, using GDS. If the voltage is not within specified value, follow the service procedure outlined below to adjust the Electronic Waste Gate Actuator (EWGA) rod length. To ensure maximum customer satisfaction, Kia is requesting the completion of this Service Action on all affected vehicles. For confirmation that the latest reflash has been done to a vehicle you are working on, verify ROM ID using the tables in this TSB.

- **P2562** - Turbocharger Boost Control Position Sensor 'A' Circuit Range / Performance
- **P2565** - Turbocharger Vane Position Sensor Circuit High Voltage

EWGA Adjustment Procedure:

3. Loosen the rod end lock nut (B) and remove the retaining clip (C).

6. Once the voltage is within specifications, install the c-clip to rod end and tighten the lock nut.
7. Cycle the key five (5) times as noted in step 4 and confirm the voltage reading of the Adaptation Value for the Lower Mechanical Stop is within specification.
8. Install all other components by reversing the order of removal.
9. Test drive the vehicle to confirm proper operation.

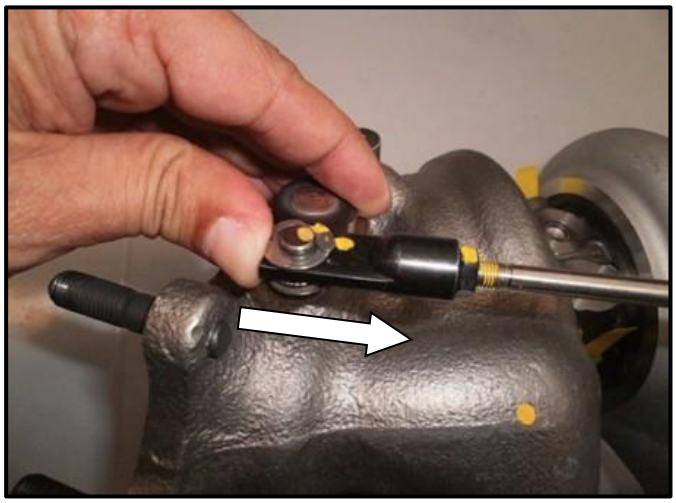
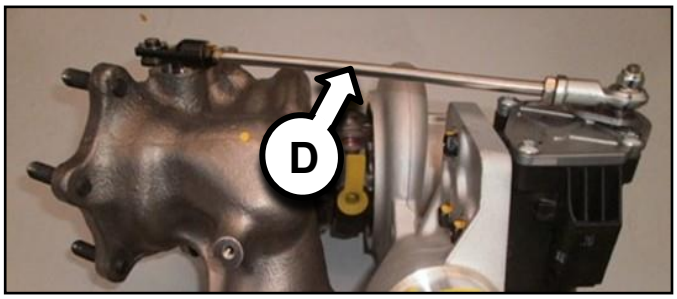
Specification: 4.1V (Cold Engine)

Verify the EWGA is in the fully closed position by applying pressure on the EWGA lever to accurately measure the output.

If unable to achieve proper voltage, it may be necessary to rotate the EWGA rod (D) to achieve proper voltage.

5. If the output voltage is not within specification, repeat step 3 in EWGA adjustment procedure until specification is within range.
