Technical Service Bulletin

01 MIL on (DTC P0456 or DTC P0442 (EVAP emission control system leak detected))

01 14 58 2035519/3 January 14, 2014. Supersedes Technical Service Bulletin Group 01 number 13-40 dated November 4, 2013 for reasons listed below.

Model(s)	Year	VIN Range	Vehicle-Specific Equipment
Q7	2013 - 2014	All	Not Applicable

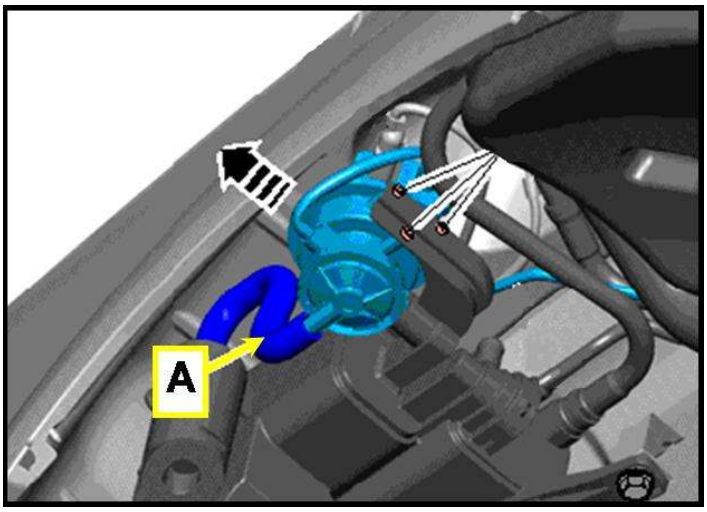
- Clamp off the hose that leads to the LDP air filter (Figure 1). Use hose clamps up to 25 mm diameter (Figure 2).
   - Pressurize the EVAP system to 12 inch/water (30mbar), and check pressure loss over time.

***Figure 1**. Hose leading to LDP air filter (A).*

***Figure 2**. Tool -3094-, hose clamps.*

3. If remaining pressure after 3 minutes is 9 inch/water (22.4 mbar) or *higher*, the system has no leaks:

- Replace the LDP with the latest part number (see parts catalog). Immediately put the old LDP into a plastic bag and seal it for shipment to Auburn Hills. Do not clean off the old LDP before shipping; all particles involved should be shipped with the part.

If remaining pressure after 3 min is *lower* than 9 inch/water (22.4 mbar), the system has a leak.

- Locate the leak with the smoke generator function of the Evaporative Emissions Tester KLI9210 and repair as necessary.
