Technical Service Bulletin

37 Transmission warning message in cluster, P060A00 stored

37 12 77 2029027/5 December 19, 2012. Supersedes Technical Service Bulletin Group 37 number 12-67 dated September 28, 2012 for reasons listed below.

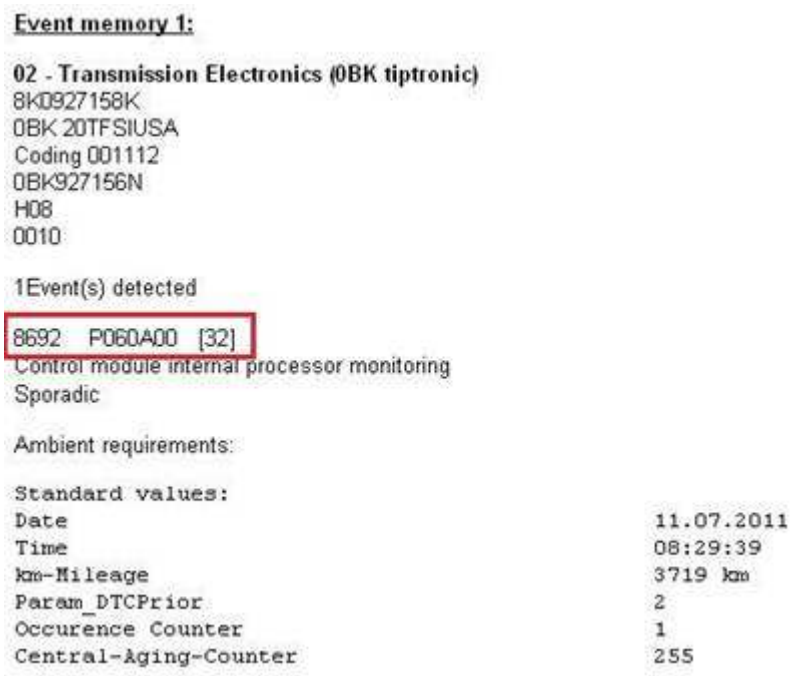
The entry **P060A00** with DFCC 8692 can be logged in the following situation: After selecting Neutral, a driving mode (D or R) is selected within one second while the vehicle rolls (at under 2 mph). This can, for example, happen when maneuvering the vehicle into or from a parking area.

The entry **P060A00** with DFCC 8694 can be logged when quickly changing from P-N because of a low diagnosis threshold.

The entry **P060A00** with DFCC 12480 can be logged because of a low diagnosis threshold when changing gear with the tip function.

Tip: DFCC is the 4-6 digits in front of the P code.

Figure 1. *4-6 digit DFCC code.*

New software in the Transmission Control Module (J217) addressed the condition.

1. Follow all instructions in the attached TSB 2011732 *00 Software Version Management (SVM), operating instructions*.
2. Update the transmission control module (J217) using the SVM action code as listed in the table below if necessary.
