Technical Service Bulletin

01 MIL on, no start or rough running (DTC P0087 - Rail fuel pressure too low or DTC P0088 - Rail fuel pressure too high)

01 13 79 2023360/3 March 20, 2013. Supersedes Technical Service Bulletin Group 01 number 11-18 dated January 25, 2011 for reasons listed below.

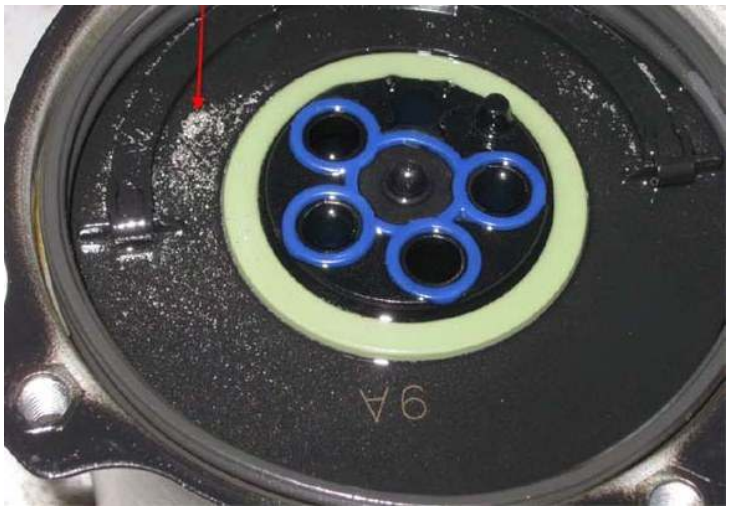
If there is any indication of fuel contamination, metal shavings/debris, or rust inside the fuel filter housing (Figures 1 and 2), **call the Technical Assistance Center (TAC) and open a ticket before attempting any repair.**

Figure 1. *Example of metal shavings and debris on top of fuel filter. Some shavings can be picked up with a magnet.*

Figure 2. *Example of rust in fuel system caused by water contamination.*
