Technical Service Bulletin (TSB)

Global Telematics Box (TBM) Update To SW 4.39 - Dealer Option

REFERENCE:	**TSB:** 08-380-26 **GROUP:** 08 - Electrical	**Date:**	October 17, 2026	**REVISION:**	—
VEHICLES AFFECTED:	**2025 (WD) Dodge Durango** **This bulletin applies to vehicles equipped with Global Telematics Box Module (Sales Code RDG).**			**MARKET APPLICABILITY:** ☒ NA ☐ MEA ☐ SA ☐ IAP ☐ EE ☐ CH **NOTE: This bulletin applies to the North America market.**	
CUSTOMER SYMPTOM:	**Customers may experience a Malfunction Indicator Lamp (MIL) illumination and one or more of the following Diagnostic Trouble Codes (DTCs):** • B22A9-96 - ECU Internal Performance-Component Internal Failure. • B1560-11 - Cellular Antenna 1-Circuit Short To Ground. • B1560-13 - Cellular Antenna 1-Circuit Open. • B1561-11 - Cellular Antenna 2-Circuit Short To Ground. • B1561-13 - Cellular Antenna 2-Circuit Open. • B1562-14 - GPS Antenna-Circuit Short To Ground Or Open. **Customers may also experience the following:** • "Uconnect Box Requires Service" Message in Radio Display Fig. 1.

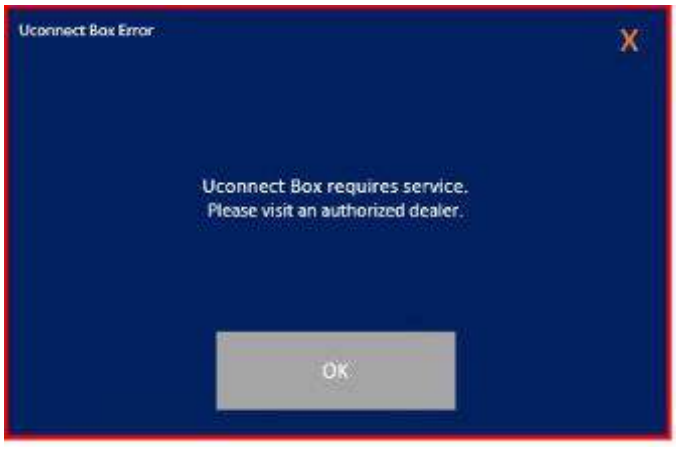
CAUSE:	**TBM Software**

Fig. 1
Uconnect Box Error Message

This bulletin involves reprogramming the TBM with the latest available software.

1. Reprogram the TBM with the latest available software. If issues arise when flashing a module using the wiTECH Diagnostic Application, please submit a ticket to the Helpdesk. The helpdesk can be found within the Help menu.
2. Clear any DTCs that may have been set in any modules due to reprogramming. The wiTECH application will automatically present all DTCs after the flash and allow them to be cleared.
