Technical Service Bulletin (TSB)

Global Telematics Box (TBM) Update To SW 4.39 - Dealer Option

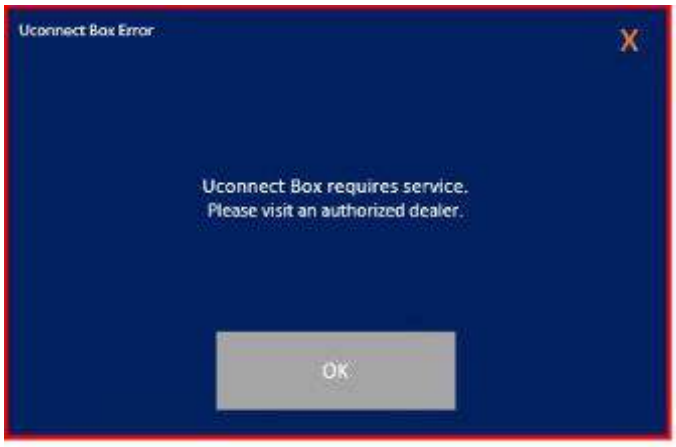
REFERENCE:	**TSB:** 08-381-26 **GROUP:** 08 - Electrical	**Date:**	October 17, 2026	**REVISION:**	—
VEHICLES AFFECTED:	**2026 (WD) Dodge Durango** **This bulletin applies to vehicles built on or before June 30, 2026 (MDH 0630XX) equipped with Global Telematics Box Module (Sales Code RDG).**			**MARKET APPLICABILITY:** ☒ NA ☐ MEA ☐ SA ☐ IAP ☐ EE ☐ CH **NOTE: This bulletin applies to the North America market.**	
CUSTOMER SYMPTOM:	**Customers may experience a Malfunction Indicator Lamp (MIL) illumination and one or more of the following Diagnostic Trouble Codes (DTCs):** • B22A9-96 - ECU Internal Performance-Component Internal Failure. • B1560-11 - Cellular Antenna 1-Circuit Short To Ground. • B1560-13 - Cellular Antenna 1-Circuit Open. • B1561-11 - Cellular Antenna 2-Circuit Short To Ground. • B1561-13 - Cellular Antenna 2-Circuit Open. • B1562-14 - GPS Antenna-Circuit Short To Ground Or Open. **Customers may also experience the following:** • "Uconnect Box Requires Service" Message in Radio Display Fig. 1.

CAUSE:	**TBM Software**

Fig. 1
Uconnect Box Error Message

This bulletin involves reprogramming the TBM with the latest available software.

1. Reprogram the TBM with the latest available software. If issues arise when flashing a module using the wiTECH Diagnostic Application, please submit a ticket to the Helpdesk. The helpdesk can be found within the Help menu.
2. Clear any DTCs that may have been set in any modules due to reprogramming. The wiTECH application will automatically present all DTCs after the flash and allow them to be cleared.
