STELLANTIS
PARTS & SERVICES

Technical Service Bulletin (TSB)

Evap / Fuel Line Quick Connect Exposed Near Exhaust

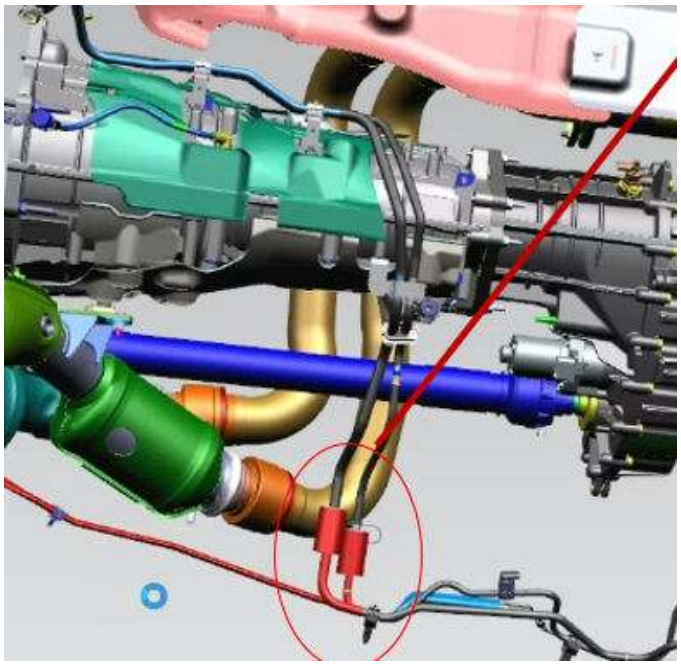
Fig. 1
Fuel Line Quick Disconnects Location

1. Raise and support the vehicle. Refer to the detailed service procedures available in DealerCONNECT/ Service Library under: Service Info> 04 - Vehicle Quick Reference / Hoisting / Standard Procedure.
2. Inspect the evap / fuel line quick disconnects Fig. 1.

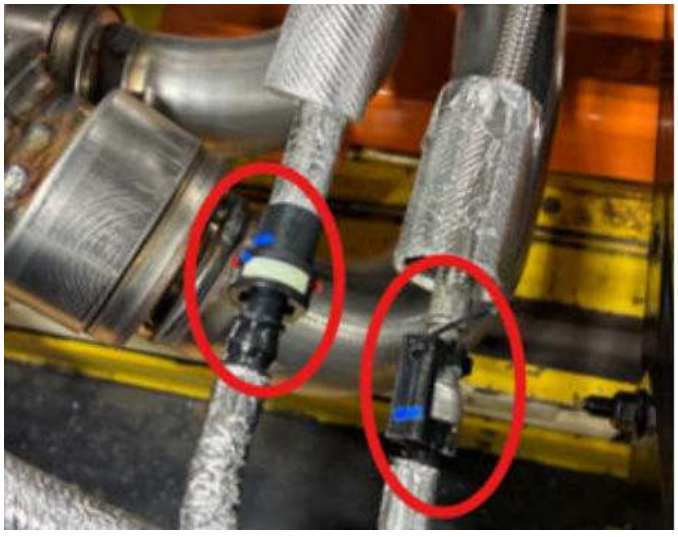
Fig. 2
Fuel/Evap Line Quick Disconnects Exposed

REFERENCE:	**TSB:** 14-011-26 **GROUP:** 14 - Fuel	**Date:**	October 31, 2026	**REVISION:**	—
VEHICLES AFFECTED:	**2026 (WS) Jeep Wagoneer / Grand Wagoneer** **This bulletin applies to the vehicle built on or after April 14, 2026 (MDH 0414XX) and on or before April 18, 2026 (MDH 0418XX) equipped with 3.0L Twin Turbo Six Pack SO ESS (Sales Code EFH).**			**MARKET APPLICABILITY:** ☒ NA ☐ MEA ☐ SA ☐ IAP ☐ EE ☐ CH **NOTE: This bulletin applies to the North American market.**	
CUSTOMER SYMPTOM:	**Customers may experience a Malfunction Indicator Lamp (MIL) illumination and the vehicle may exhibit/set the following Diagnostic Trouble Code (DTC):** • P0456-00 EVAP System Small Leak.				
CAUSE:	**Exposed evap / fuel line quick disconnects**

3. Are the evap / fuel line quick disconnect heat shields improperly positioned, exposing the evap / fuel line quick disconnects Fig. 2?

- YES>>> Proceed to Step 4.
- NO>>> This bulletin has been completed. Use Inspection LOP (14-70-10-94) to close the active RSU.
