| <b>HYUNDAI</b><br><b>Technical Service Bulletin</b> | GROUP<br><b>FUEL SYSTEMS</b> | NUMBER<br><b>25-FL-002H</b> |
| <b>SUBJECT:</b> HIGH PRESSURE FUEL PUMP REPLACEMENT<br>(WARRANTY EXTENSION Z04) | | |

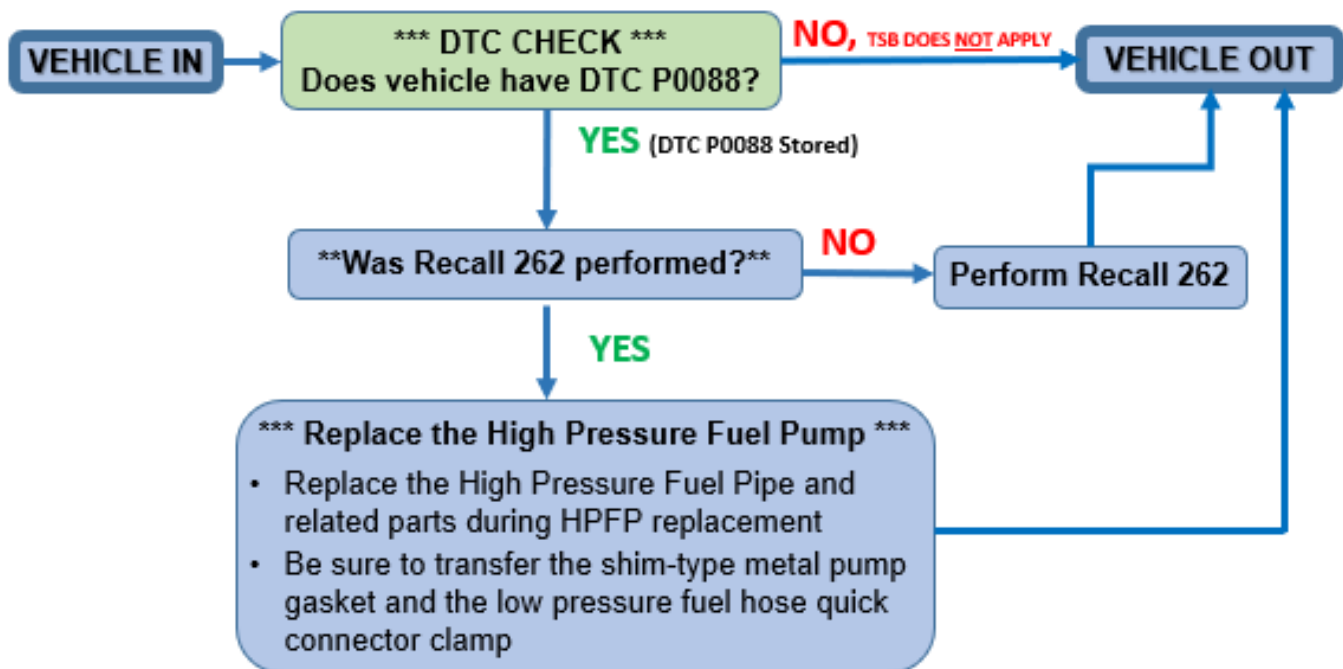
## Inspection and Service Procedure Overview:

**Description:** Certain 2019-2022MY Veloster N (JSN), 2022-2023MY Elantra N (CN7N), and 2022-2023MY Kona N (OSN) vehicles are equipped with high pressure fuel pump (HPFP) assemblies that have fuel control valves (FCV) that could allow excess fuel to enter the fuel pump due to gradual wear of the FCV plunger. An air/fuel mixture that runs too “rich” may result in a reduction or loss of motive power at low speeds. The vehicle will also have Diagnostic Trouble Code (DTC) P0088.

Follow the service procedure in this TSB to replace the HPFP.

- Using a GDS scan tool, inspect to confirm if vehicle has DTC P0088 (or P008800).
  - If vehicle has DTC P0088/P008800, continue with the steps below to replace the high pressure fuel pump.
  - If vehicles does **NOT** have DTC P0088/P008800, this TSB does **NOT** apply. Continue with normal diagnosis.
