## Technical Service Bulletin

**GROUP****FUEL SYSTEMS****NUMBER****25-FL-002G****DATE****FEBRUARY 2025****MODEL(S)****G70 (IK)****SUBJECT:**

HIGH PRESSURE FUEL PUMP REPLACEMENT  
(WARRANTY EXTENSION Z05G)

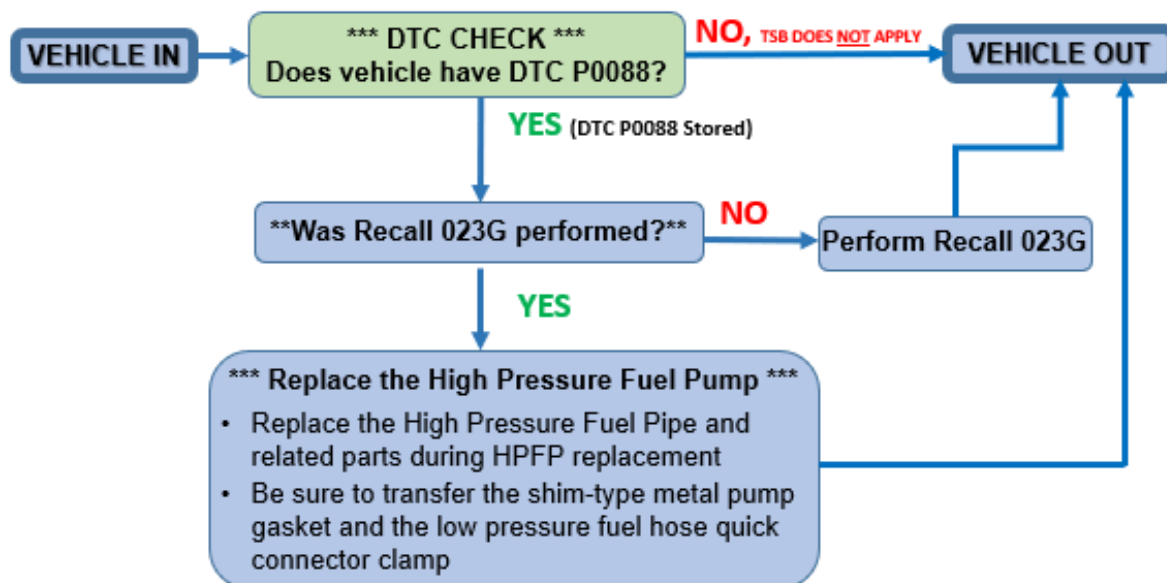
## Inspection and Service Procedure Overview:

**Description:** Certain 2019-2023MY G70 (IK) vehicles are equipped with high pressure fuel pump (HPFP) assemblies that have fuel control valves (FCV) that could allow excess fuel to enter the fuel pump due to gradual wear of the FCV plunger. An air/fuel mixture that runs too “rich” may result in a reduction or loss of motive power at low speeds. The vehicle will also have Diagnostic Trouble Code (DTC) P0088.

Follow the service procedure in this TSB to replace the HPFP.

1. Using a GDS scan tool, inspect to confirm if vehicle has DTC P0088 (or P008800).
  - If vehicle has DTC P0088/P008800, then follow the next steps below to replace the high pressure fuel pump.
  - If vehicles does **NOT** have DTC P0088/P008800, this TSB does **NOT** apply. Continue with normal diagnosis.
