# Technical Service Bulletin

| Topic | New Continental GT and New Continental GTC - Window drop glass operation |
| Transaction No. | 2075821/1 |
| Release date | Feb 24, 2025 |

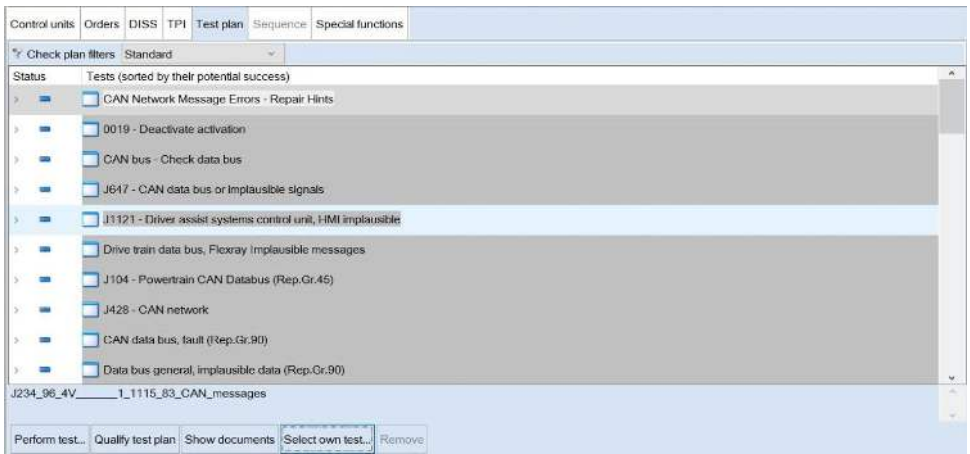
Figure 1

Open the test plan tab in ODIS and select "select own test" (Figure 1).

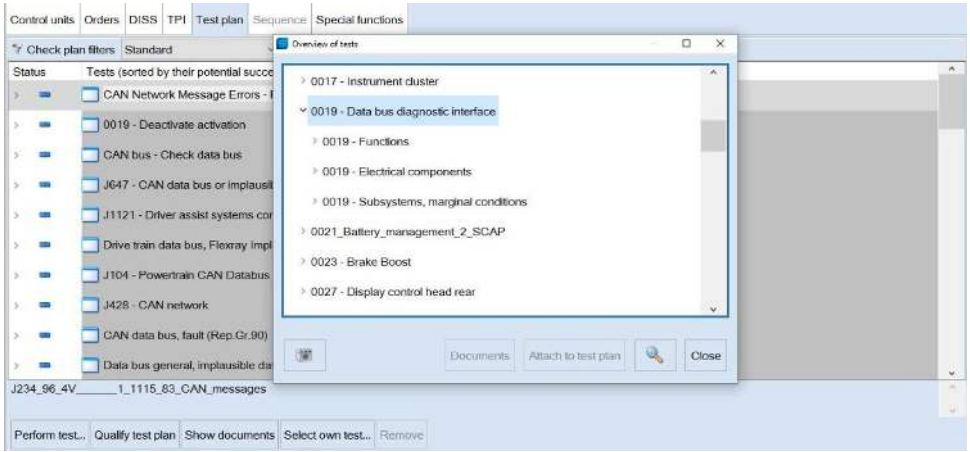
Figure 2

Now select address 0019 Data bus diagnostic interface (Figure 2), then within “functions” select “read measured values” (Figure 3)

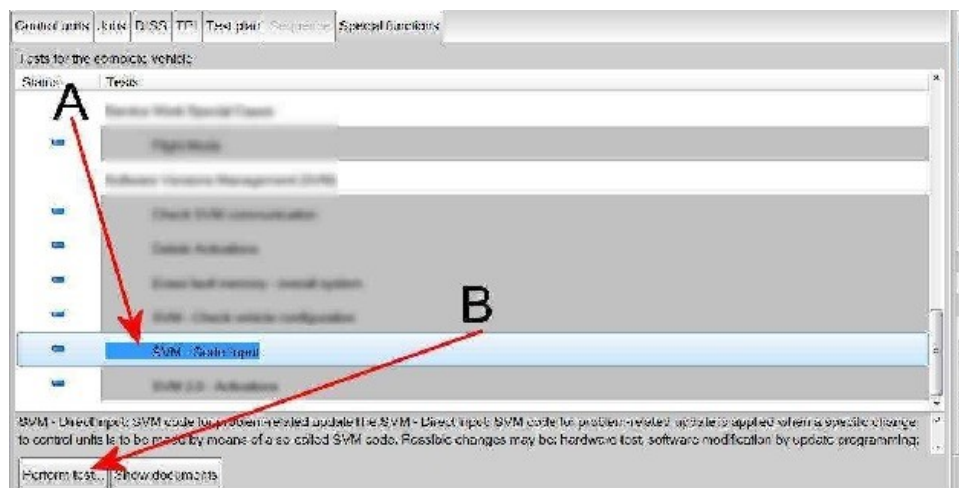
3a) Referring to Figure 6 - Within the Special functions tab - Select SVM - Code Input (Point A)

- Select Perform test (Point B)

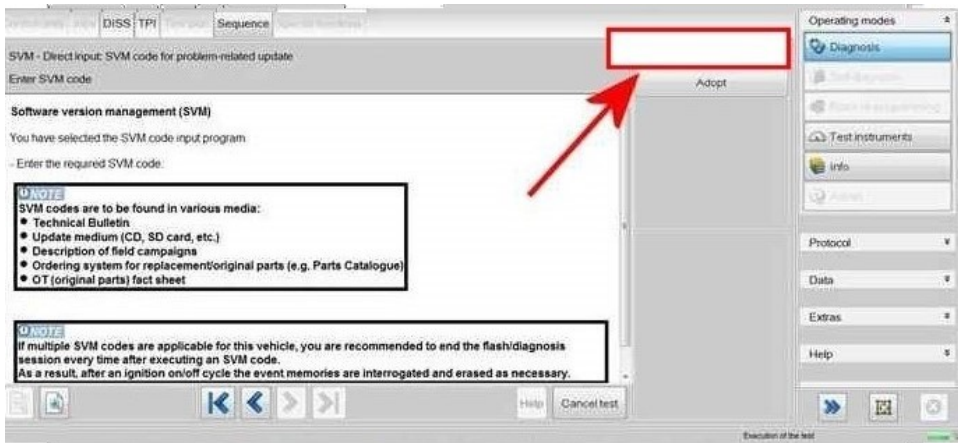
3b) Referring to Figure 7 - Enter the SVM code 372WDD01

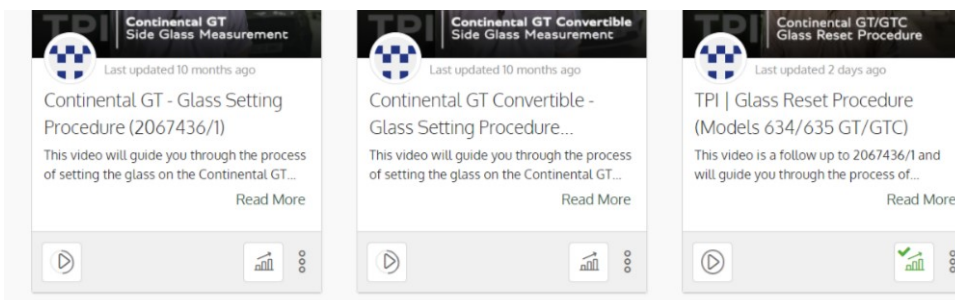
- The operative must review the (x3) videos which are available on the Digital Learning HUB (see example shown in Figure 10 of all videos which must be reviewed)
