# Service Bulletin

Bulletin No.: 25-NA-050

**Subject: DTC U0265 and Other Front Camera Module Software Concerns**

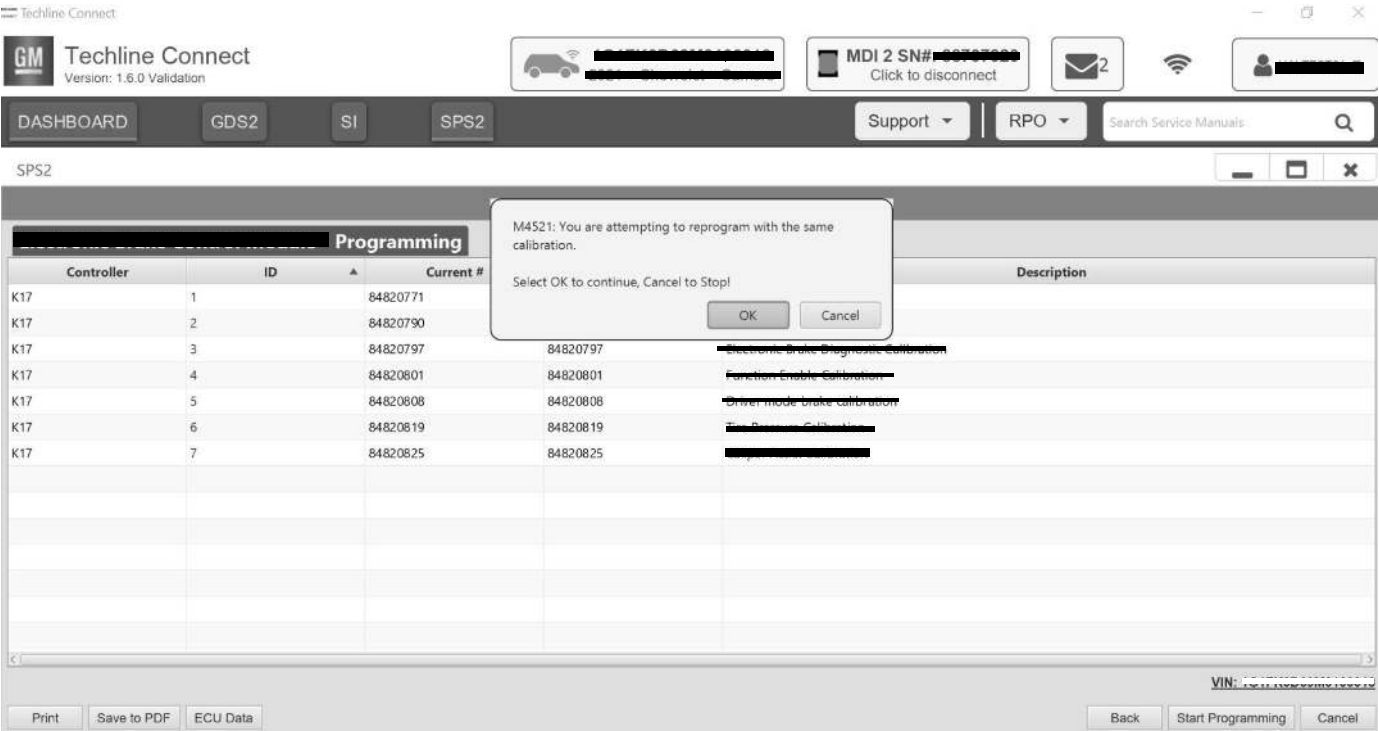
5877000

**Important:** Techline Connect screen shown above.

**Important:** If the same calibration/software warning is noted on the TLC Summary screen, select OK and follow screen instructions. After a successful programming event, the WCC is located in the Service Programming System dialogue box of the SPS Summary screen. Record the WCC on the job card. No further action is required. Refer to the Warranty Information section of this bulletin.
