## Technical Service Bulletin

| <b>Topic</b> | 93 Charging door does not open when button pressed - B1A8FF0, B1A89F0, B1A8AF3, B1A88F3 |
| <b>Brand</b> | Audi |
| <b>Transaction No.</b> | 2071343/2 |

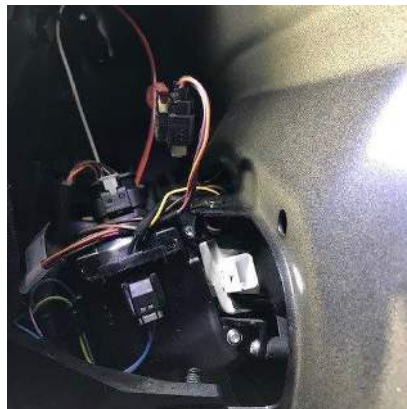
1. Unplug the connector from the charging indicator (Figure 4).  
Check the contacts and connector of the charging indicator(s).

**Figure 4:** The connector has been unplugged.

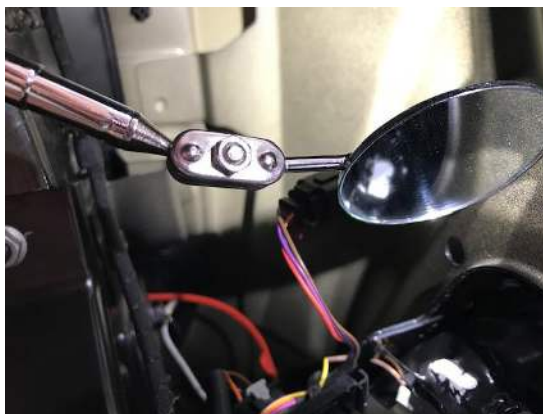
**Figure 6:** Use inspection mirror to carefully examine the charging indicator connector.

3. Check the connector point on the charging indicator for cracks (Figure 1).

If the connector point is cracked or the pins are oxidized (Figure 7), replace the damaged charging door unit as described under the heading **“Removing and installing charging door unit”** below.

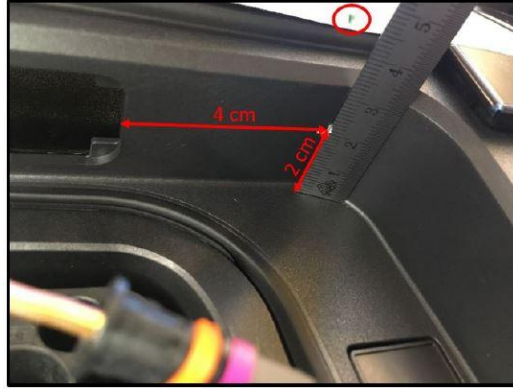
**Figure 11:** The drill mark should be at the same level as the first mark at 2 cm.

4. Open the charging door using the button and make a drill mark at the same level as the first mark, exactly as depicted in Figure 11.

As an alternative to marking at the letter “n” (left side of vehicle) or “e” (right side of vehicle), a dimension of 4 cm (Figure 11) may also be used.

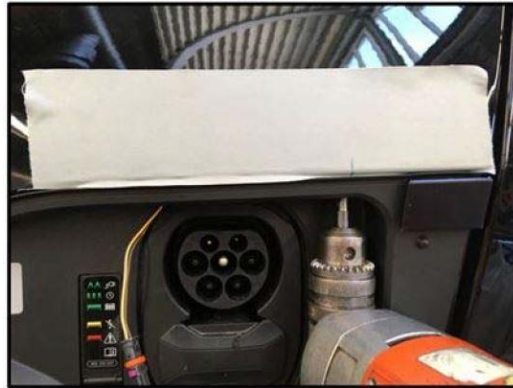
**Figure 12:** Use an angled drill/angle bit to drill to a depth of 15mm at the marked location.

5. Drill through the retaining lug from the inside using an angled drill/angled bit and a short commercially available spot weld drill (diameter approximately 7mm) to a depth of approximately 15 mm at the marked location (Figure 12).

**Remove the drilling residue at the charging socket using a compressed air gun.**

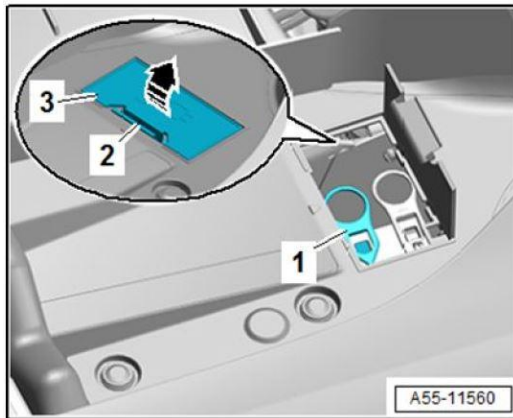
**Figure 13:** The plenum chamber door and manual release cable.

6. Release catch (2) on the plenum chamber and open the cover (3), then move the manual release cable (1) clear (Figure 13).
