# Technical Service Bulletin

| Topic | Window Drop Glass Operation Continental GT/GTC 25MY |

Retailer glass reset procedure for New GT/GTC

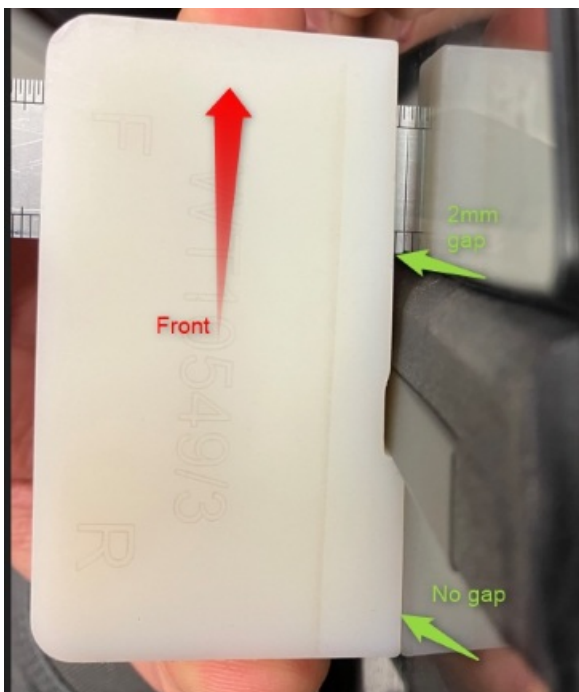
Figure 11

When the window is parallel take the 2mm step from the tool and minus the 2mm gap between front window and tool = -0mm (as shown in figure 11)

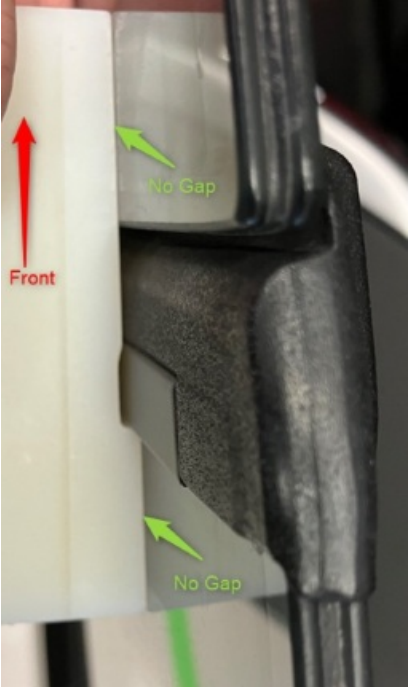
Figure 13

When the rear window is inboard and there is a 2mm step from the tool, when there is no gap between either window and tool (figure 13), the recorded measurement should be -2mm (figure 14)

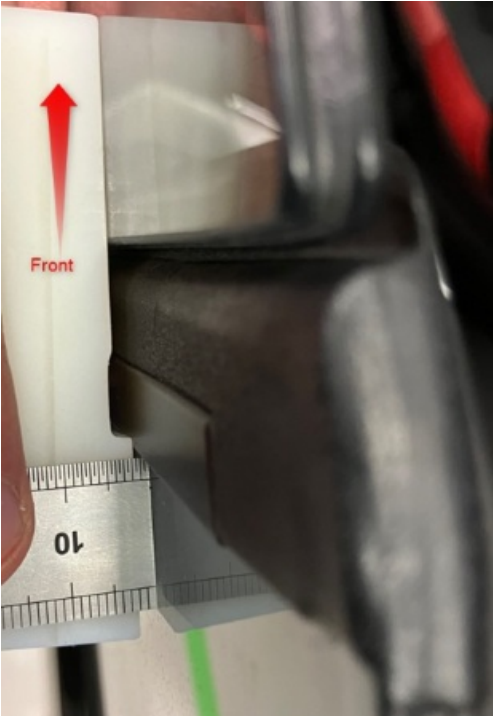
Figure 15

When the rear window is inboard and there is a 2mm step from the tool as well as an additional 1.5mm gap to the window (figure 15), the recorded measurement should be -3.5mm (figure 16).

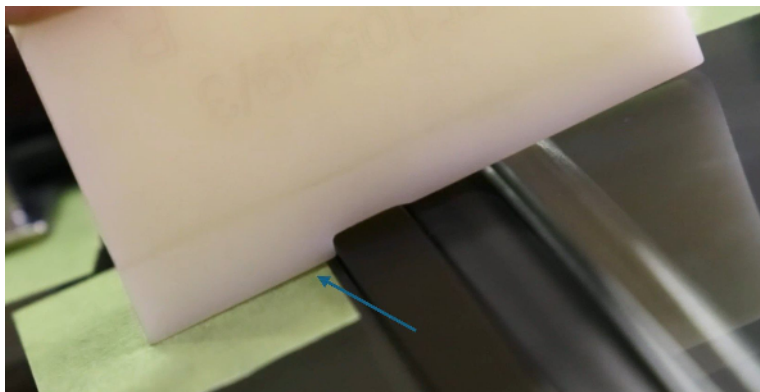
Figure 17

If the tool (WT10549/3) does not sit flush against the rear window then this shows rear window is more than 2mm inboard (more than -2mm), check this by holding the tool on the front window and measuring gap between the rear glass and the tool (as shown in figure 17)

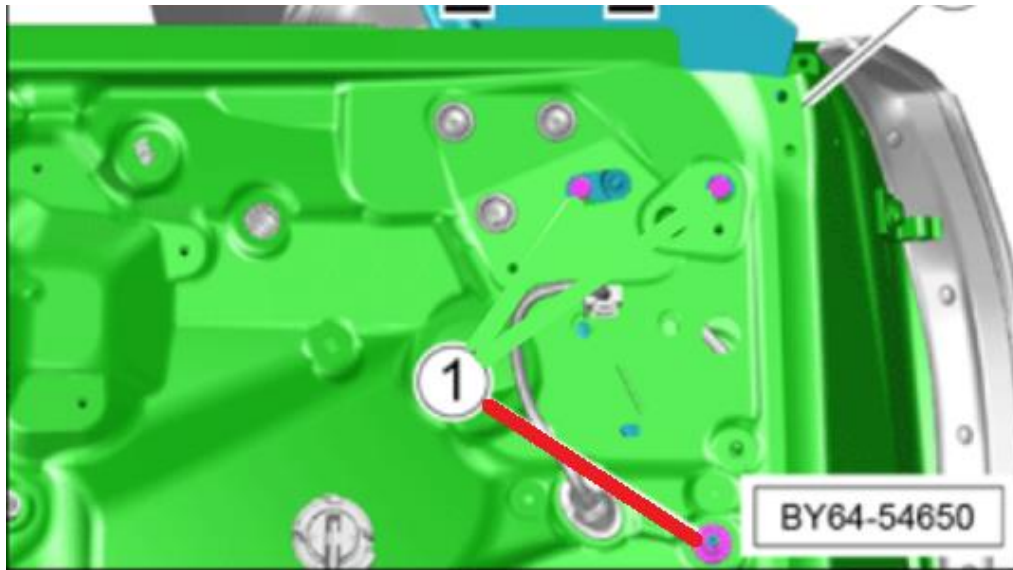
Measurement between bottom of mounting washer and division bar frame, is 12.5mm.

To reset this adjuster without removing the quarter glass, loosen the lock nut, screw the adjuster all the way in clockwise until it bottoms out on the frame, then unscrew anti clockwise 4 complete turns then set height and profile to ELSA specification before moving on to the next step.

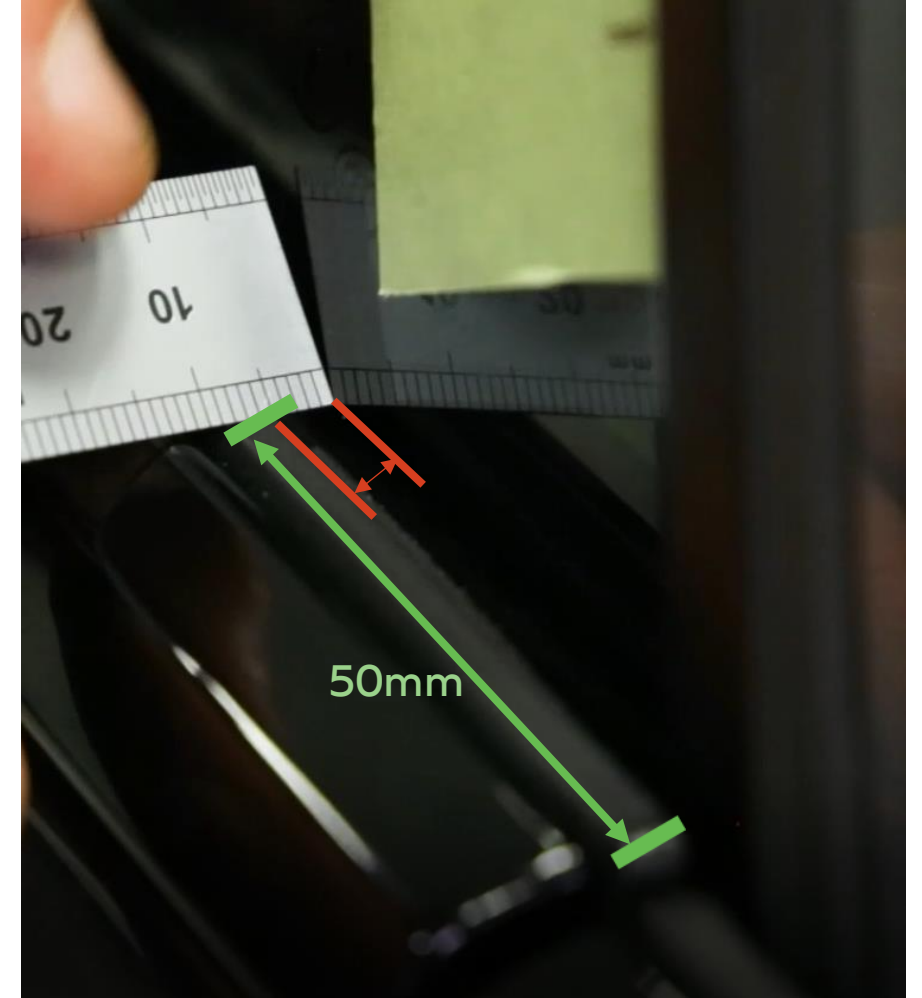
When setting front to rear window profile and waist rail measurements ensure that the front window does not move outboard excessively when the rear window closes as this will increase current draw on the rear motor during the period where it is monitoring for it's end stop, excess current draw in this zone can cause a false anti-trap scenario.
