**HYUNDAI**  
**Technical Service Bulletin**

NUMBER  
**25-EM-005H**

MODEL(S)  
**SANTA CRUZ (NXT)**

**SUBJECT:** INTEGRATED THERMAL MANAGEMENT (ITM)  
REPLACEMENT & ECU SOFTWARE UPDATE – DTC P218100

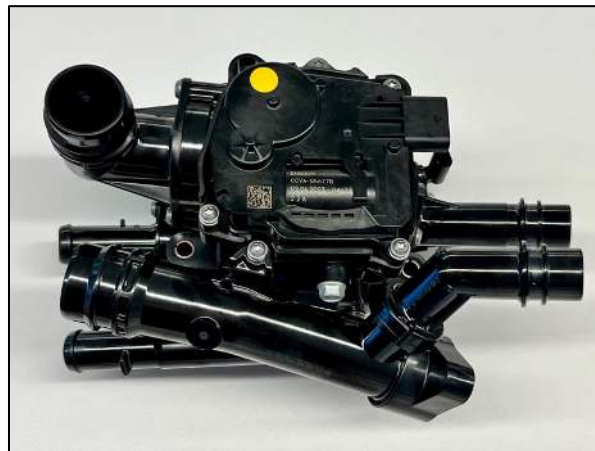
**Description:** Certain 2022-2023MY Santa Cruz (NXT) vehicles may exhibit a warning lamp illumination for a diagnostic trouble code P218100 that is related to the Integrated Thermal Management Module (ITM). Follow the service procedure outlined in this bulletin to replace the ITM with a revised part and update the Engine/Electronic Control Unit (ECU).

- Completion of both ITM replacement using the part listed below and the ECU updates to revise the control logic is required to repair “DTC P218100 - Cooling System Performance”.
- A Prior Approval (PA) is **NOT** required for this repair, regardless if the affected part is outside of the New Vehicle Limited Warranty (5 years/60,000 miles).
