# Service Bulletin

Bulletin No.: 24-NA-166

**Subject: DTC C1171 C1172 C1173 C1174 Tire Pressure Monitor Sensor Unable to Relearn Ethernet Cable Overlay for TCP OnStar Module**

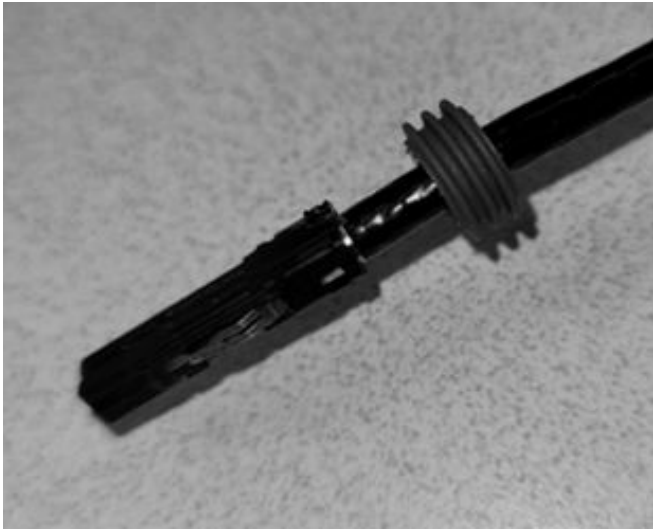
6720420

Here is the empty housing shell. Circle in red is the 1 release tab. The arrow is showing the direction the tab needs to be pressed to release the cable. Moving it away from the middle.

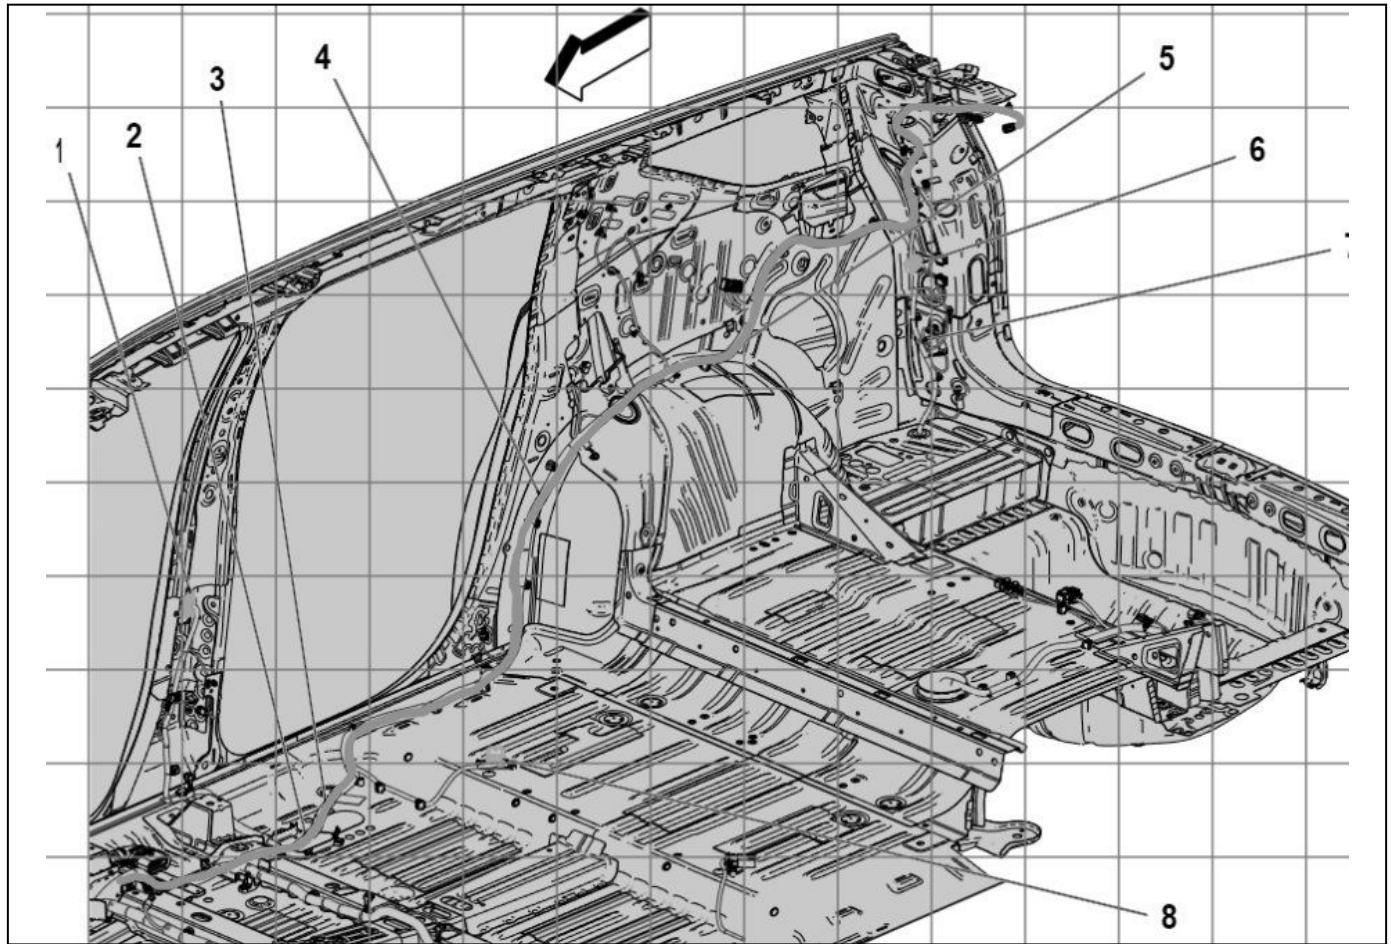
6706066

**Note:** Replacement Ethernet Cable routing shown in Green.

18. Begin to route the new Service cable starting at X205 and following the Body Wiring Harness running back towards the Telematic Control Module. Use the diagrams above to reference cable routing.
