## Technical Service Bulletin (TSB)

### Incorrectly Routed Wheel Speed Sensor Wiring

| REFERENCE: | TSB: 05-003-25<br>GROUP: 05 - Brakes | Date: | July 11, 2025 | REVISION: | – |
| VEHICLES AFFECTED: | 2025 (DP) RAM 4500/5500 Cab Chassis<br>This bulletin applies to vehicles built on or after February 05, 2025 (MDH 0205XX) and on or before March 31, 2025 (MDH 0331XX) equipped with a 6.4L V8 HEMI Upgrade HD Engine (Sales Code ESL). | | | MARKET APPLICABILITY:<br><div><input checked="" type="checkbox"/> NA<input type="checkbox"/> MEA</div> <div><input type="checkbox"/> SA<input type="checkbox"/> IAP</div> <div><input type="checkbox"/> EE<input type="checkbox"/> CH</div><br><b>NOTE:</b> This bulletin applies to North America markets. | |

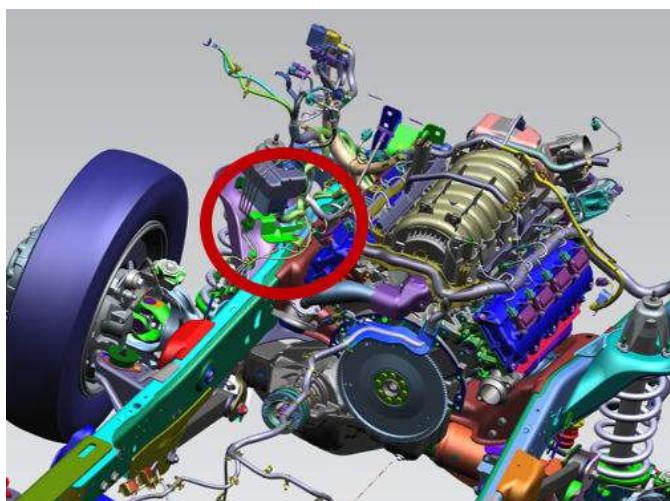
**Fig. 1**  
Inspection Area

1. Remove the left front wheelhouse splash shield to gain access to the wheel speed wiring harness inspection area [Fig. 1](#). Refer to the detailed service procedures available in DealerCONNECT/Service Library under: Service Info> 23 - Body / Exterior / Shield, Splash, Front Wheelhouse / Removal.

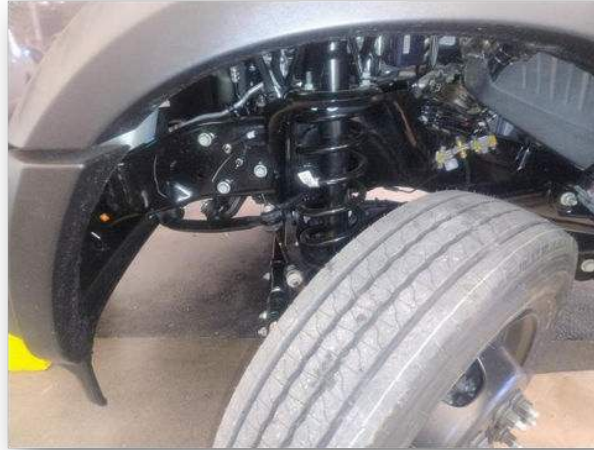
**Fig. 2**

2. Turn the steering wheel full lock to the left [Fig. 2](#).

Left Front Wheel Fully Turned

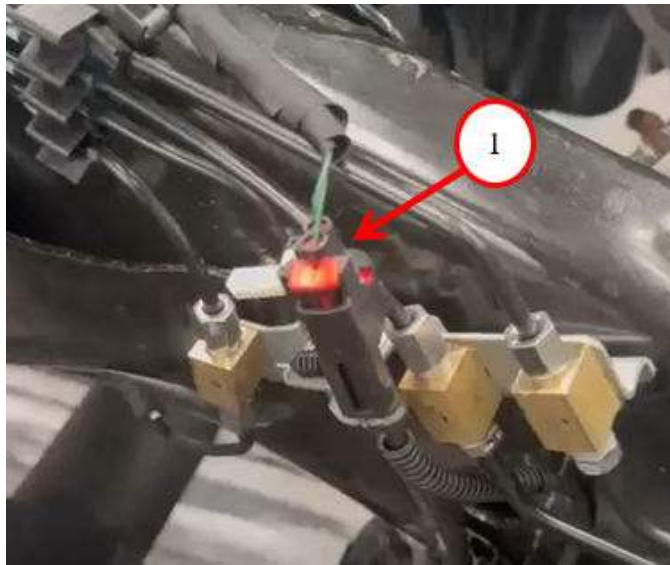
**Fig. 4**  
ABS Wire Harness Connector

5. Disconnect the Anti-Lock Brake System (ABS) wire harness connector [Fig. 4](#).

1 - ABS Wire Harness Connector

13. Connect the ABS wire harness connector [Fig. 4](#).
14. Install the left front wheelhouse splash shield. Refer to the detailed service procedures available in DealerCONNECT/Service Library under: Service Info> 23 - Body / Exterior / Shield, Splash, Front Wheelhouse / Installation.
15. Clear DTCs.
