# Technical Service Bulletin

| <b>Topic</b> | Continental GT and GTC - Window drop glass operation |
| <b>Transaction No.</b> | 2070497/10 |

Retailer glass reset procedure for GT/GTC

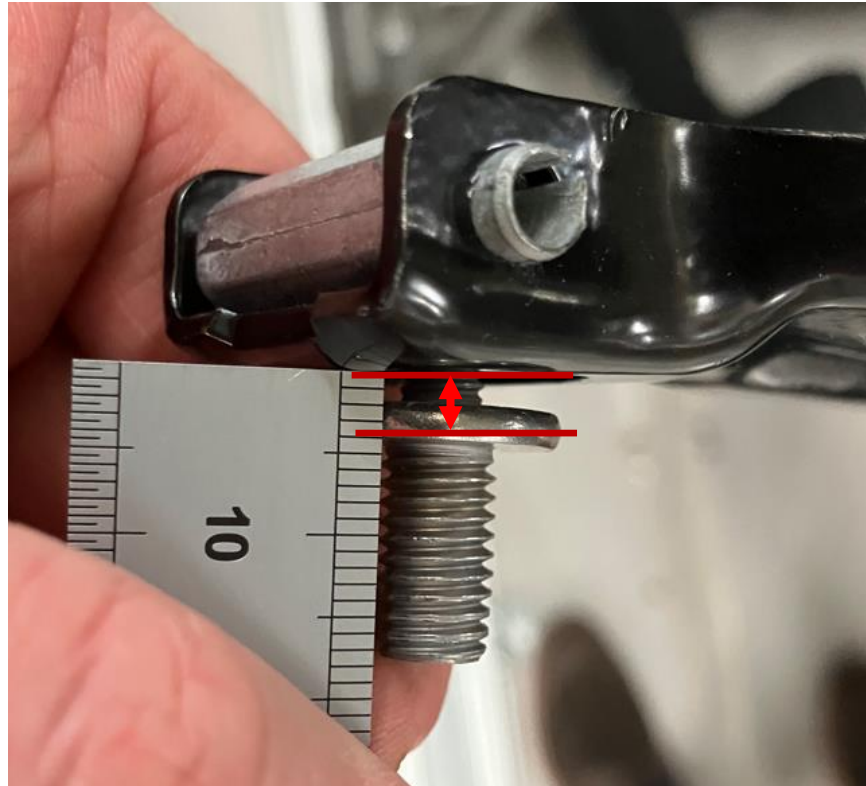
X1

Images for reference, regulator does  
not require removal from vehicle

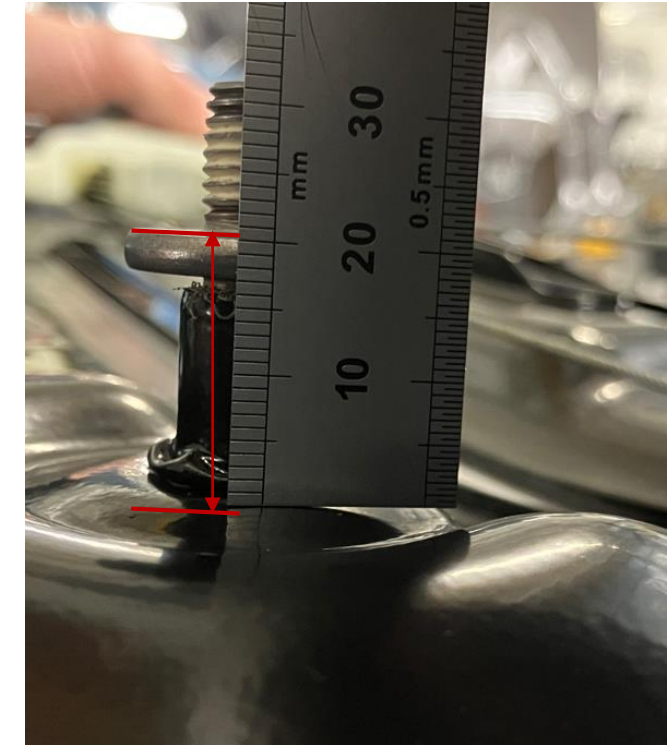
## Adjuster 3

Images for reference, regulator does not require removal from vehicle

fully screw in clockwise until hard stop, then unscrew 1 turn anticlockwise to achieve 20mm gap as seen below
