# Technical Service Bulletin

| <b>Topic</b> | Window Drop Glass Operation Continental GT/GTC 25-26MY |
| <b>Transaction No.</b> | 2075821/4 |

Retailer glass reset procedure for New GT/GTC

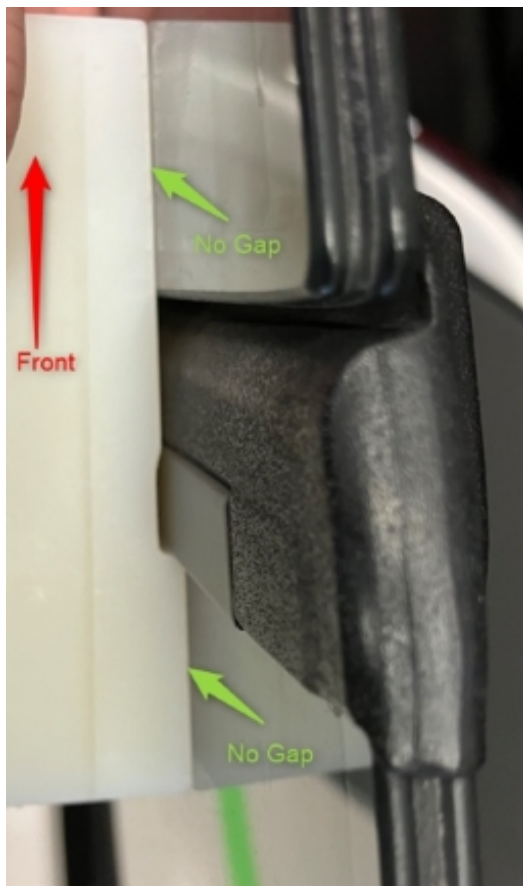
Figure 6

When the rear window is inboard and there is a 2mm step from the tool, when there is no gap between either window and tool (figure 6), the recorded measurement should be -2mm (figure 7)

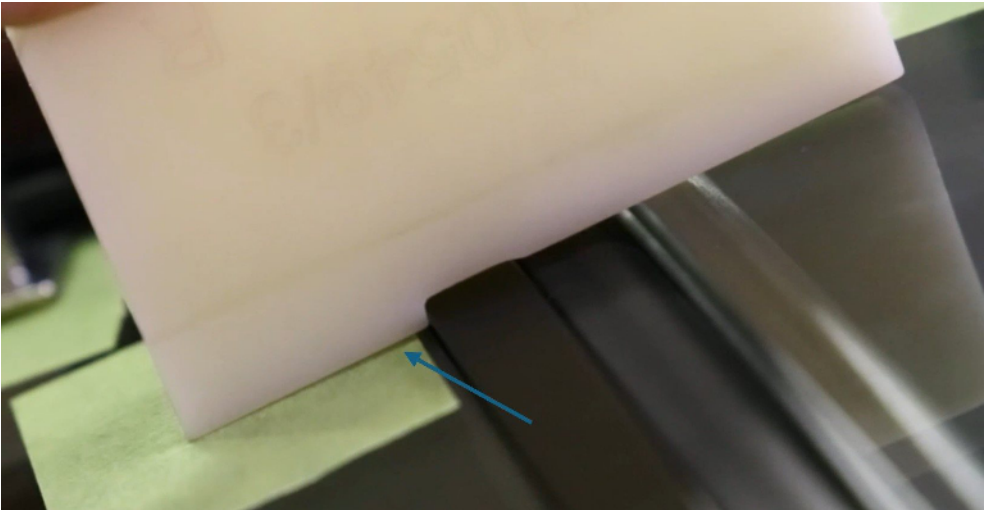
Figure 10

If the tool (WT10549/3) does not sit flush against the rear window then this shows rear window is more than 2mm inboard (more than -2mm), check this by holding the tool on the front window and measuring gap between the rear glass and the tool (as shown in figure 10)
