**Technical Service Bulletin (TSB)**  
**Fuel Injector Leak**

| REFERENCE: | TSB: 14-009-25 REV. B<br>GROUP: 14 - Fuel System | Date: | November 8, 2025 | REVISION: | 14-009-25 REV. A |
| VEHICLES AFFECTED: | 2022 - **2025** (B1) Jeep Renegade<br>2022 - **2025** (H1) Jeep Commander<br>2022 - **2025** (M1) Jeep Compass<br>This bulletin applies to the vehicle built on or before **July 31, 2025 (MDH 0731XX)** equipped with a 1.3L I4 Turbo MAIR DI Engine w/ESS E100 (Sales Code EYJ). | | | MARKET APPLICABILITY:<br><div><input type="checkbox"/> NA<input type="checkbox"/> MEA</div> <div><input checked="" type="checkbox"/> SA<input type="checkbox"/> IAP</div> <div><input type="checkbox"/> EE<input type="checkbox"/> CH</div><br>NOTE: **This bulletin applies to the South America market.** | |

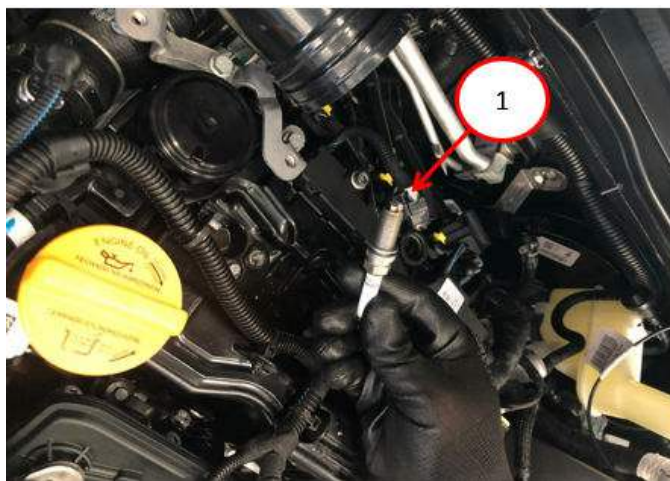
**Fig. 1**  
Spark Plugs

1. Remove the spark plugs [Fig. 1](#). Refer to the detailed service procedures available in DealerCONNECT/Service Library under: Service Info> 5510D10 – Velas de ignição – Remoção e Recolocação.
