## Vehicle does not start due to interlock failure

| Topic number | LI54.10-P-080004 |
| Function group | 54.10 - Battery, power supply, voltage converter |
| Validity | 243 with SA codes BAD or BAE |

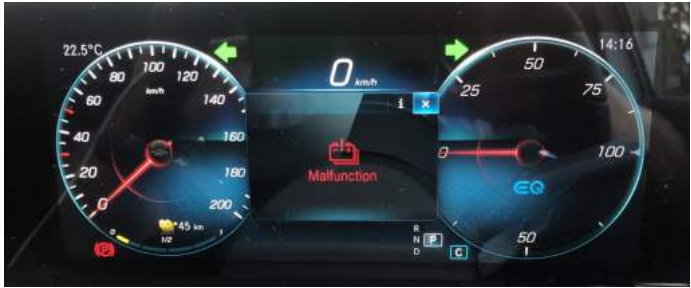
- Vehicle cannot be started
- Warning in the instrument cluster related to High-voltage on board electrical system
- The following fault codes related to interlock can be found in the High Voltage Control units :

- PTCU (N127) :
  - P154700 - There is a warning due to a detected fault in the interlock circuit.
- BMS (N82/9) :
  - P0A0B00 - The interlock circuit of the high-voltage on-board electrical system has a malfunction.

- DCB (N116/5):
  - P0A0D00 - The interlock circuit of the high-voltage on-board electrical system has a short circuit to positive.
- OBL (N83/11) :
  - P0A0A00 - The interlock circuit of the high-voltage on-board electrical system has an electrical fault.

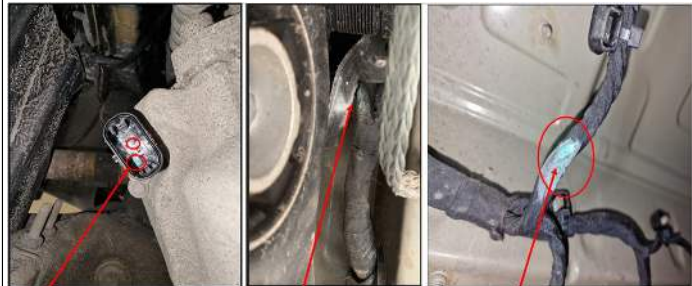
| Attachments | |
|---|---|
| <a href="#">Additional check point 1.jpg</a> | |

| Attachments | |
|---|---|
| | Oxidation in DV connector in ILK circuit pins (Check AC compressor and PTC heater) |
| | Twisted harness Harness scratching with the body |
| | Harness scratching with the body |
