2021-2024MY  
K5 (DL3a)  
w/Theta III 2.5L T-GDI

260

November 2025

ITM REPLACEMENT AND ECM  
LOGIC IMPROVEMENT (CA2511)

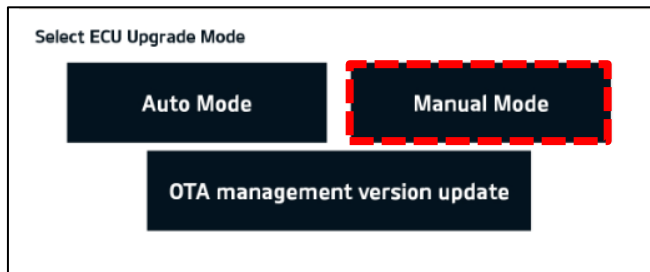
The ECU and TCM **MUST** be programmed in **Manual Mode ONLY** using the KDS 2.0 download as described in this bulletin.

The required software must be installed by selecting the **'Manual Mode'** ECU Upgrade option.

'Manual Mode' passwords.
