2023MY  
Sportage (NQ5, NQ5a)  
w/Theta III 2.5L GDI

259 (Rev 1, 11/6/2025)

## TECHNICAL SERVICE BULLETIN

## LOGIC IMPROVEMENT (CA2509)

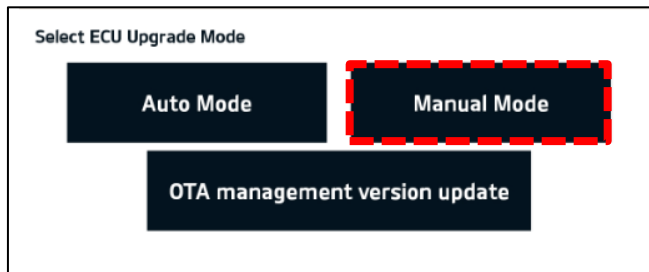
The ECU and TCM **MUST** be programmed in **Manual Mode ONLY** using the KDS 2.0 download as described in this bulletin.

The required software must be installed by selecting the **'Manual Mode'** ECU Upgrade option.

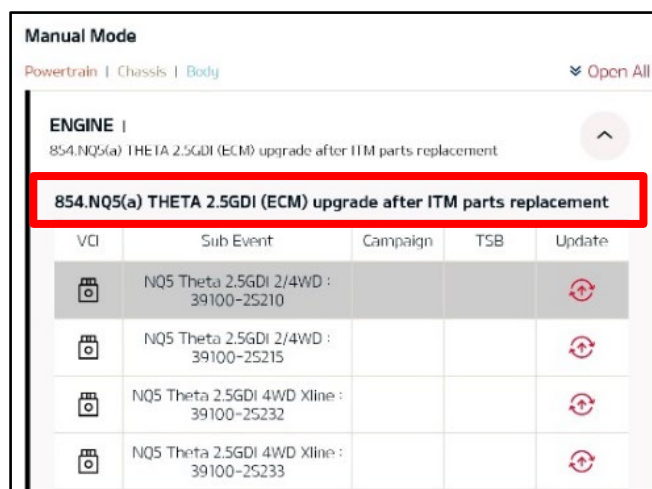
- 854.NQ5(a) THETA 2.5GDI (ECM) Upgrade After ITM Parts Replacement

Verify the affected vehicle Calibration Identification of the applicable ECU ROM ID and reference the Information Table on page 4 as necessary.
