# Service Bulletin

Bulletin No.: 24-NA-166

**Subject: DTC C1171 C1172 C1173 C1174 Tire Pressure Monitor Sensor Unable to Relearn Ethernet Cable Overlay for TCP OnStar Module**

**This Service Bulletin replaces PIT6188E. Please discard all versions of PIT6188.**

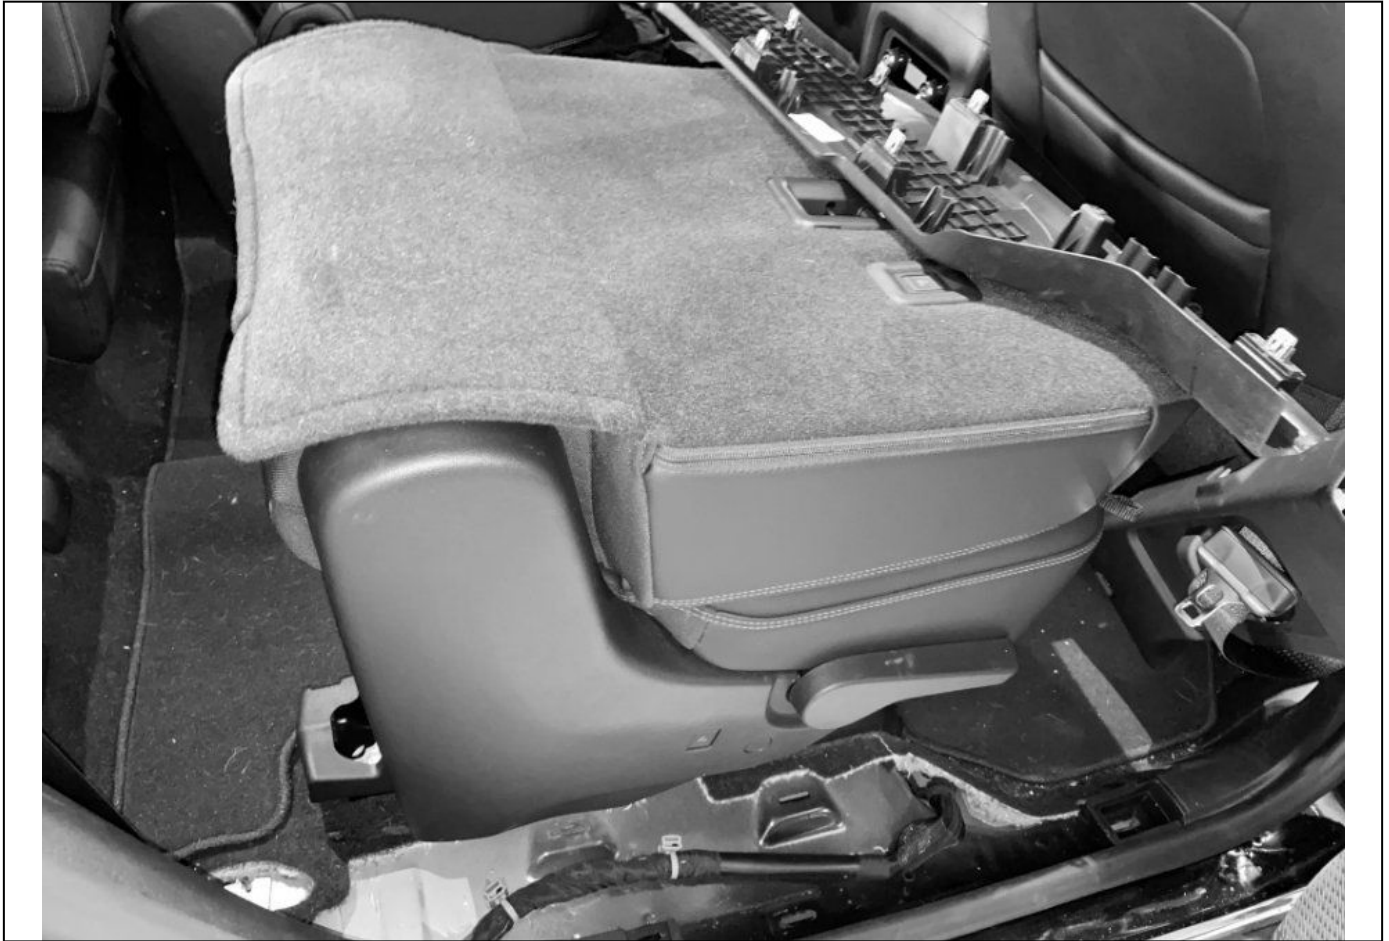
6699007

2. Transfer housing connectors.
3. Fold the 3rd row seats forward.
4. Remove the Rear Compartment Floor Stowage Compartment Divider. Refer to *Rear Compartment Floor Stowage Compartment Divider Replacement* in SI.
5. Remove the Right-Hand Front Side Door Sill Garnish Molding. Refer to *Front Side Door Sill Garnish Molding Replacement* in SI.
6. Remove the Right-Hand Rear Side Door Sill Garnish Molding. Refer to *Rear Side Door Sill Garnish Molding Replacement* in SI.
7. Loosen the Center Pillar Lower Trim Panel from the vehicle. Refer to *Center Pillar Lower Trim Panel Replacement* in SI.

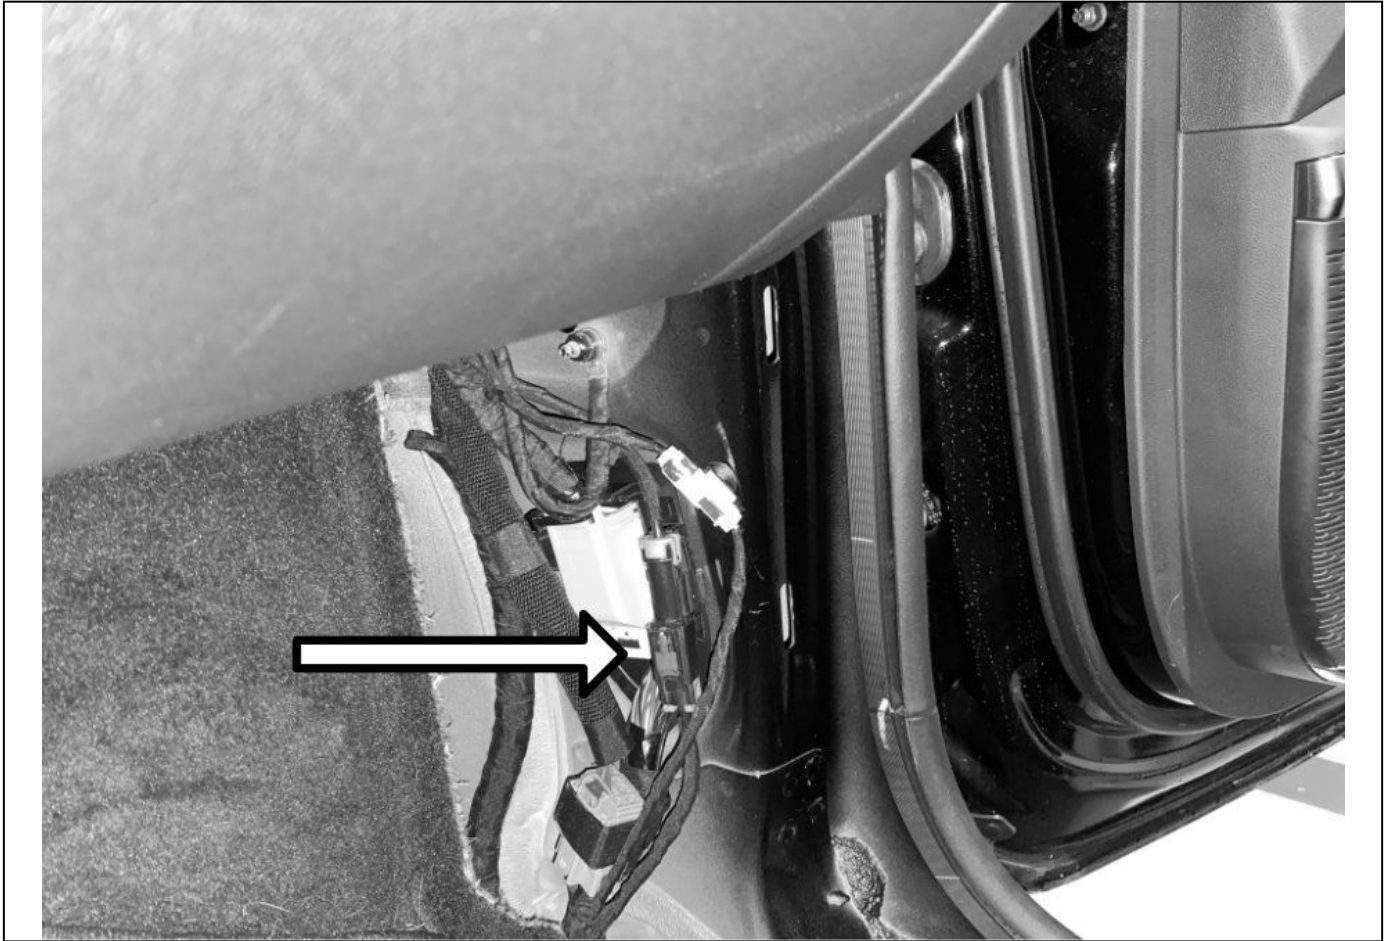
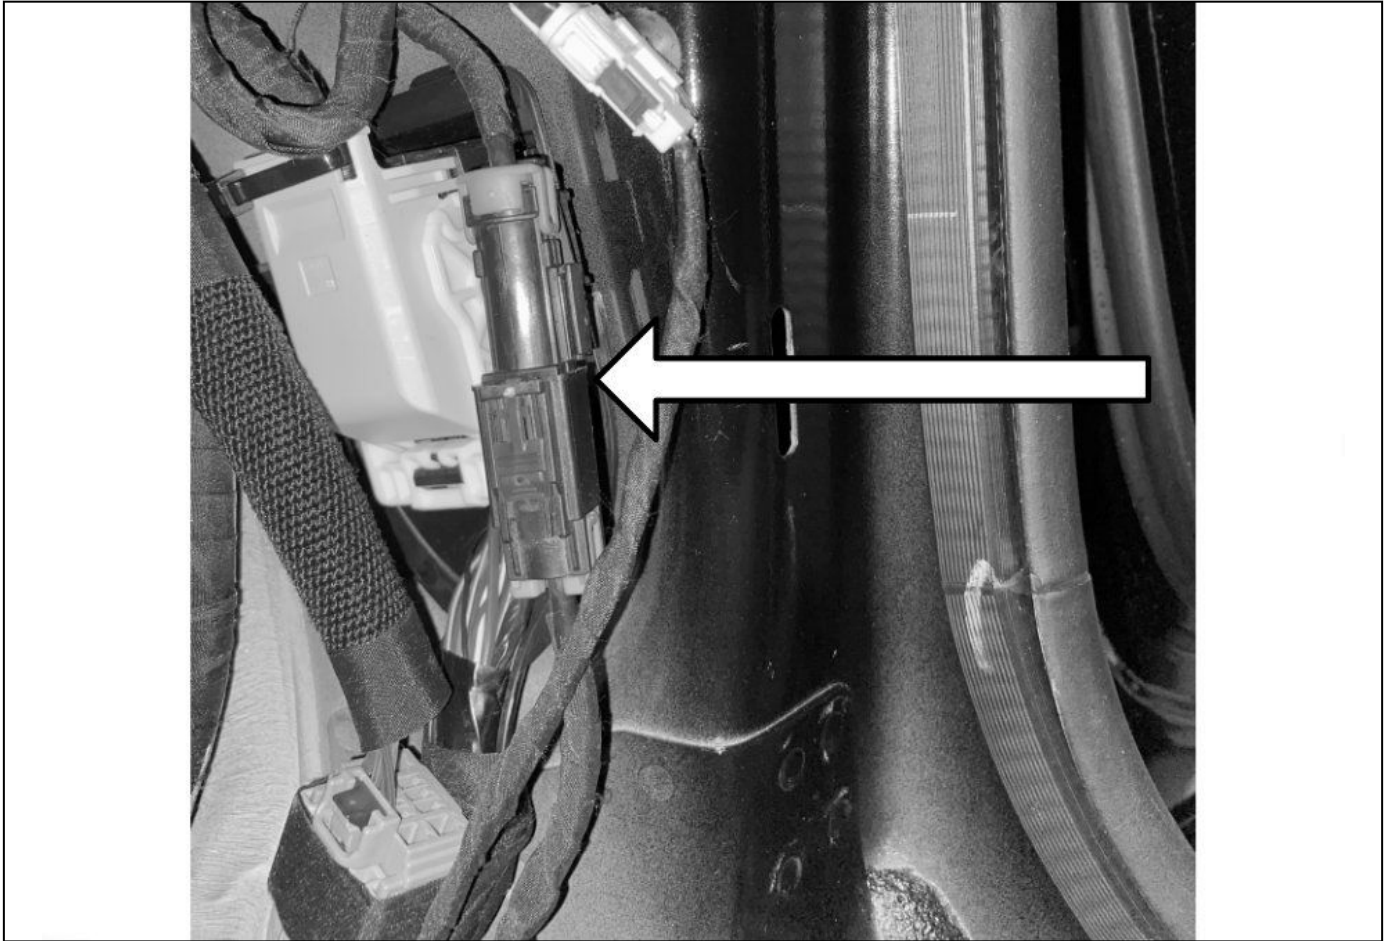
8. Fold and raise up the Right-Hand Rear seat. **DO NOT REMOVE.**
9. Remove the Right-Hand Quarter Upper and Lower Rear Trim Panel. Refer *Quarter Lower Rear Trim Panel Replacement (Right Side)* in SI.
10. Loosen the Left-Hand Quarter Upper Trim Panel. Refer to *Quarter Upper Trim Panel Replacement* in SI.

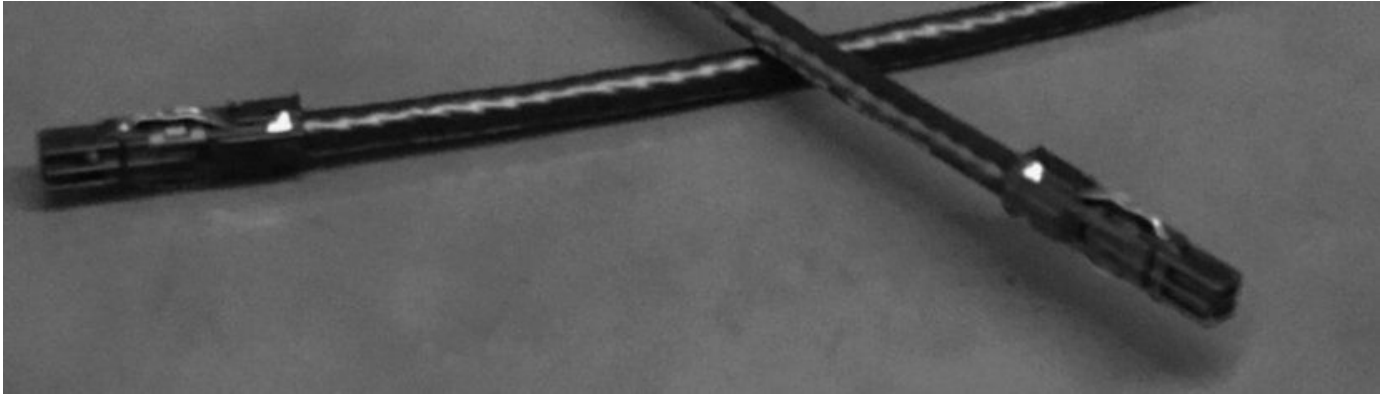
6720419

14. Transfer both housings to the new cable. The new cable will come without the housings.

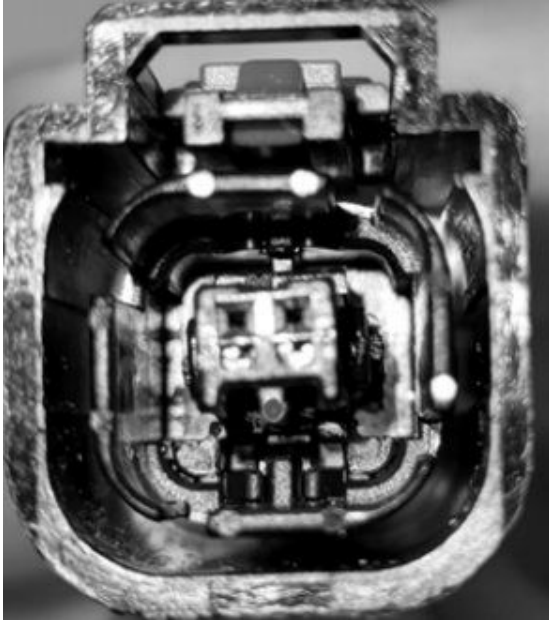
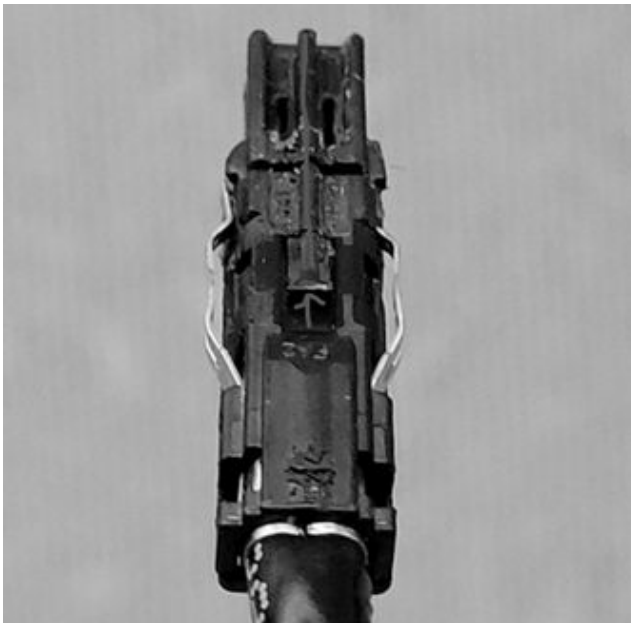
The best way to get to the release tab is to follow the cable's middle ridge to the back (do not ride the wall of the housing or you will miss it, use the cable's middle ridge to guide you). Using light pressure, press away from the center towards the housing to release. Make sure to apply light pulling pressure to the back of the cable so it can release while depressing the tab.

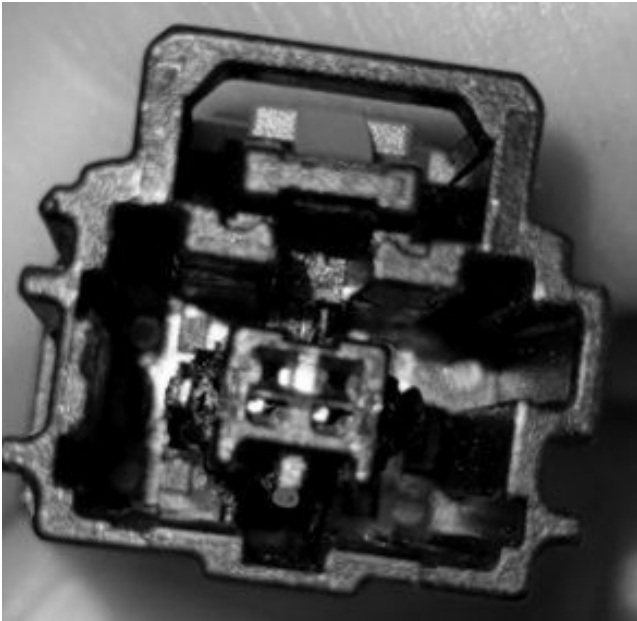
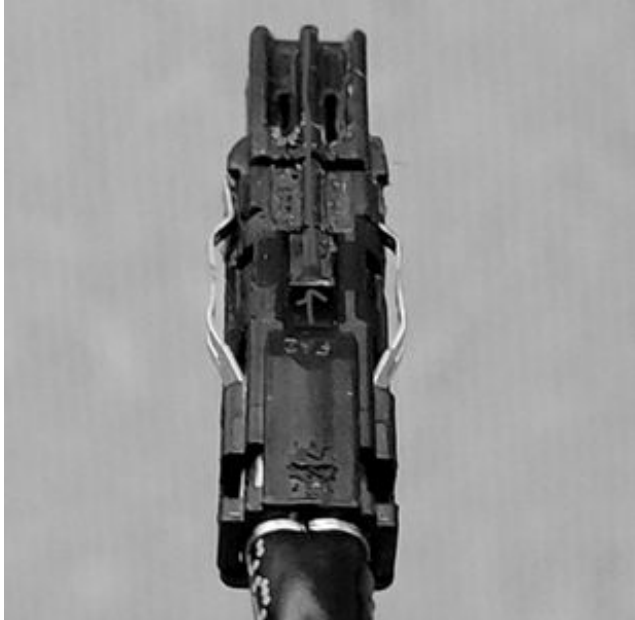
The best way to get to the release tab is to follow the cable's middle ridge to the back (do not ride the wall of the housing or you will miss it, use the cable's middle ridge to guide you.) Using light pressure, press away from the center towards the housing to release. Make sure to apply light pulling pressure to the back of the cable so it can release while depressing the tab.

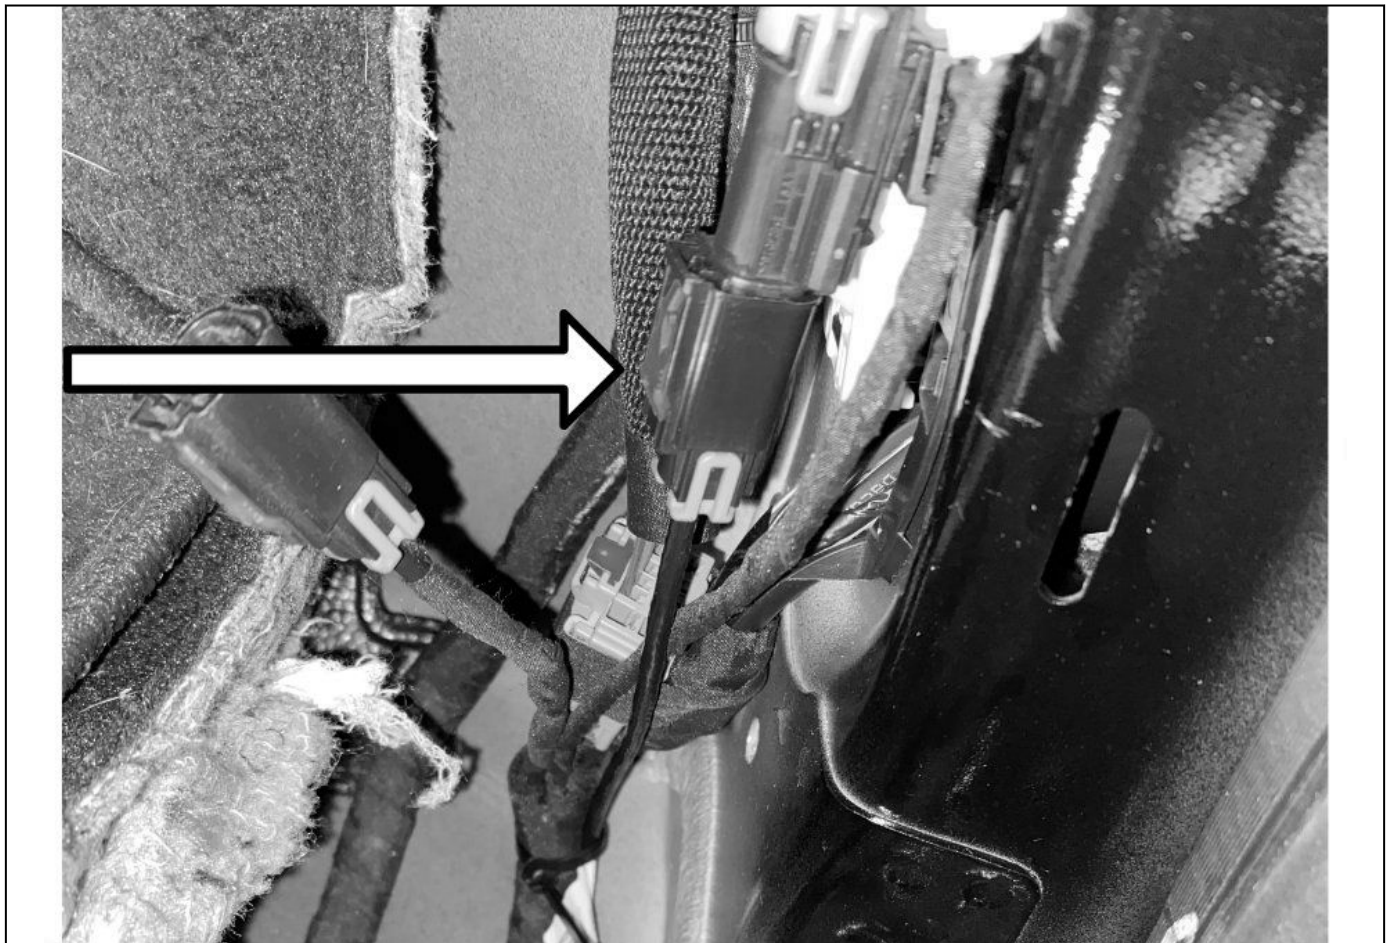
6706059

17. Connect the Replacement Ethernet Cable the connector at X205.

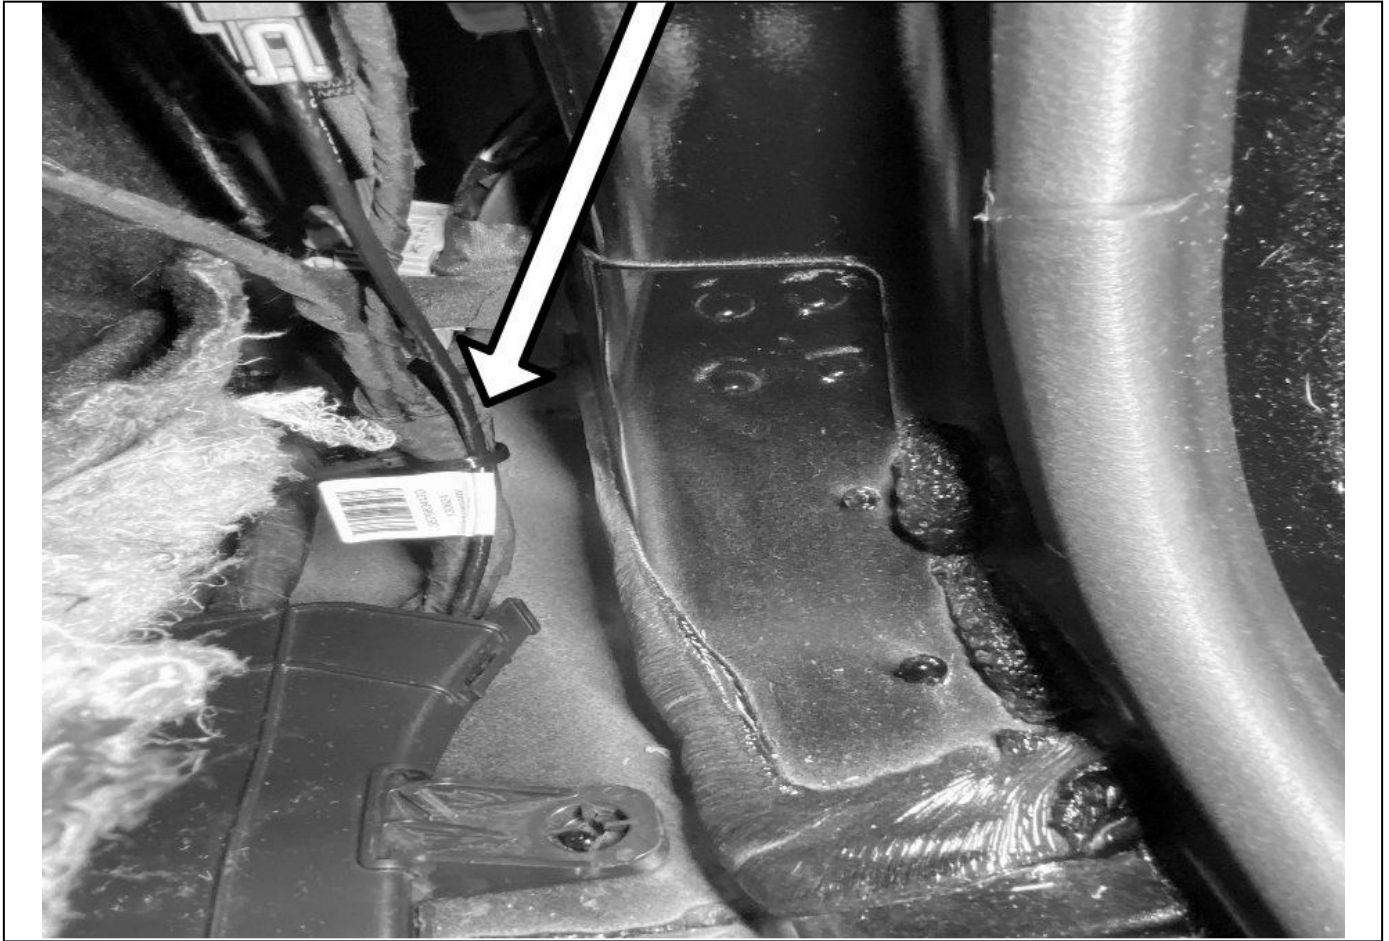
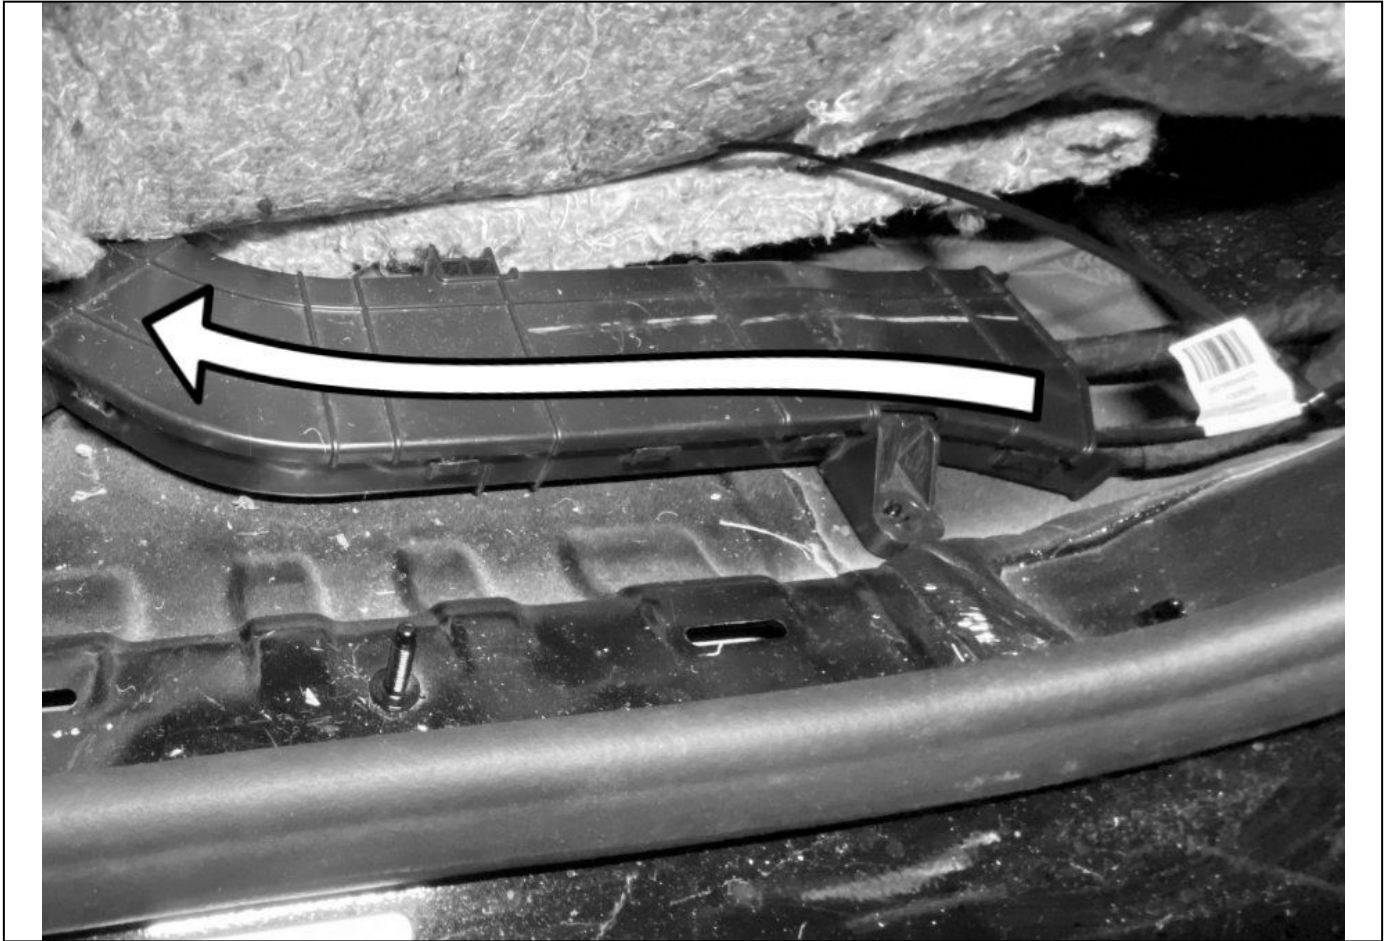
19. Run the replacement Ethernet Cable through the body wiring harness clamshell and underneath the Front Passenger Seat.

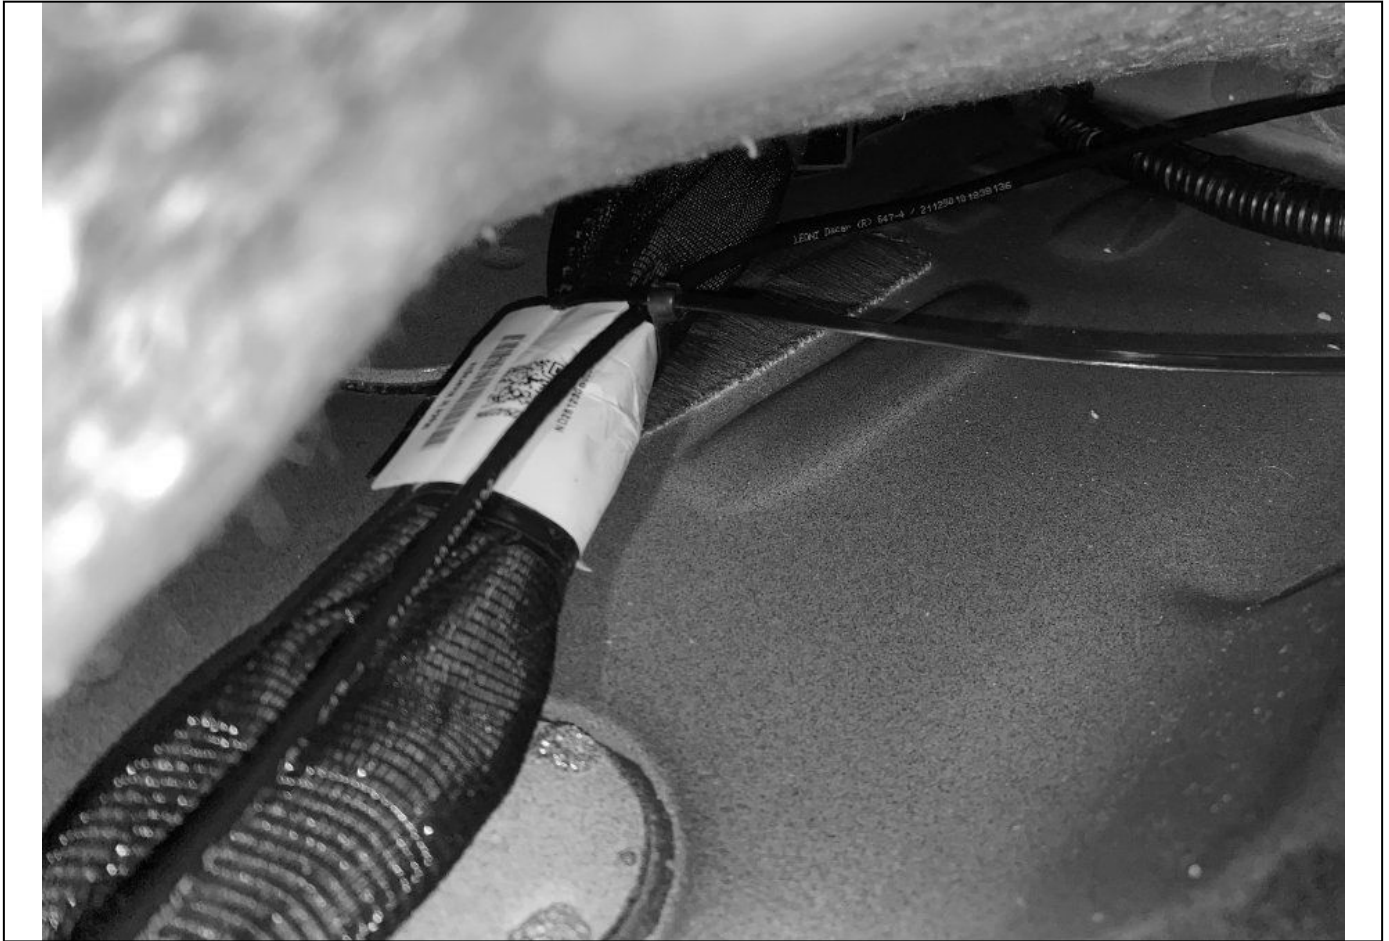
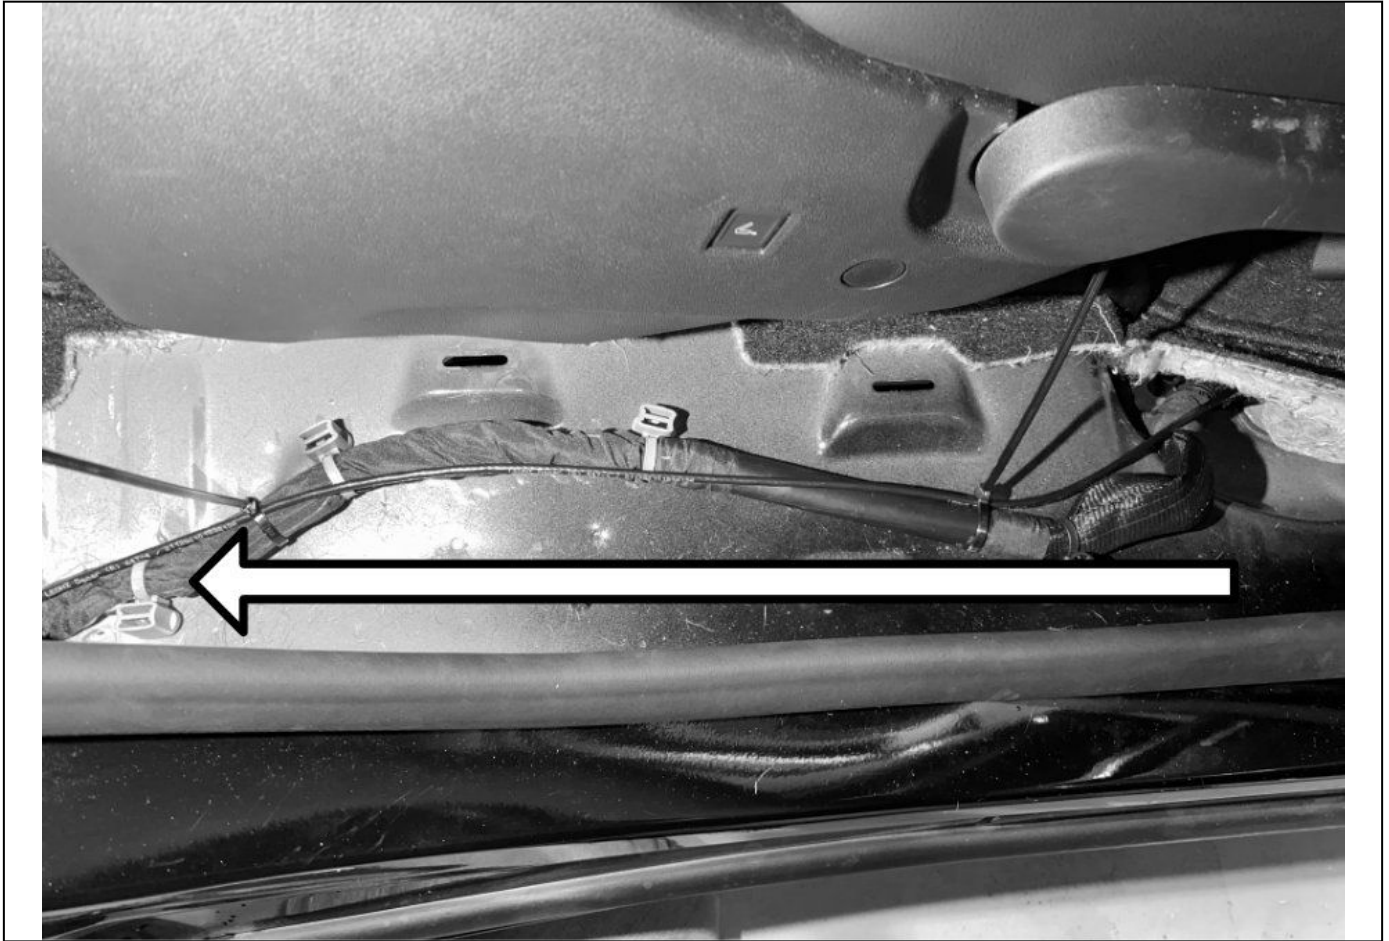
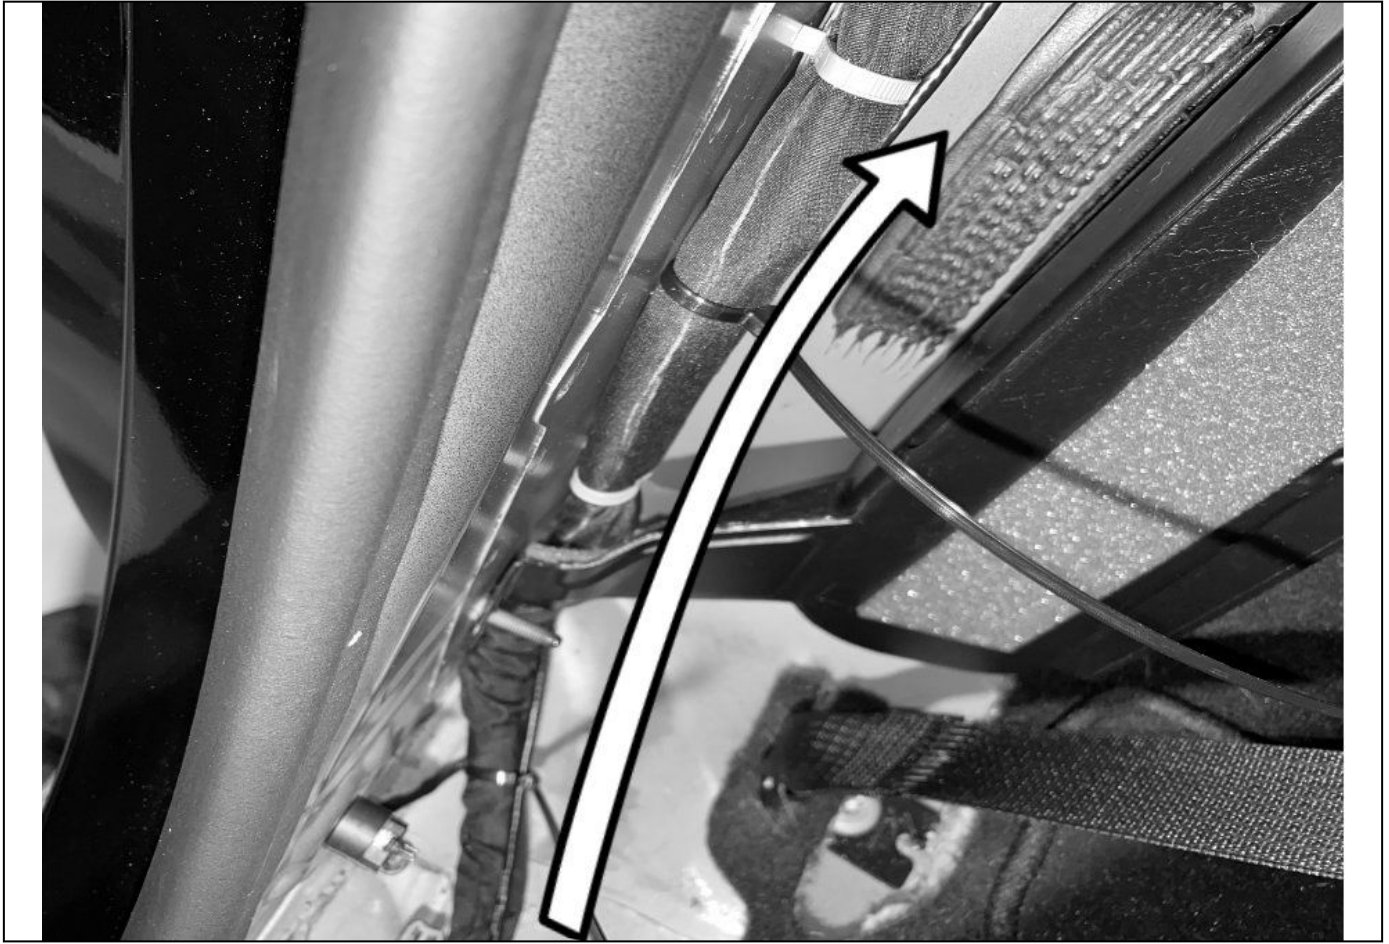
20. Continue to route the replacement Ethernet Cable alongside the Body Wiring Harness in the rear passenger compartment and up the C-Pillar.

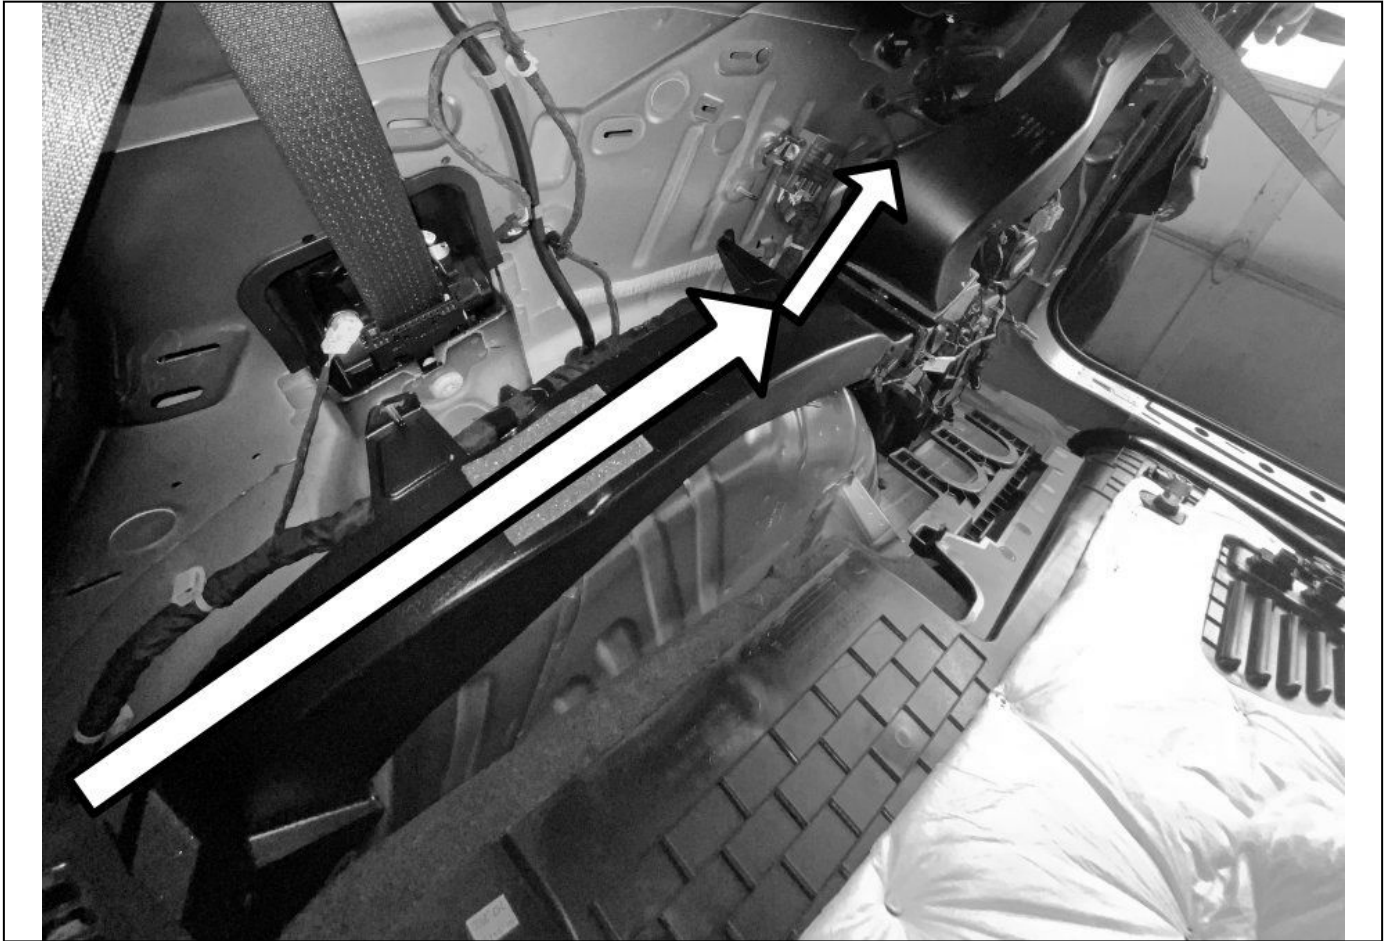
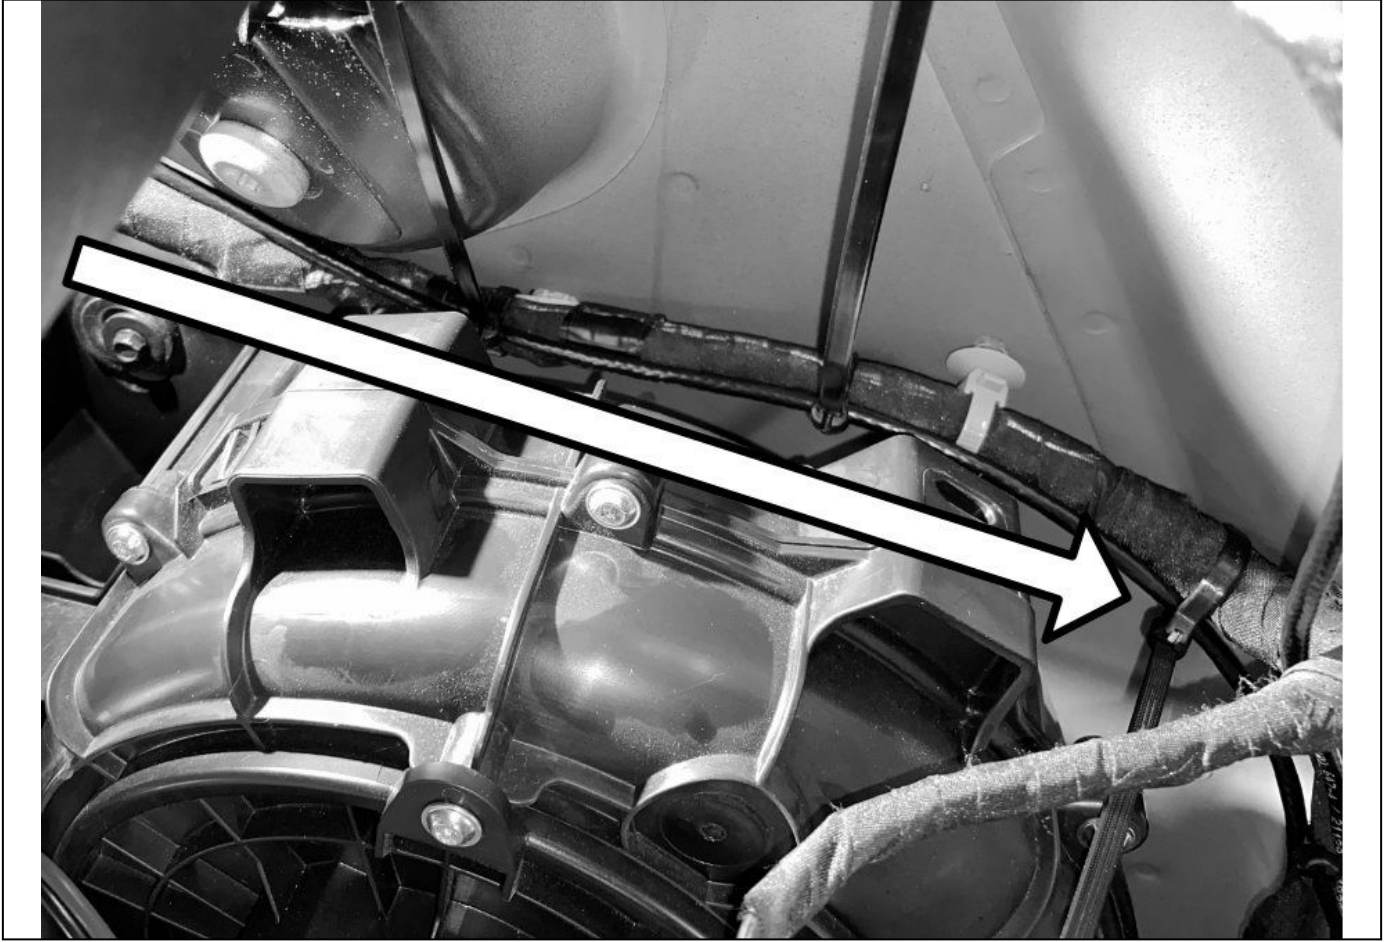
21. Continue to route the replacement Ethernet Cable following the Body Wiring Harness through the Rear HVAC area.

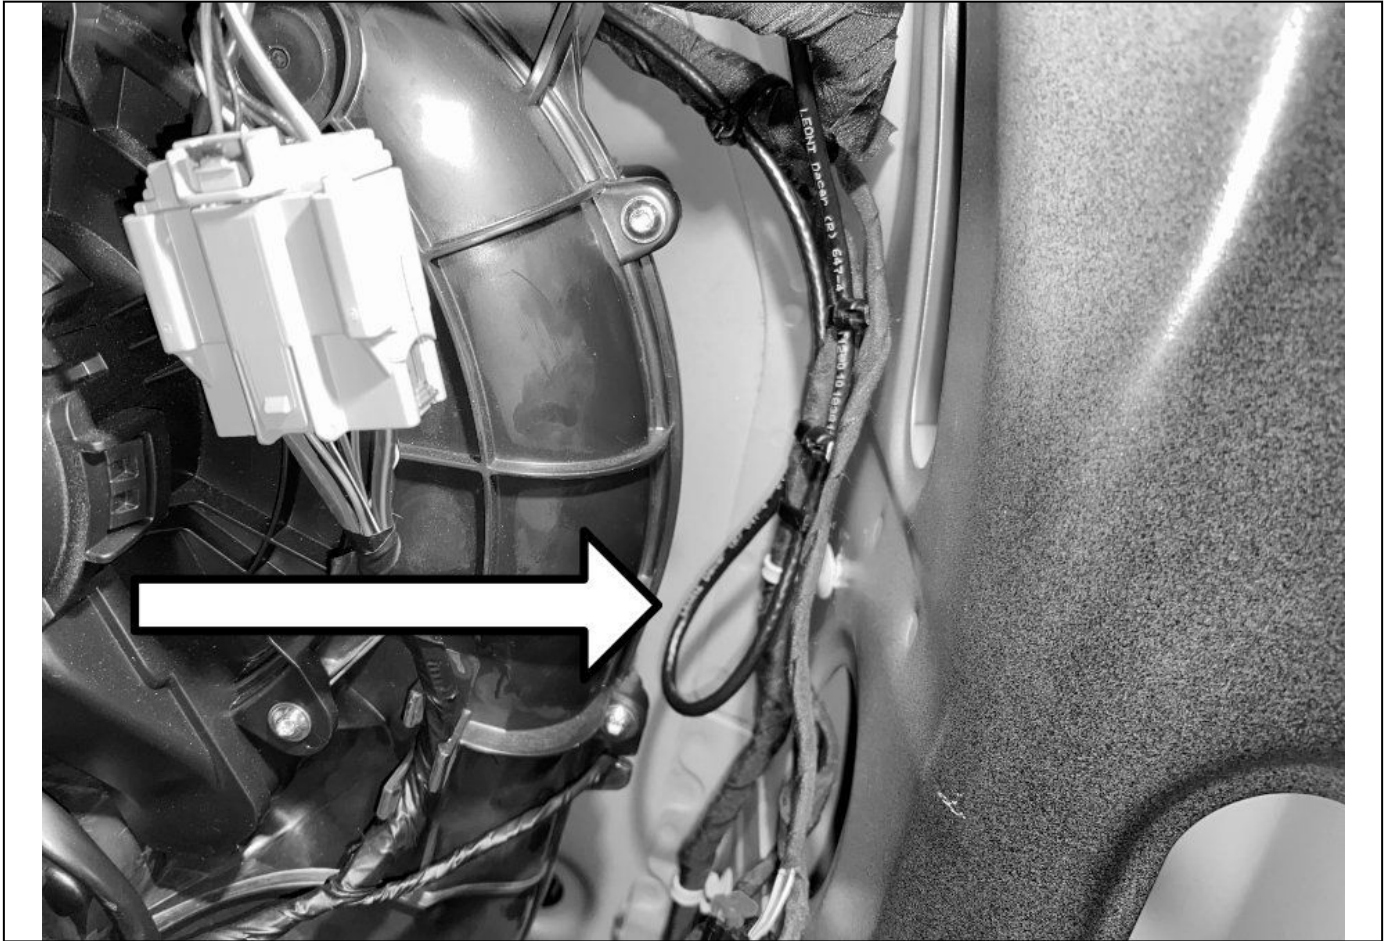
6706129

**Important:** Ensure the replacement Ethernet Cable will have enough slack so that it is not pulling on the connector at X7 of the Telematic Control Module. Failure to do so could damage the connector at the module.

22. Make a small loop to remove some of the excess cable and secure with a wire tie. Ensure to leave plenty of slack so that the cable will not pull on the connector at X7 of the Telematic Control Module.

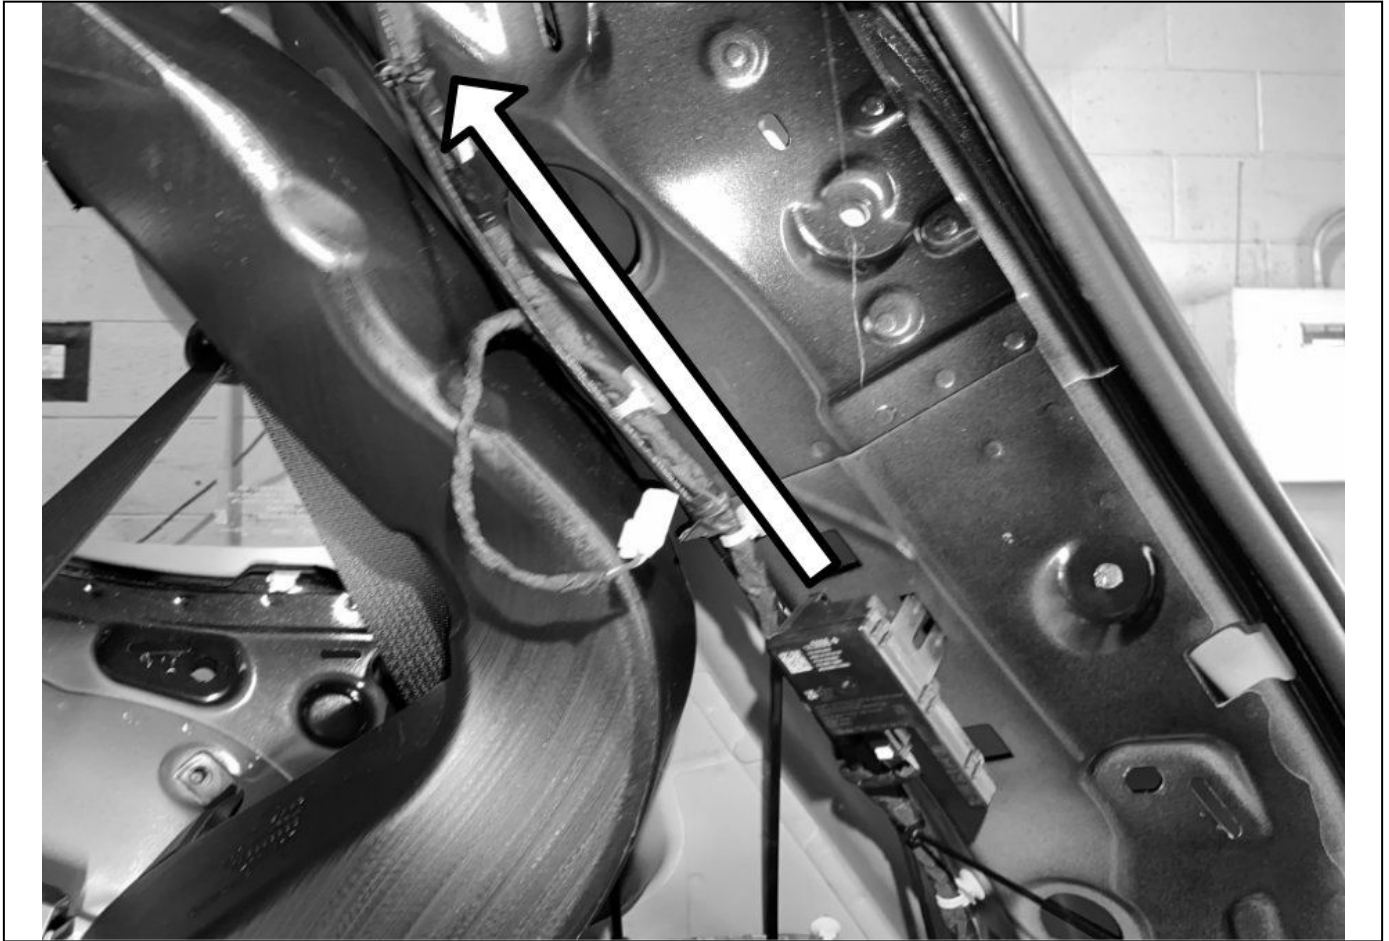
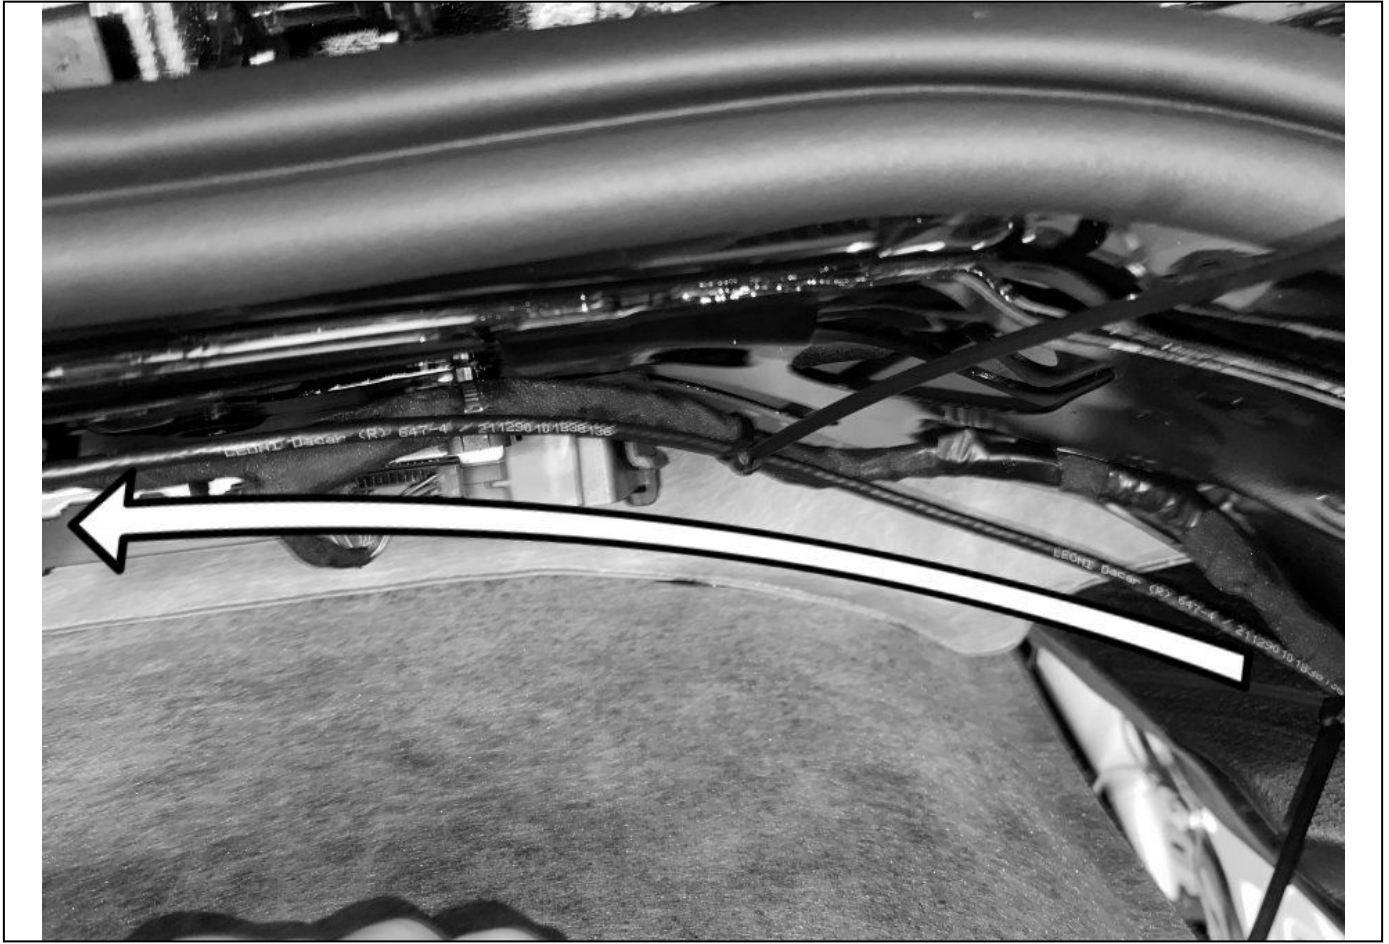
23. Follow the Body Wiring Harness up the rear of the vehicle and into the rear of the headlining.

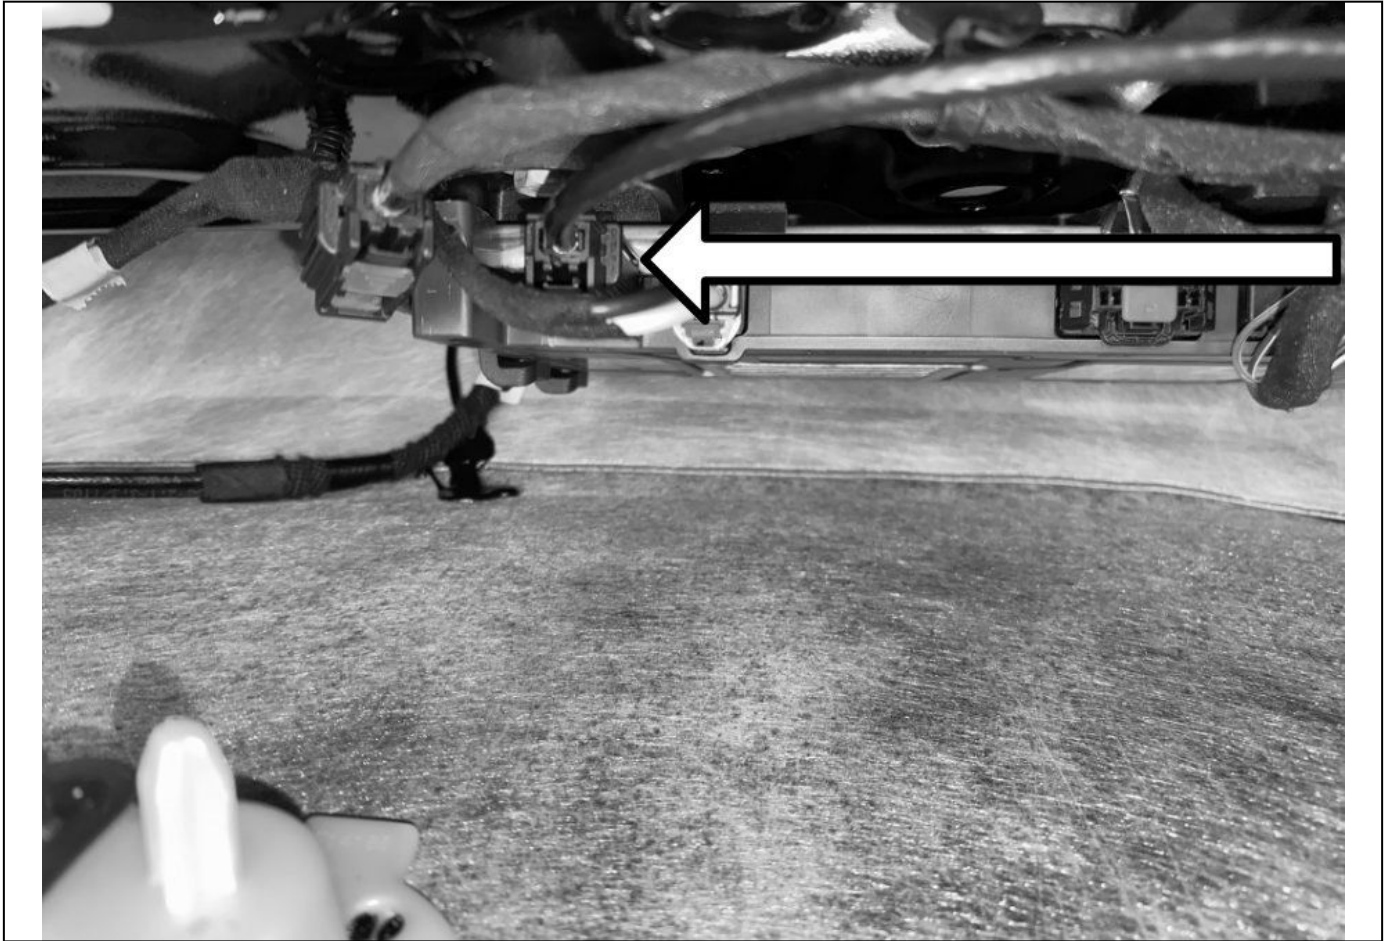
6706159

**Note:** If there is not an adequate amount of slack in the cable return to the loop made in Step 17 and gain extra slack from the loop. Resecure the loop with a wire tie if necessary.

24. Connect the replacement cable into X7 of the Telematic Control Module. Ensure that the cable has enough slack left to not pull on the X7 connector.
