| <b>Topic</b> | New Continental GT and GTC - Window drop glass operation |
| <b>Transaction No.</b> | 2070497/5 |

Retailer glass reset procedure for GT/GTC

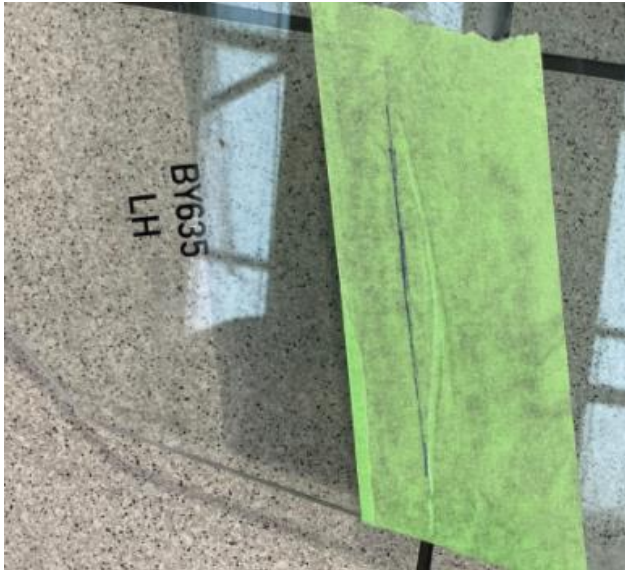
- Z Axis height adjustment on front drop glass

Example: Front drop glass Z axis not adjusted correctly. Bottom of tape was level with waist rail seal, after slackening pinch bolt (3 in bottom left image) front drop glass lowered 14mm to where pen marked line is.

Z-axis adjusters (bottom middle and right images) had not been used, pinch bolt had been slacked and glass lifted out of the regulator to achieve specification. This has a knock on effect of altering the 10mm division bar intrusion seen in previous slide as glass is loose and can be accidentally moved in X-axis.

## Z-Axis height should only be adjusted by the 4mm Allen key adjusters as per ELSAPRO

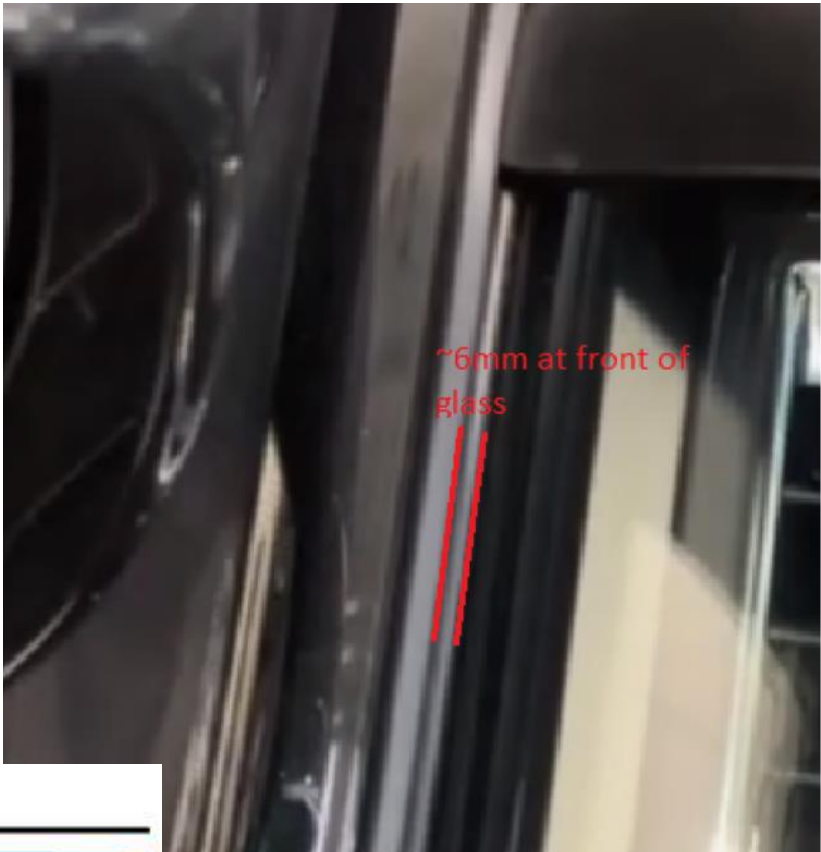
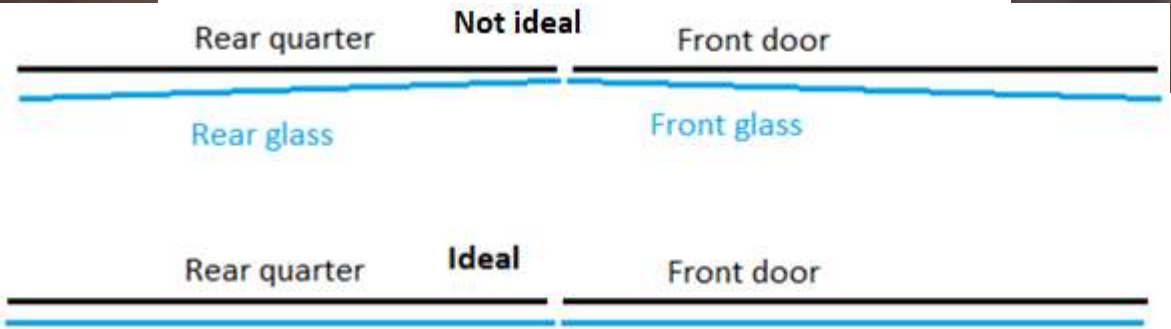
2mm at rear edge would have been set to achieve specified flush/2mm underflush profile condition between front and rear glasses, the rear quarter glass mirrors this taper condition. This potentially increases the risk of false anti trap as rear window/seal does not engage with front window at the correct angle.

Suggested to set to specification on problem vehicles as per next slide. If both windows are set between 4-6mm then the flush/2mm underflush profile can be easily achieved.

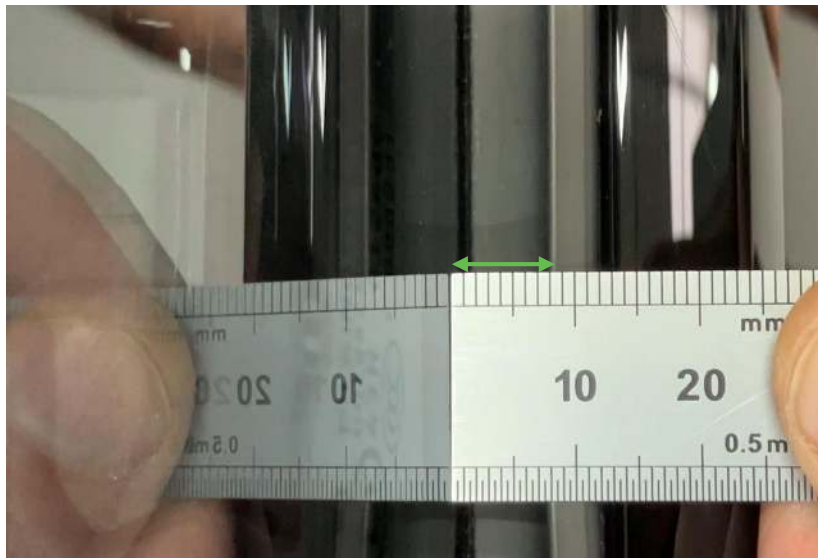
RHF window, front window closed, rear window open. Note gap

If more tension is required to resolve a wind noise or water ingress then aim for no more than 0.25mm of outboard movement.
