# Service Bulletin

Bulletin No.: 09-07-30-012F

**Subject:** No Reverse, 3rd or 5th, Check Engine Light Illuminated, DTC P0776  
(Replace 3-5 Reverse Clutch Plate (Waved))

**Models:** 2008-2009 Buick Enclave  
2008-2009 Chevrolet Equinox, Malibu  
2009 Chevrolet Traverse  
2007-2009 GMC Acadia  
2007-2009 Pontiac G6  
2008-2009 Pontiac Torrent  
2007-2009 Saturn AURA, OUTLOOK  
2008-2009 Saturn VUE  
All Equipped with 6T70/75 6-Speed Automatic Transmission  
(RPOs MH2, MH4, MH6 or MY9)

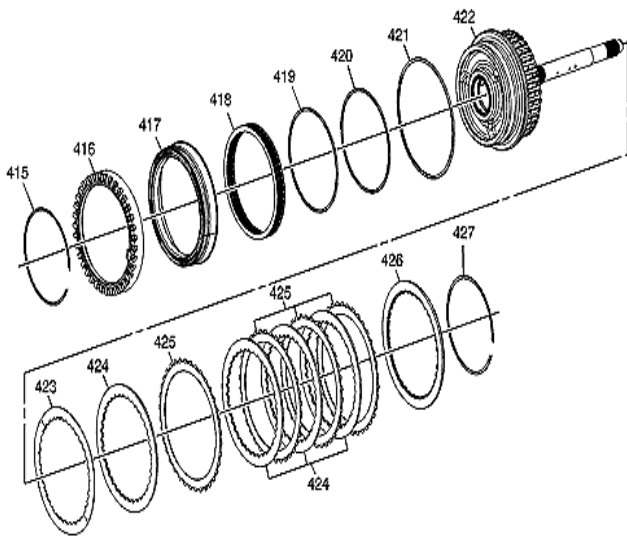
2584818

This condition may be caused by a broken 35R clutch wave plate allowing the apply piston to over-stroke the piston to leak and causing loss of apply. This normally will not occur before approximately 32,000 km (20,000 mi). Debris generated by the condition can affect the operation of the speed sensors and other clutches.

A new 3-5 reverse clutch plate (WAVED), P/N 24254103 (423), has been released to address this condition. Refer to SI for the appropriate repair instructions.

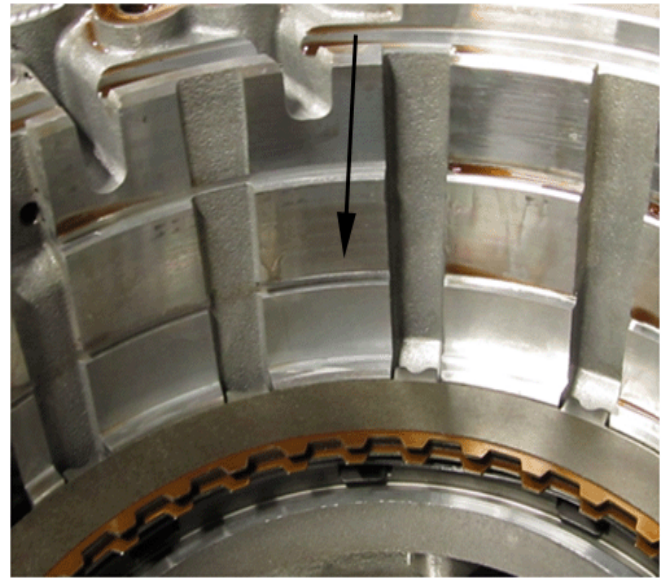
2753502

A broken 35R wave plate can generate varying amounts of debris inside the transmission. In most cases this debris has not passed through the pump fluid filter (201) damaging the pump, valve bodies or torque converter. This debris can be cleaned and the transmission successfully repaired.

1. After removing the transmission from the vehicle, remove the case cover assembly (35). Inspect the case cover for damage. This part is serviced and can be replaced if it is damaged.
2. Remove the 35R/456 clutch housing assembly (422) and inspect it for a broken 35R wave plate (423).
3. Inspect the case (21) for damage caused by a broken wave plate as shown below.
