**TECHNICAL INSTRUCTIONS**  
**FOR**  
**SPECIAL SERVICE CAMPAIGN 24LC03**  
**MALFUNCTION INDICATOR LAMP (MIL) IS ON WITH DTC P05CE00**  
**SOFTWARE UPDATE**

**CERTAIN 2023-2024 NX 350 VEHICLES**  
**CERTAIN 2023-2024 RX350 VEHICLES**  
**CERTAIN 2024 TX 350 VEHICLES**

**Updated 10.10.2024 – Add Note to Confirm Calibration ID**

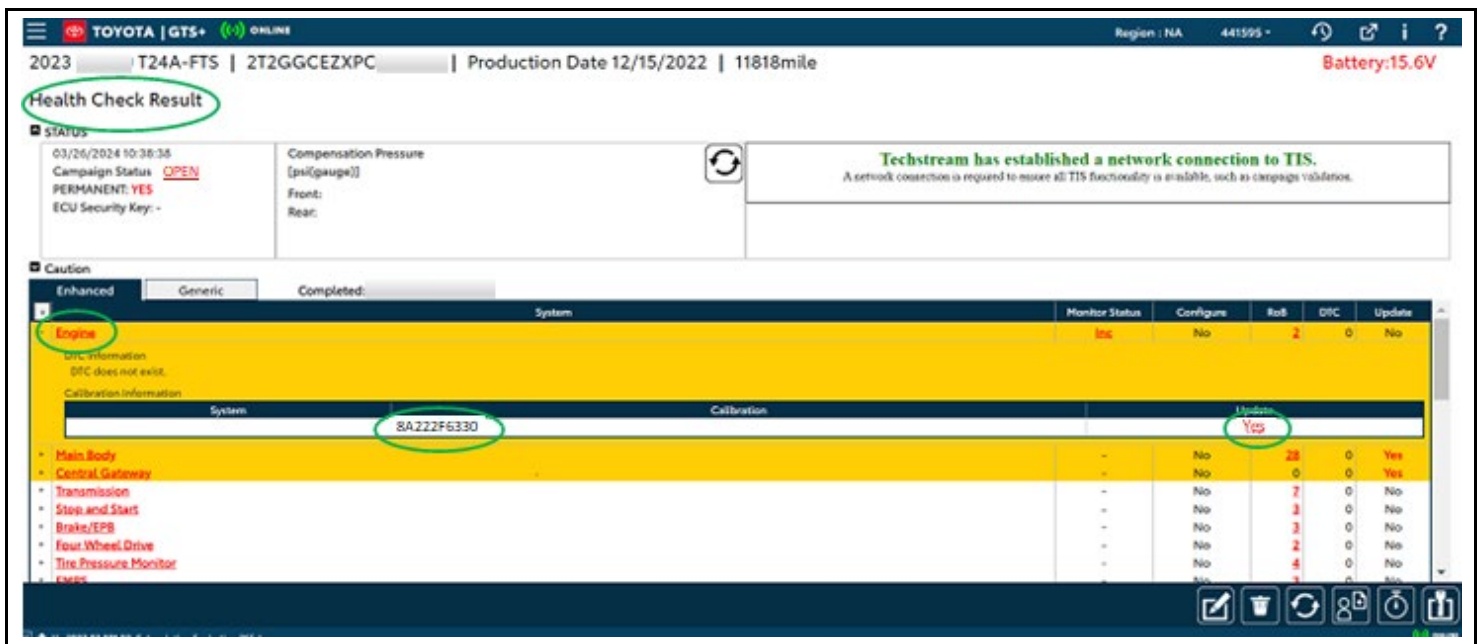
- Locate the "Update" column of the "Calibration Information" for the Engine system on the "Health Check Result" screen.
- Determine the status of an available update; indicated by a YES or NO.

**NOTE:** Confirm the current calibration ID for the ENGINE ECU. It is possible the Health Check will show "NO" update available while reporting a calibration ID that is able to be updated. See Engine Control Computer Calibrations table on page 7.

Is there an update available for the Engine ECU (ENG & ECT)?

Proceed to section VII. Vehicle preparation on page 5.

Campaign complete. Return the vehicle to the customer.

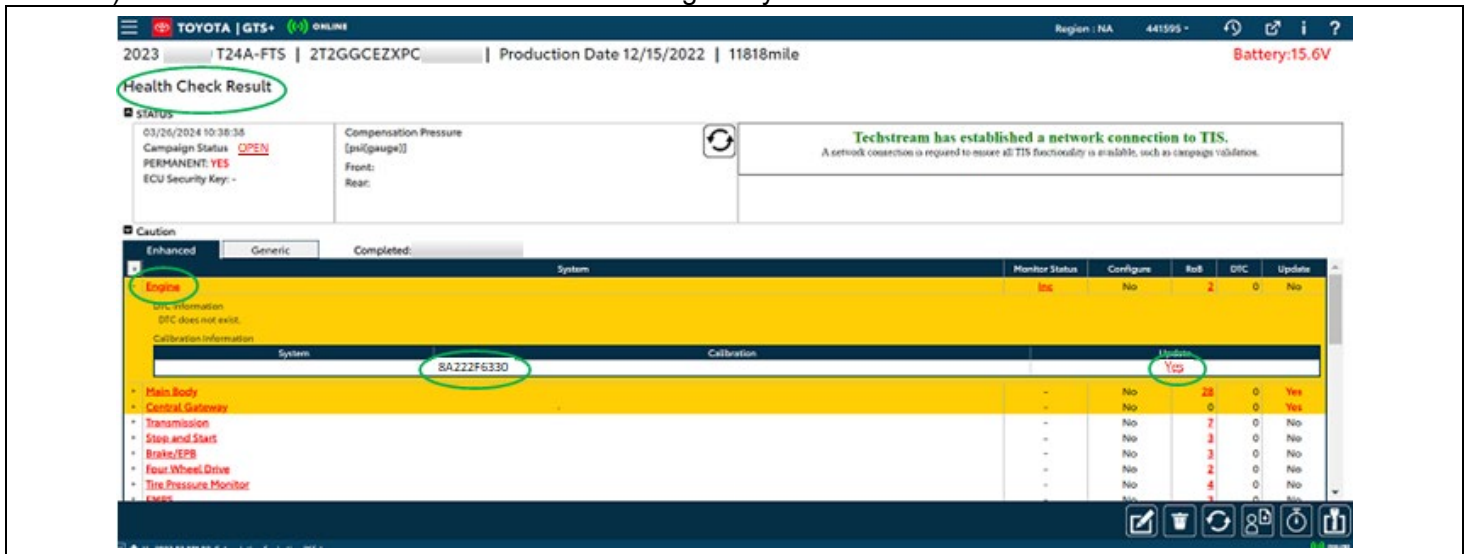
### 1. CONFIRM THE CALIBRATION ID

- a) Confirm the current calibration ID in the Engine System.

If the Engine Control Computer has the **New** CIDs, no update is necessary.

\*\*If you see any of the "Current Calibration ID" from the Engine Control Computer Calibration Table, please download the CUW file from the **New Calibration ID** column in this document. Proceed with the update utilizing the Calibration Update Wizard.

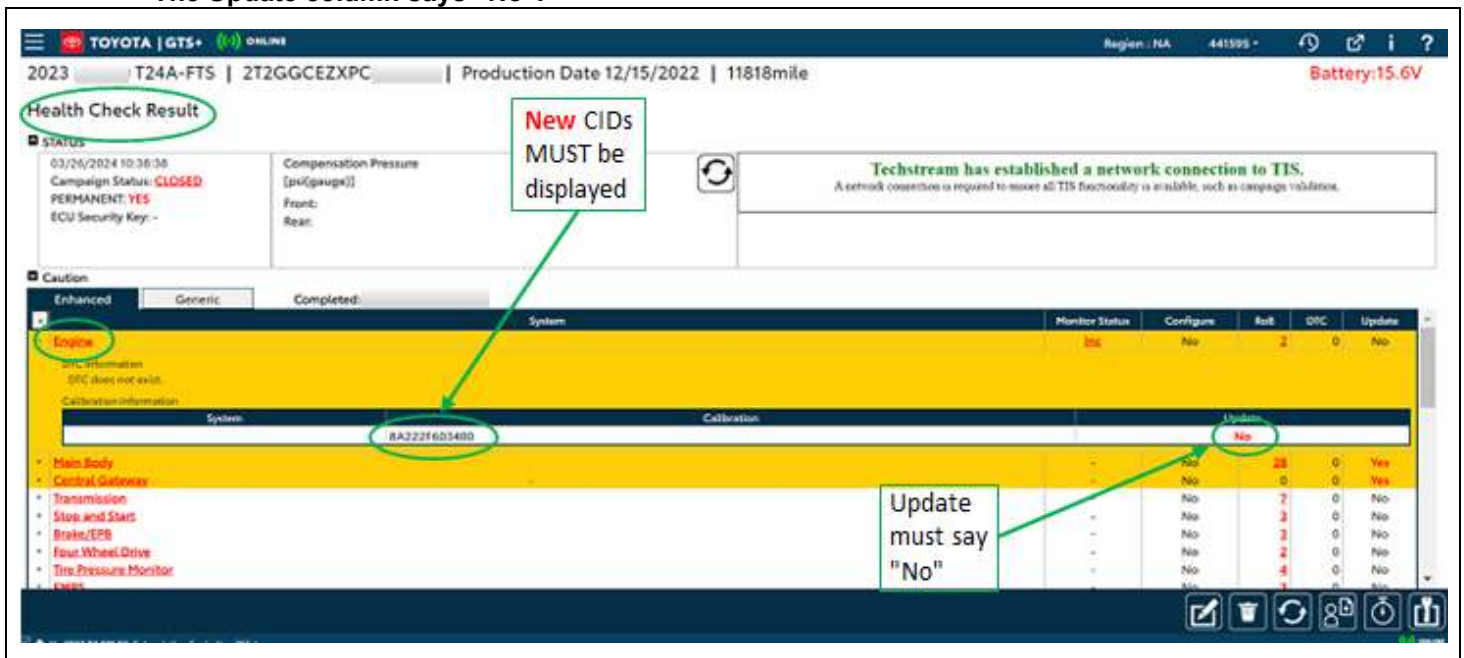
### 3. CONFIRM CID UPDATE

- On the Stored Data tab, confirm the following for the Engine System:
  - The Calibration number has the "New CID" number.
  - The Update column says "No".

**Have someone other than the technician who completed the software update confirm the CIDs have been updated successfully to the NEW CIDs. Refer to page 5.**
