| Topic | Window Drop Glass Operation Continental GT/GTC 19-24MY |
| Transaction No. | 2080375/2 |

Window Drop Glass Operation | Continental GT/GTC |19-24MY

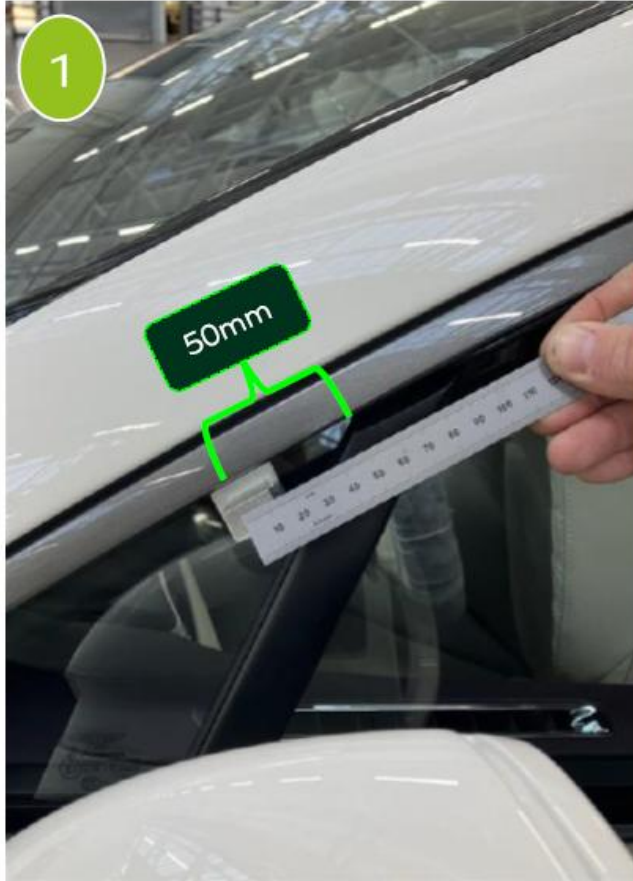
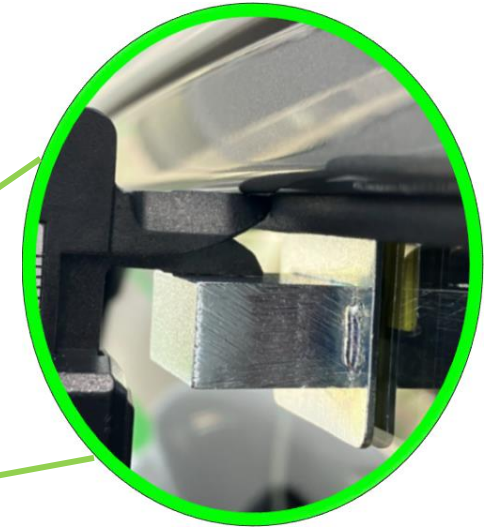
# INTERLOCK POINT 1

Place block 50mm in front of front div bar

Record measurement for all interlock points

From block to bright ware for all interlock points

If the measurement is out of specification refer to ElsaPro Repair Group 64 'Front door quarter glass – To adjust'

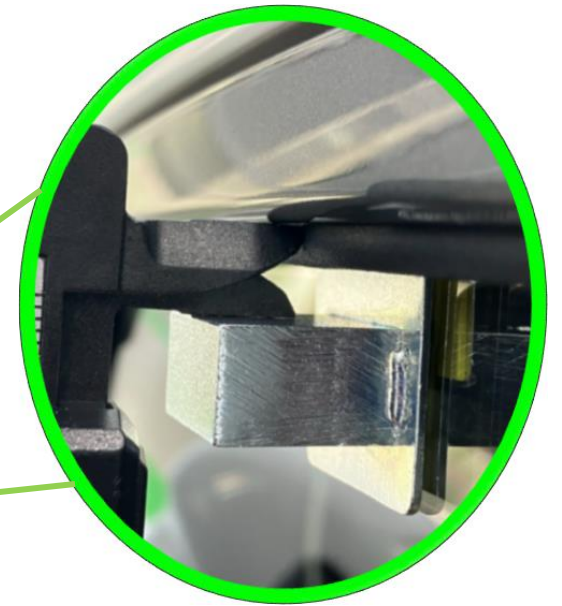
# INTERLOCK POINT 6

Place block 50mm from corner point of bright ware

Record measurement for all interlock points

**Specification**  
8mm  $\pm$  1mm  
(Interlock Tool WT10549/1)

If the measurement is out of specification refer to ElsaPro

**Repair Group 64 'Slide glass checking and adjusting'**

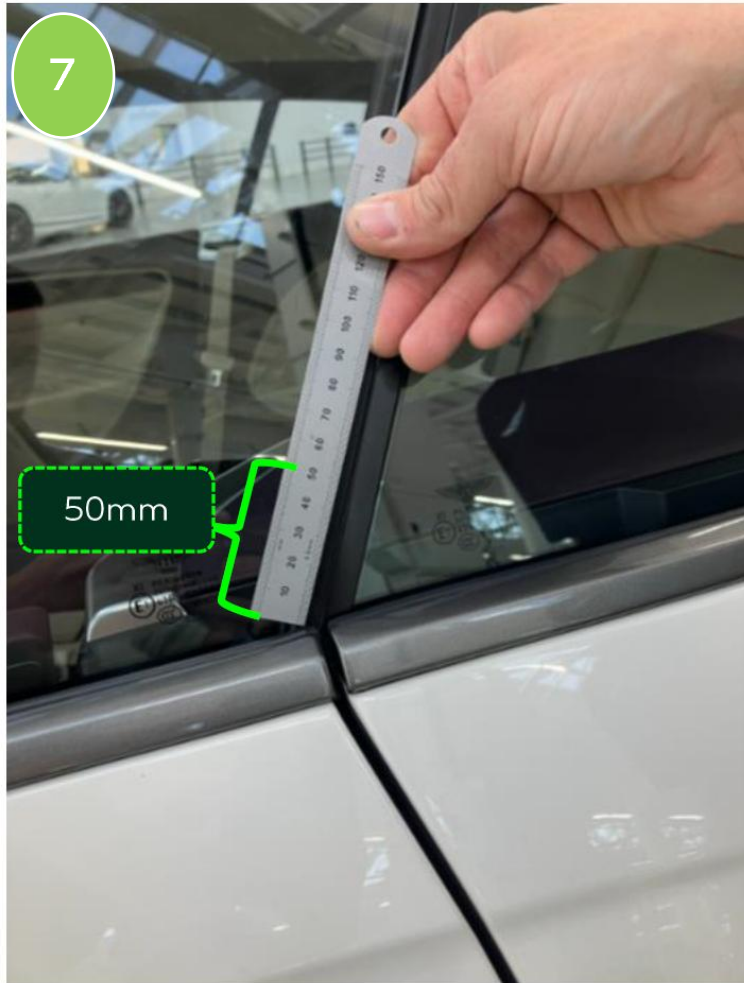
# INTERLOCK POINT 7

50mm from seal

Record measurement

**Repair Group 64 'Slide  
glass checking and  
adjusting'**

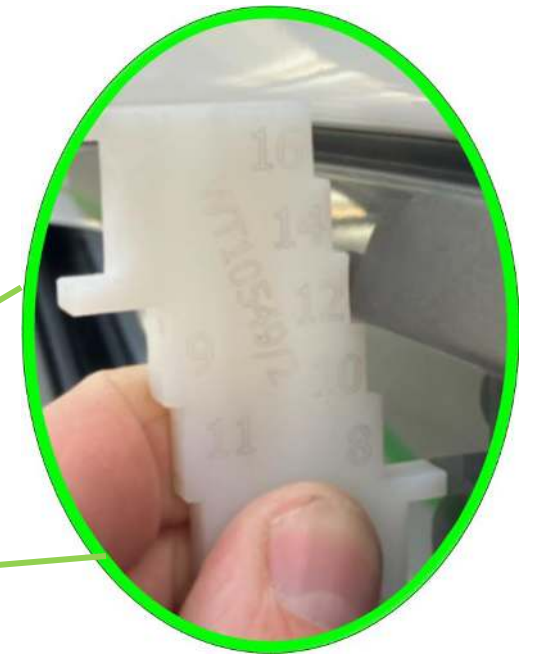
# PROFILE POINT 1

50mm in front of front div  
bar

**Specification**  
10mm  $\pm$  1mm  
(Profile Tool WT10549/2)

Flat against glass to  
brightware

If the measurement is  
out of specification refer  
to ElsaPro

**Repair Group 64 'Slide  
glass checking and  
adjusting'**

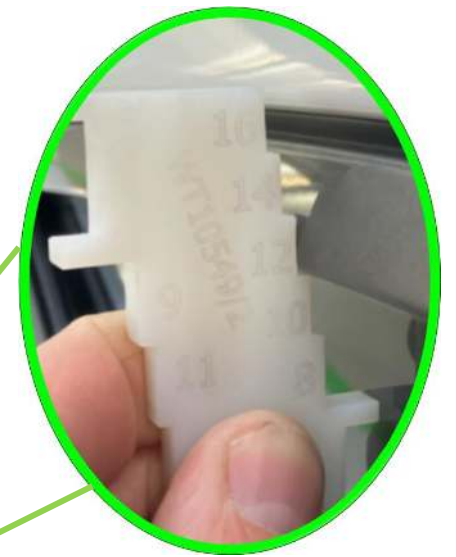
# PROFILE POINT 2, 3, 4

150mm behind front  
div bar

50mm in front of  
rear div bar

50mm behind  
rear div bar

Flat against glass to  
brightware

**Repair Group 64 'Slide  
glass checking and  
adjusting'**

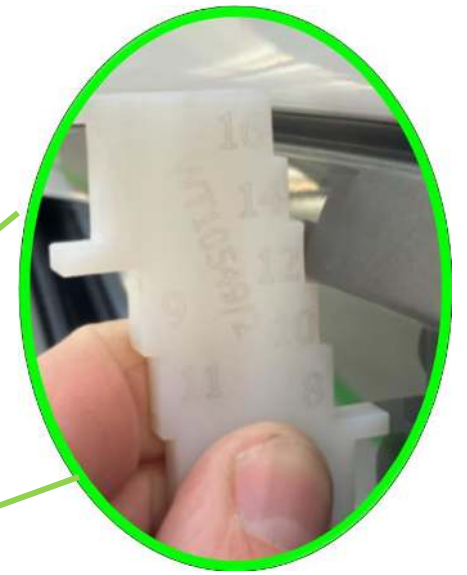
# PROFILE POINT 5

50mm from corner  
point of bright ware

Flat against glass to  
brightware

**Specification**  
10mm  $\pm$  2mm  
(Profile Tool WT10549/2)

**Repair Group 64 'Slide glass  
checking and adjusting'**

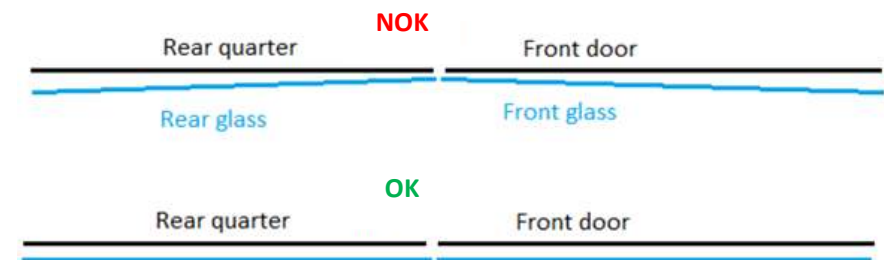
See image below, for OK and NOK after adjustment/checking

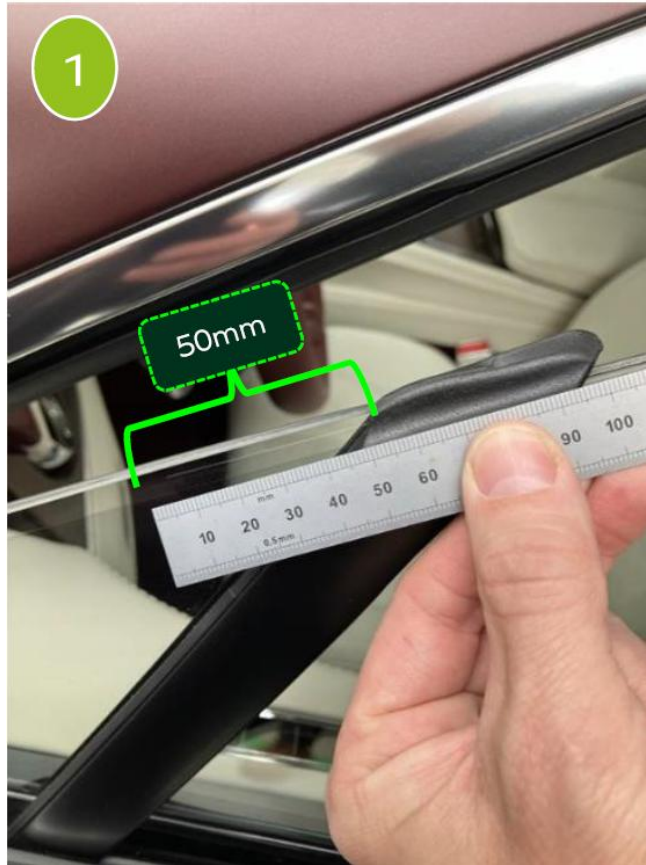
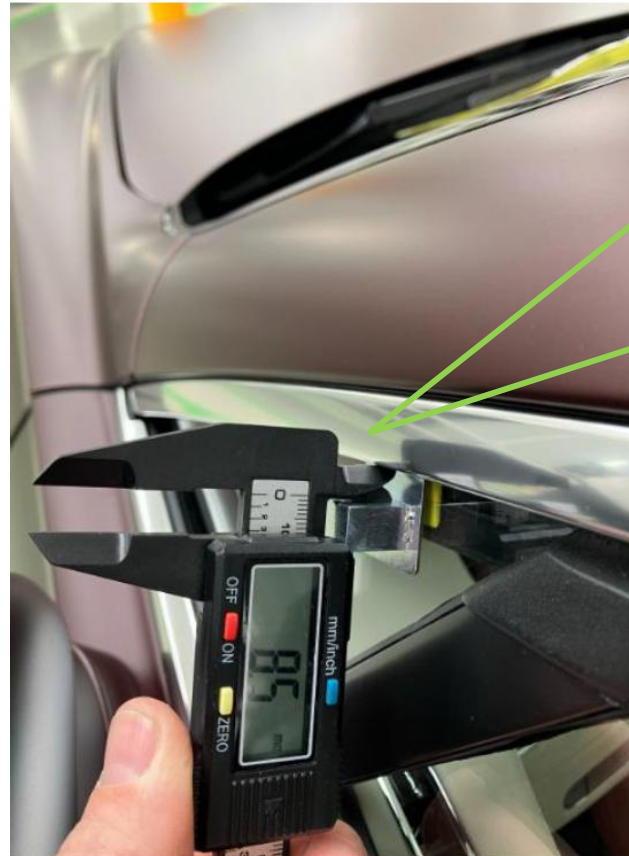
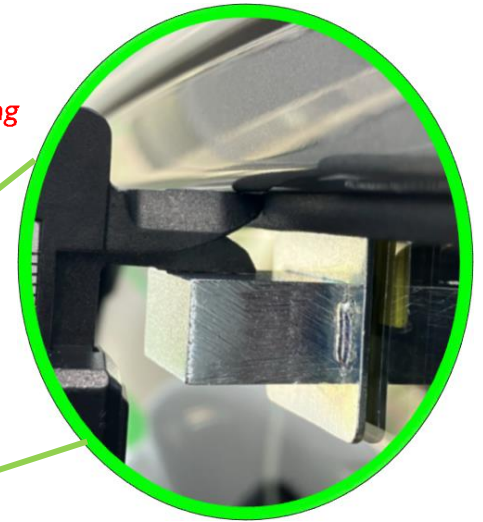
# INTERLOCK POINT 1

Place block 50mm in front of front div bar

From block to bright ware for all interlock points

**Specification**  
7.5mm  $\pm$  1mm  
(Interlock Tool WT10549/1)

If the measurement is out of specification  
refer to ElsaPro  
**Repair Group 64 'Front door quarter  
glass – To adjust'**

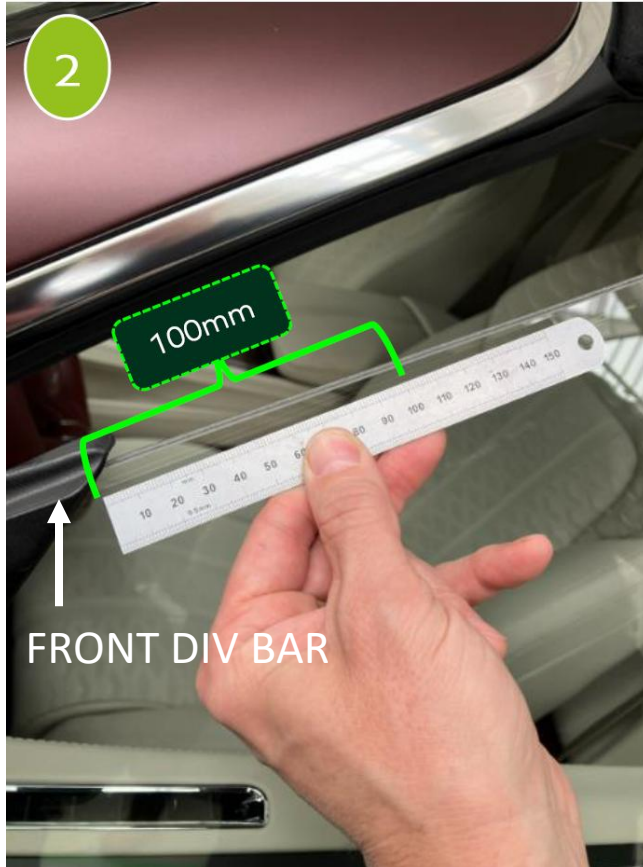
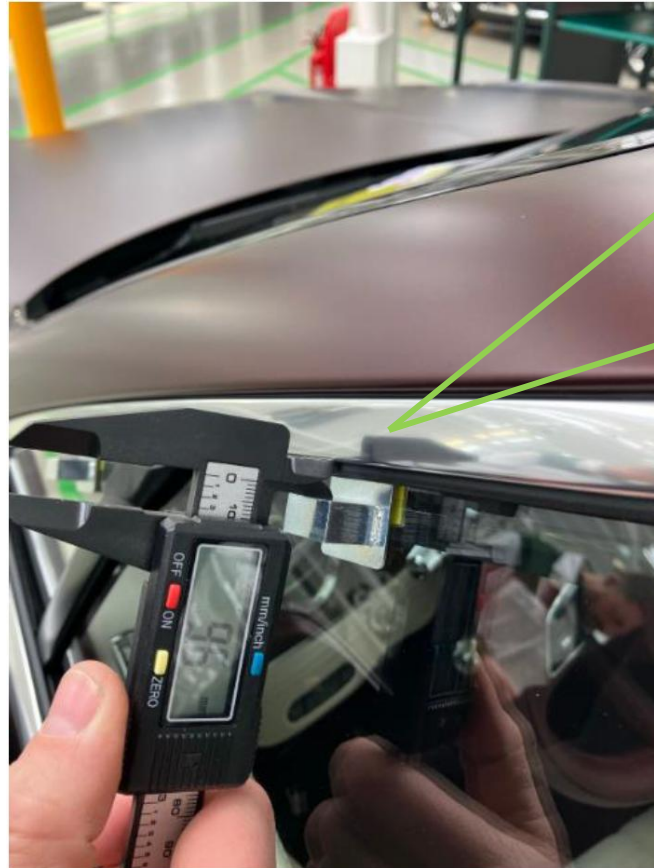
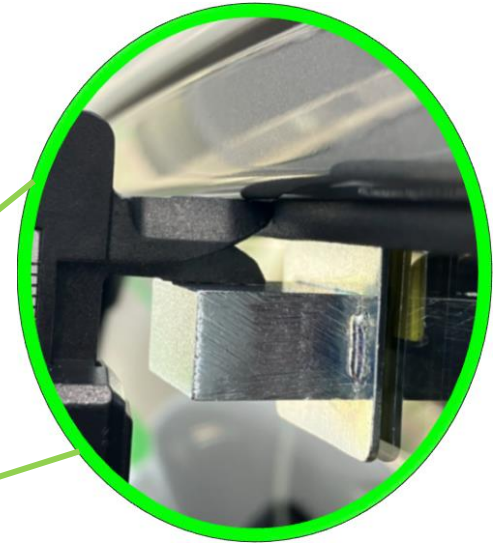
# INTERLOCK POINT 2

Place block 100mm in front of front div bar

From block to bright ware for all interlock points

**Repair Group 64 'Front door quarter glass – To adjust'**

*If the specification for interlock points 2, 3 or 4 cannot be achieved through normal adjustment, refer to page 6 of the glass reset procedure.*

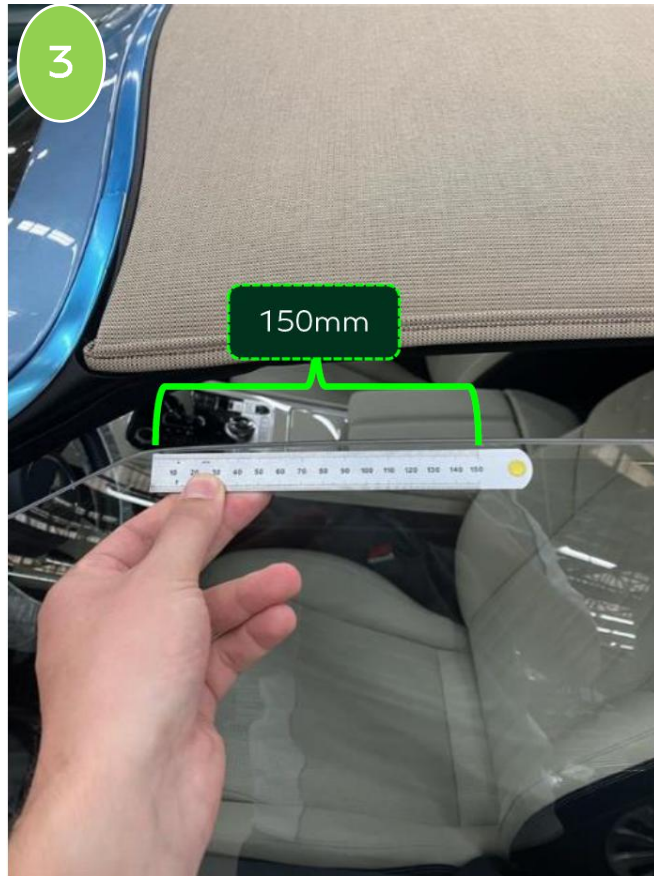
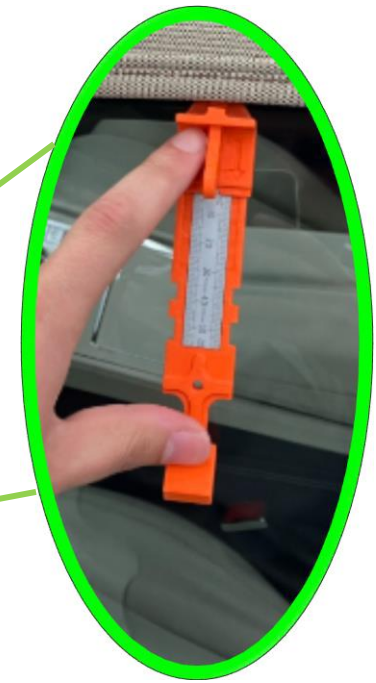
# INTERLOCK POINT 3

150mm from front corner of window glass as shown

**Specification**  
7mm  $\pm$  1mm  
(Interlock Tool WT10554)

If the measurement is out of specification refer to ElsaPro Repair Group 64 'Front door quarter glass – To adjust'

*If the specification for interlock points 2, 3 or 4 cannot be achieved through normal adjustment, refer to page 6 of the glass reset procedure.*

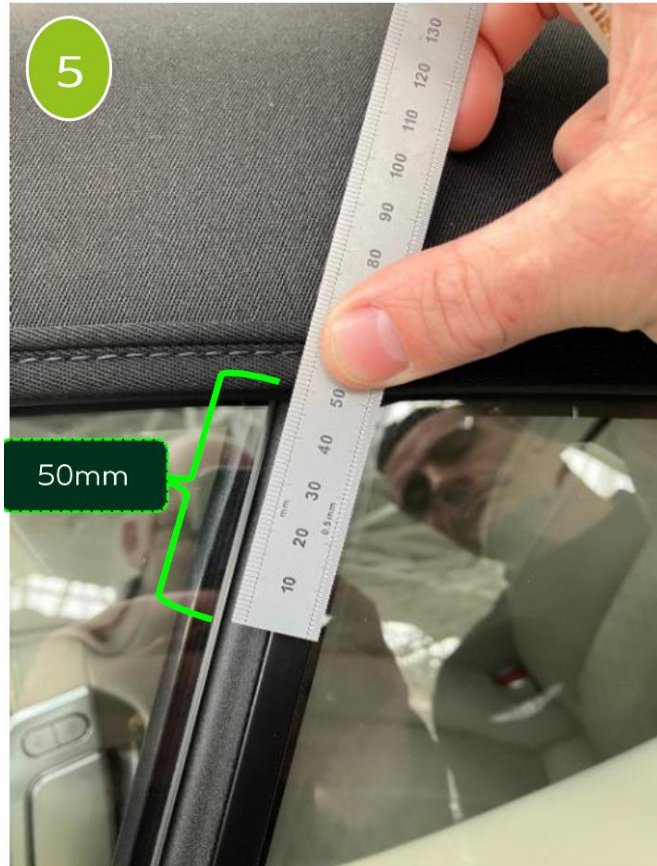
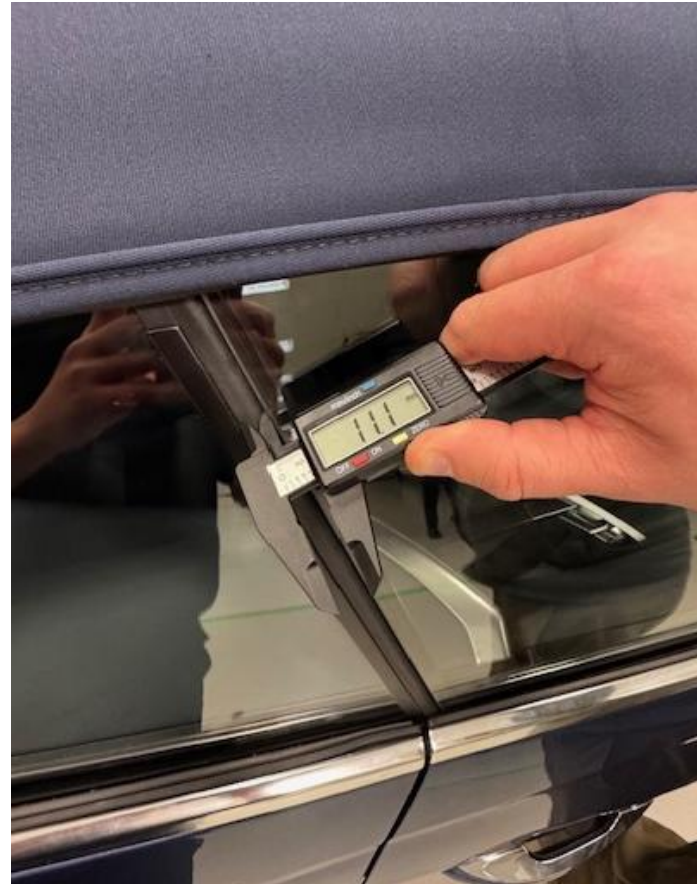
# INTERLOCK POINT 5 ROOF UP

50mm from corner

**Specification**  
11mm  $\pm$  1mm  
(Ruler/vernier)

If the measurement is out of specification refer to ElsaPro Repair Group 64 'Front door quarter glass – To adjust'

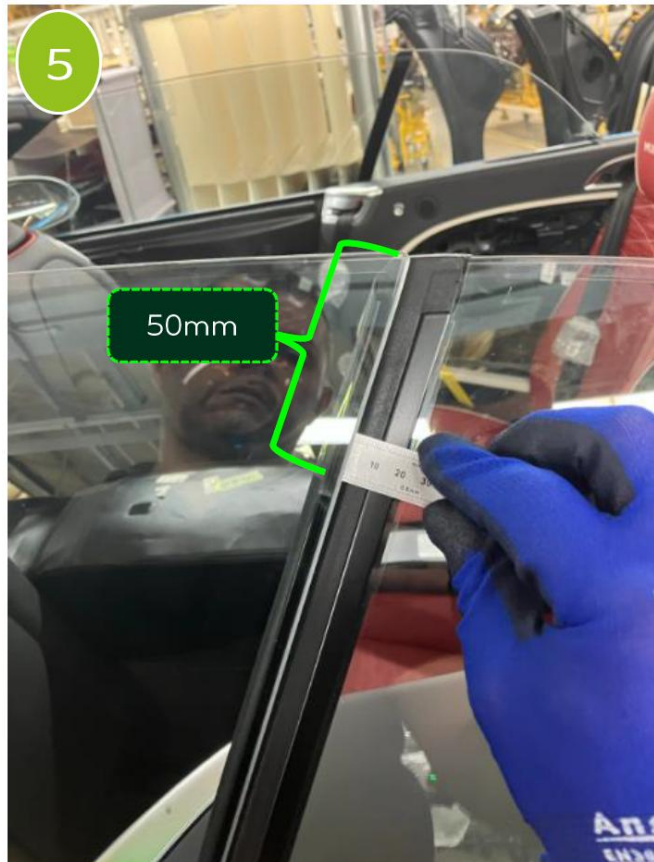
# INTERLOCK POINT 5 ROOF DOWN

Take measurement  
50mm from top of glass

**Specification**  
11mm  $\pm$  1mm  
(Ruler/vernier)

If the measurement is out of  
specification refer to ElsaPro  
**Repair Group 64 'Front door  
quarter glass – To adjust'**

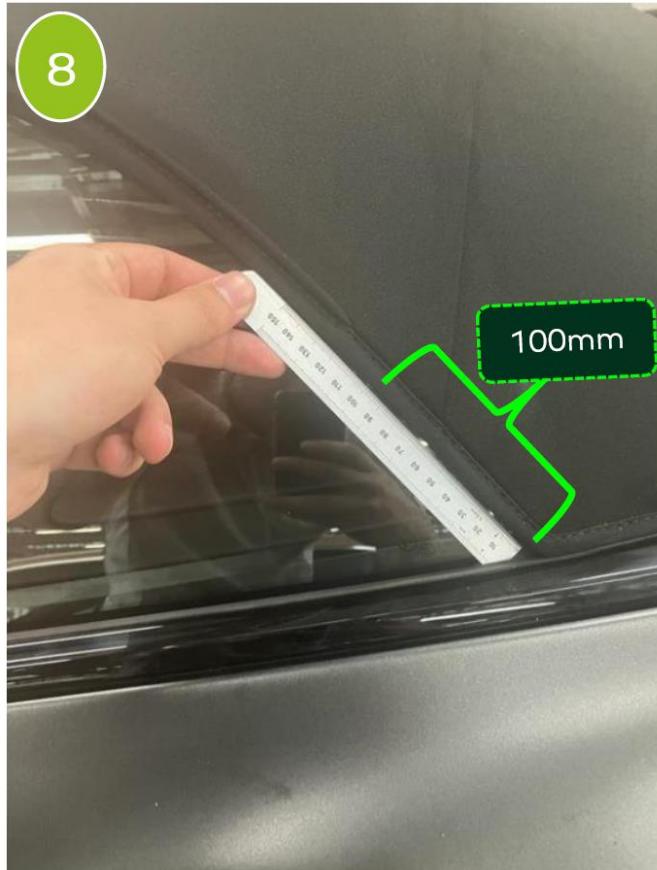
# INTERLOCK POINT 8

100mm from corner

**Specification**  
8.5mm – 16mm  
(Interlock Tool WT10554)

If the measurement is out of specification refer to ElsaPro Repair Group 64 'Front door quarter glass – To adjust'

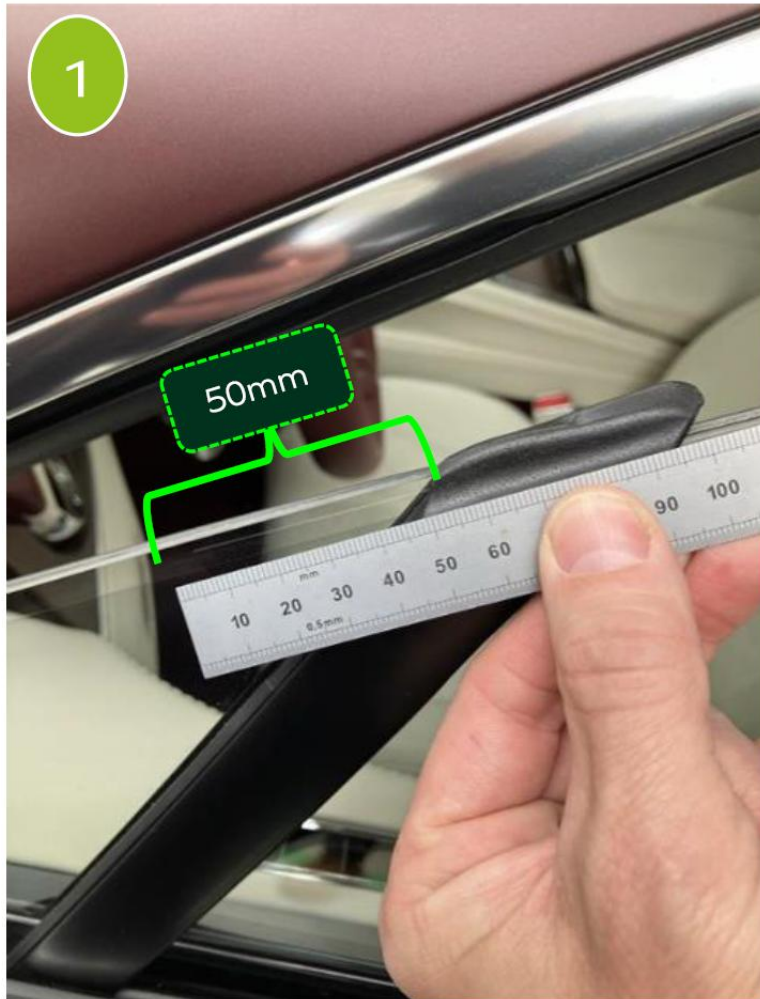
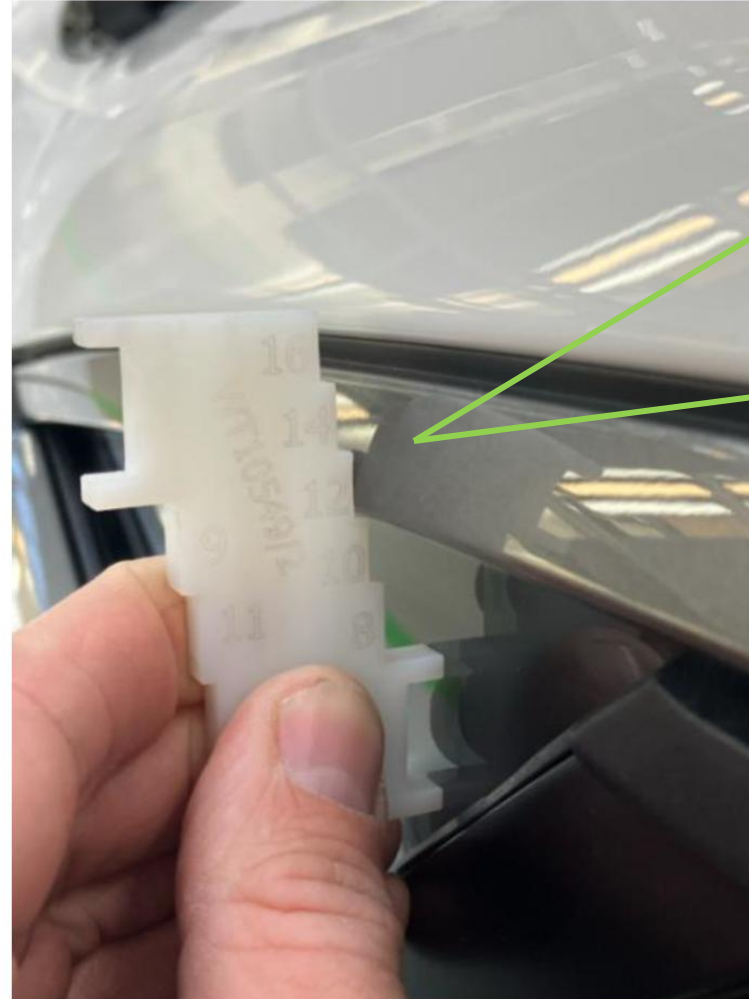
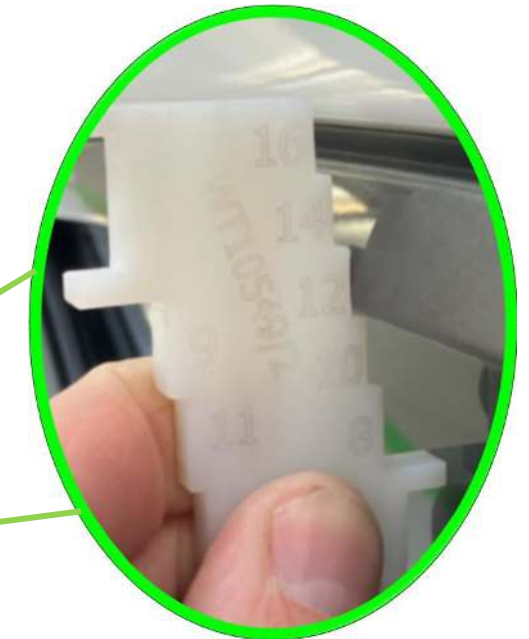
# PROFILE POINT 1

50mm in front of front div  
bar

**Specification**  
10mm  $\pm$  1mm  
(Profile Tool WT10549/2)

If the measurement is out of  
specification refer to ElsaPro  
**Repair Group 64 'Slide glass  
checking and adjusting'**

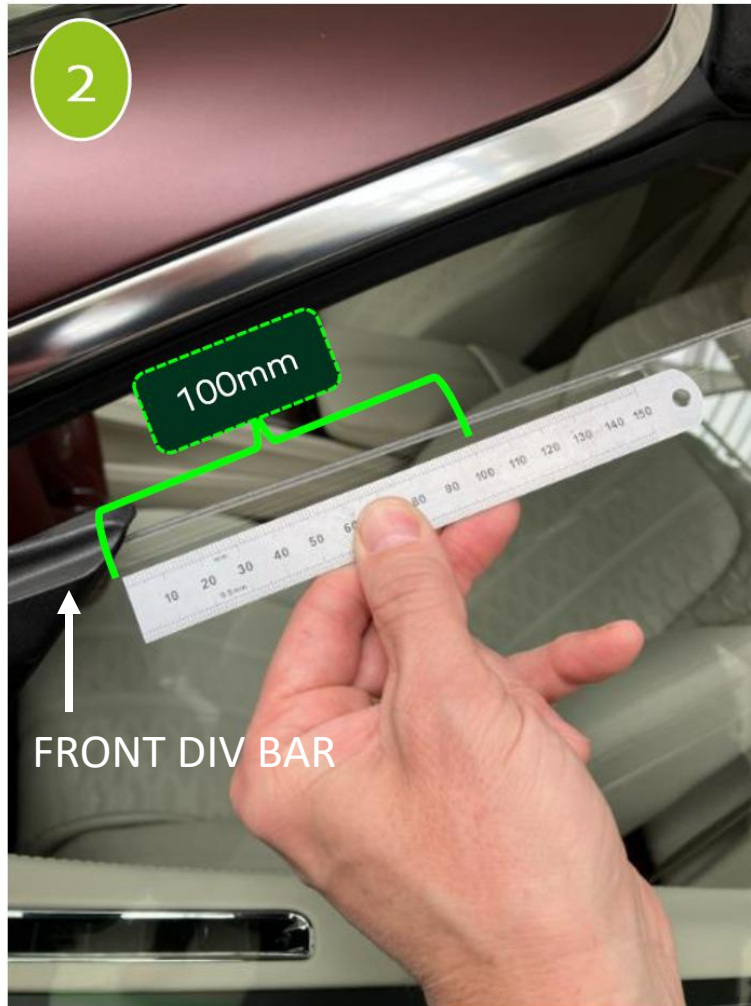
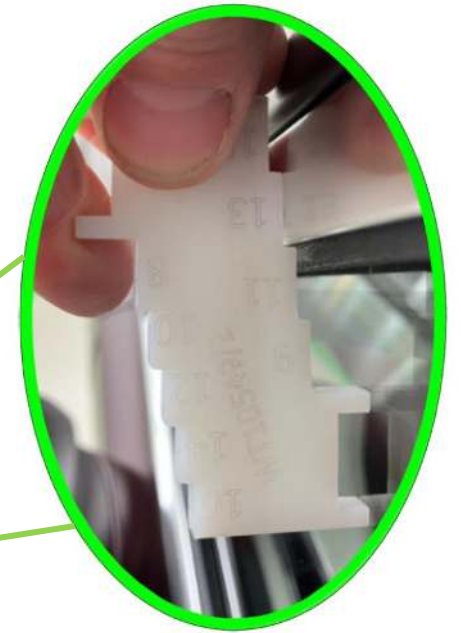
# PROFILE POINT 2

Place block 50mm in front  
of front div bar

**Specification**  
14mm  $\pm$  2mm  
(Profile Tool WT10549/2)

If the measurement is out of  
specification refer to ElsaPro  
**Repair Group 64 'Slide glass  
checking and adjusting'**

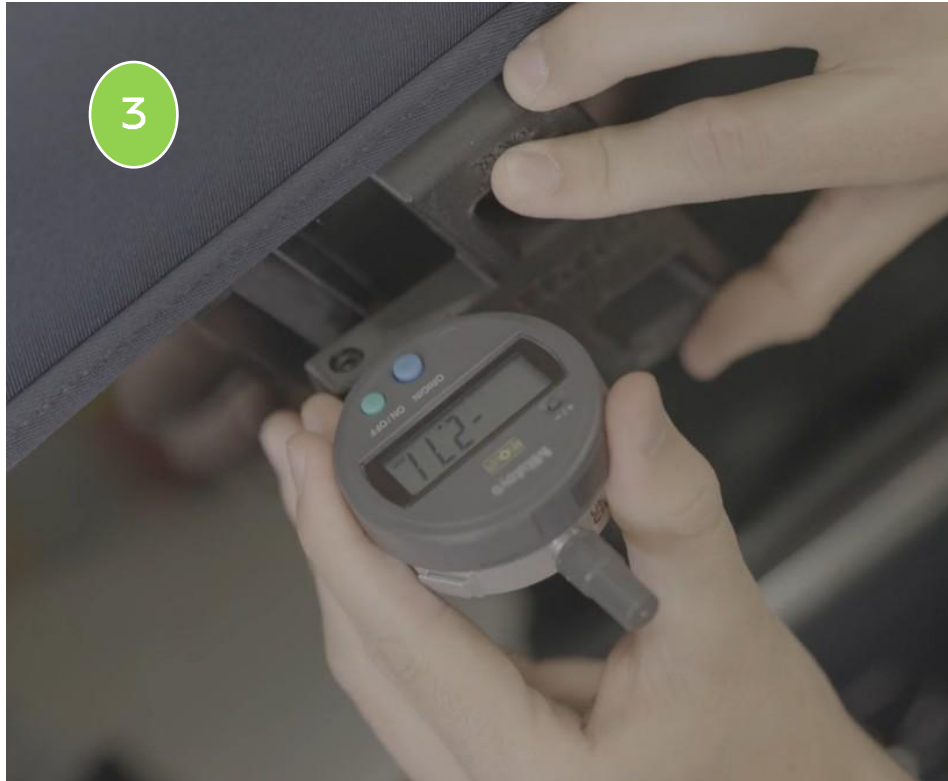
# PROFILE POINT 3 ROOF UP (DIGITAL DTI GAUGE - LATEST TOOL)

**Specification**  
0mm +0 / -2.5mm

**Repair Group 64**  
**'Slide glass checking and adjusting'**

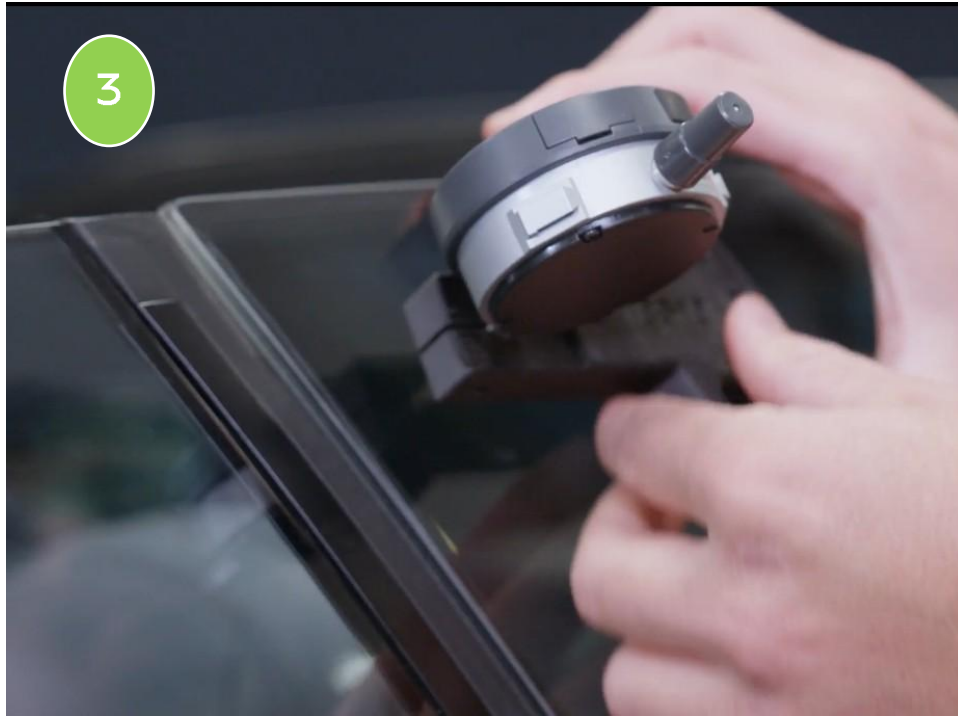
## PROFILE POINT 3 ROOF DOWN (DIGITAL DTI GAUGE - LATEST TOOL)

**Specification**  
0mm +0 / -3mm

**Repair Group**  
**64 'Slide glass**  
**checking and**  
**adjusting'**

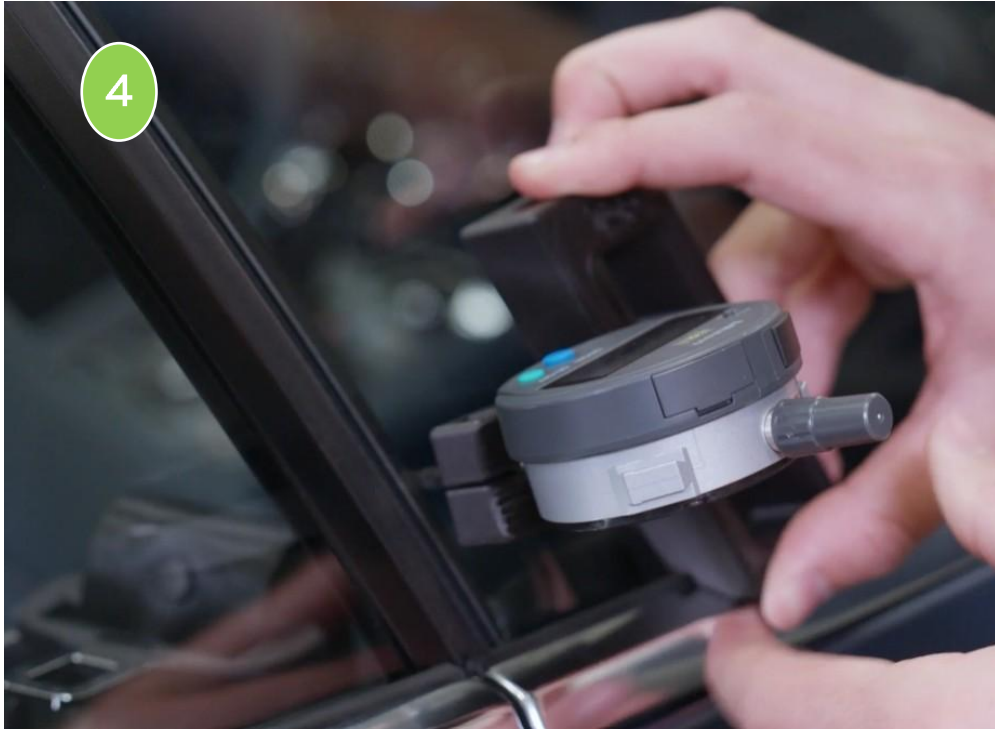
## PROFILE POINT 4 ROOF UP (DIGITAL DTI GAUGE - LATEST TOOL)

**Specification**  
0mm +0 / -2.5mm

**Repair Group 64**  
**'Slide glass checking and adjusting'**

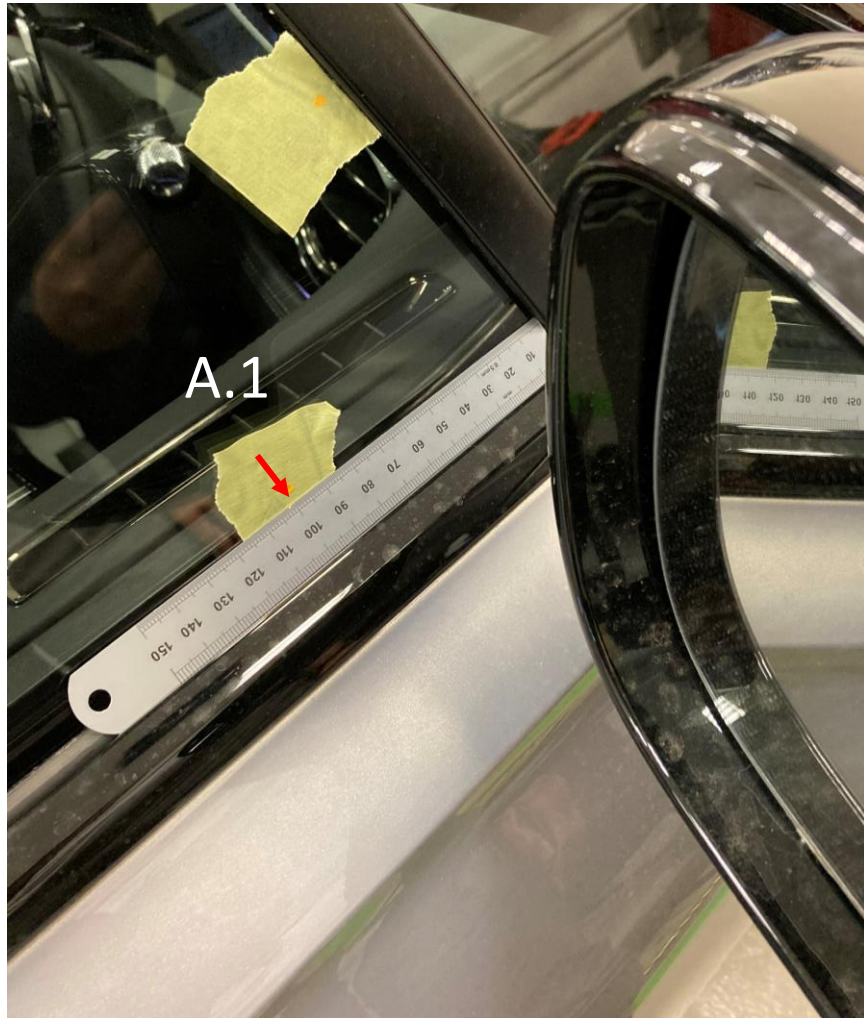
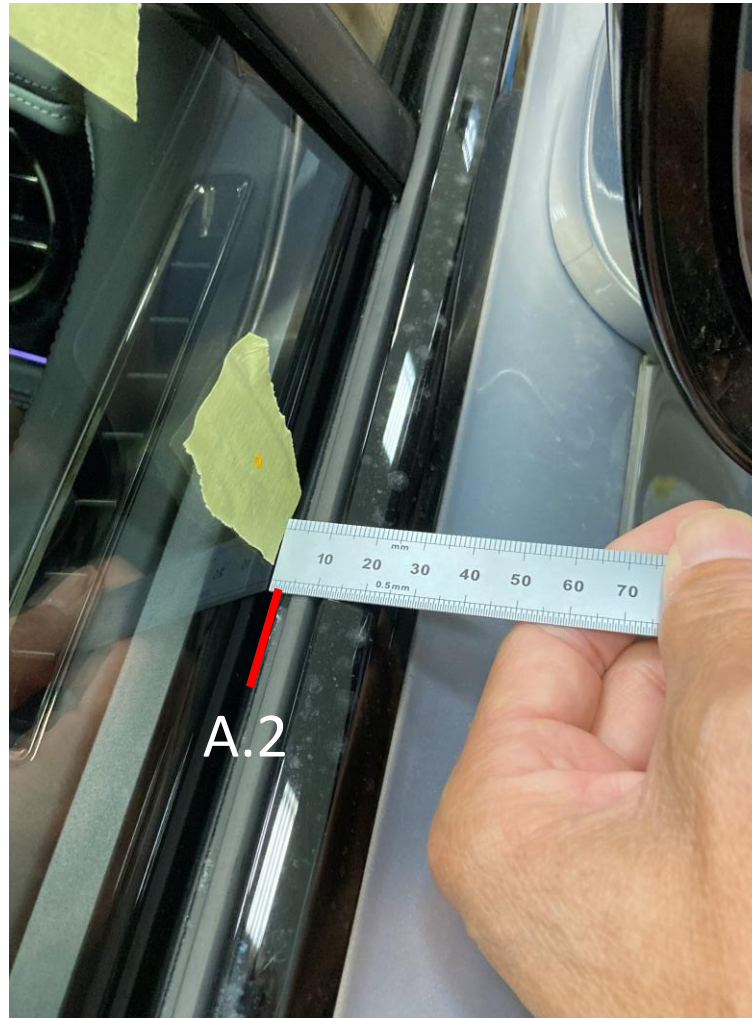
# WAIST SEAL MEASUREMENT POINT A

Mark on tape 100mm from div bar (A.1)

Measure from first lip rubber seal to window glass (A.2)

**Repair Group 64 'Slide glass checking and adjusting'**

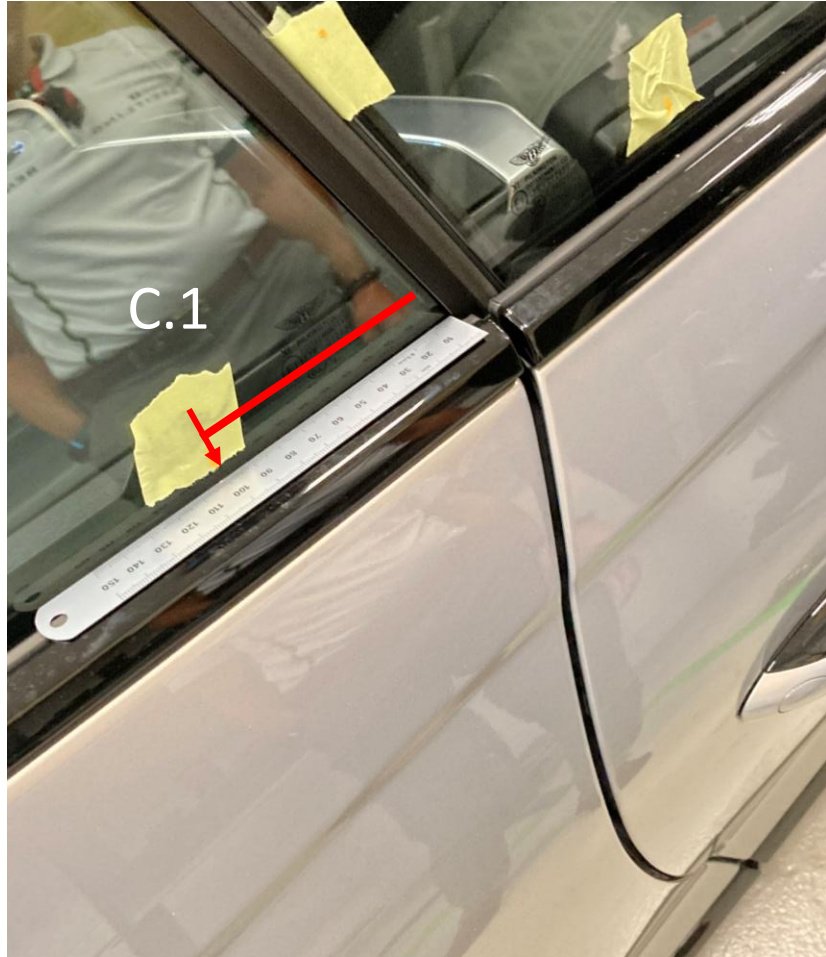
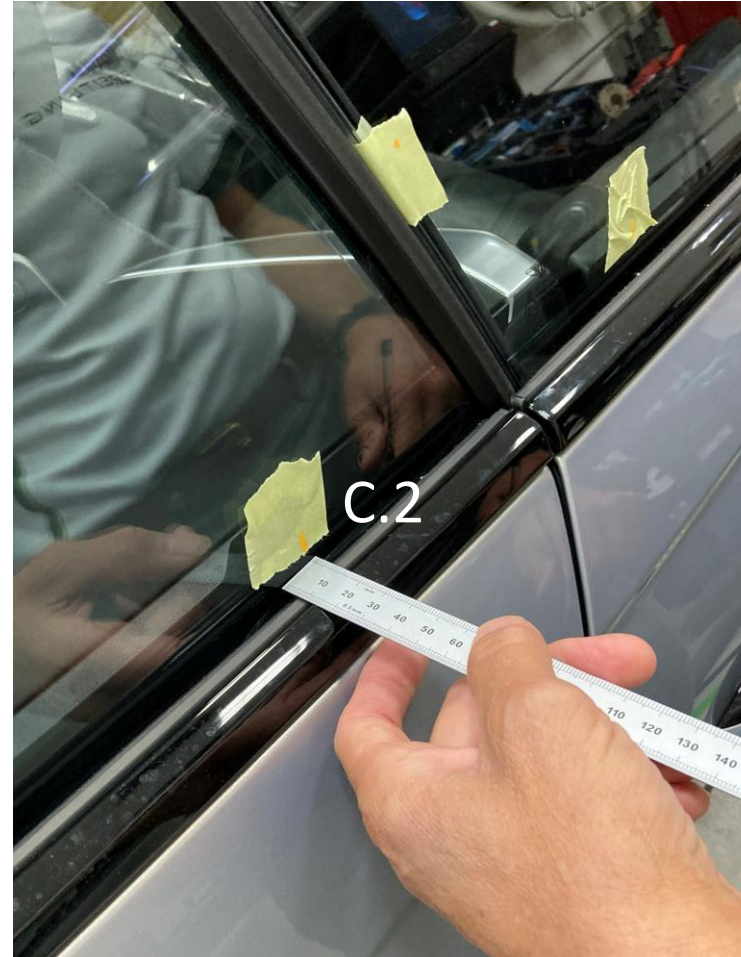
# WAIST SEAL MEASUREMENT POINT C

Mark on tape 100mm  
from div bar (C.1)

Measure seal to  
window gap (C.2)

If the measurement is out  
of specification refer to  
ElsaPro **Repair Group 64**  
**'Slide glass checking and  
adjusting'**

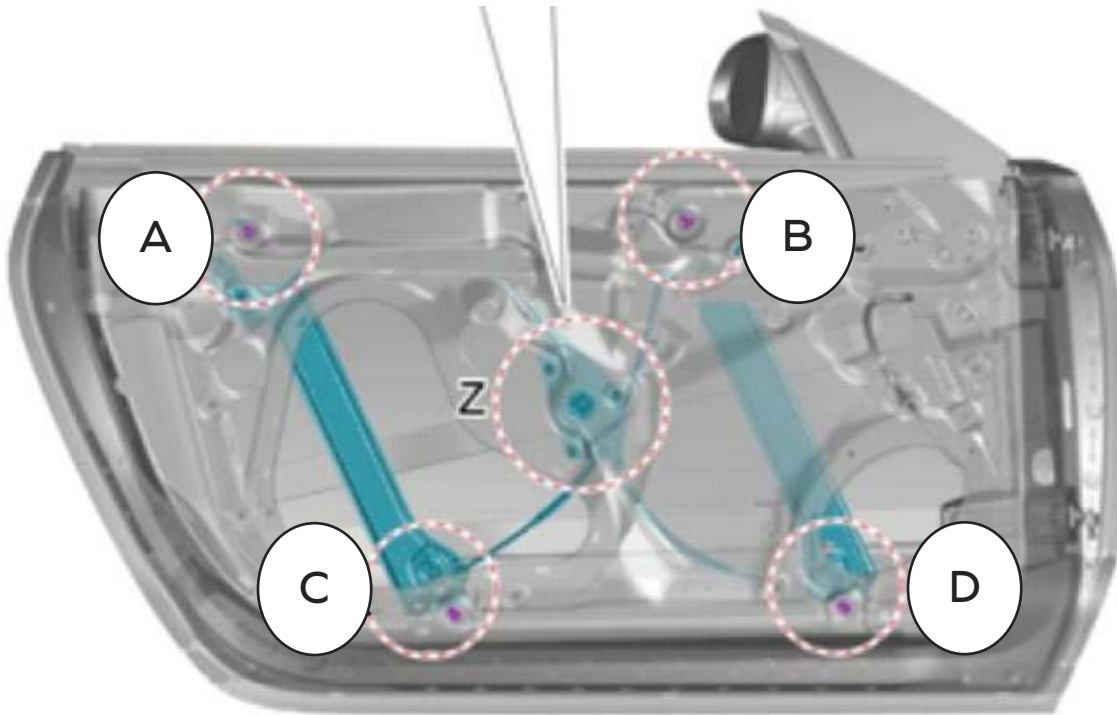
*Figure 2*

For the front door, poor door profile point is a major contributing factor here and should be checked/adjusted if window found to be entering seal incorrectly.

If this is not correct, it will cause the window to bounce back causing a loss of basic settings.

In instances of multiple window drop concerns it has been found that to achieve the glass set specification, some adjusters are being adjusted out of specification.

In some cases, since not all adjusters are visible, there is a possibility that the adjusters can be set to their maximum inboard/outboard and induce excess tension in the regulators and affect the angle the windows enter the seals. There is free play built into the front and rear regulators, therefore as the windows are being held in place by the cant rail/convertible roof seals when closed, this may not be apparent when measuring. However, these extreme adjustments can cause issues with how the windows enter the cant rail/convertible roof seals or how the front and rear glasses interlock with each other, in some cases this can cause the seals to pinch and cause an anti-trap condition leading to window reversal.

1. loosen the lock nut.
2. Screw the adjuster fully clockwise until it bottoms out on the frame.
3. Unscrew the adjuster counterclockwise by four complete turns.
4. Resecure the lock nut.

Finally, set the height and profile to the TPI specification before proceeding to the next step.

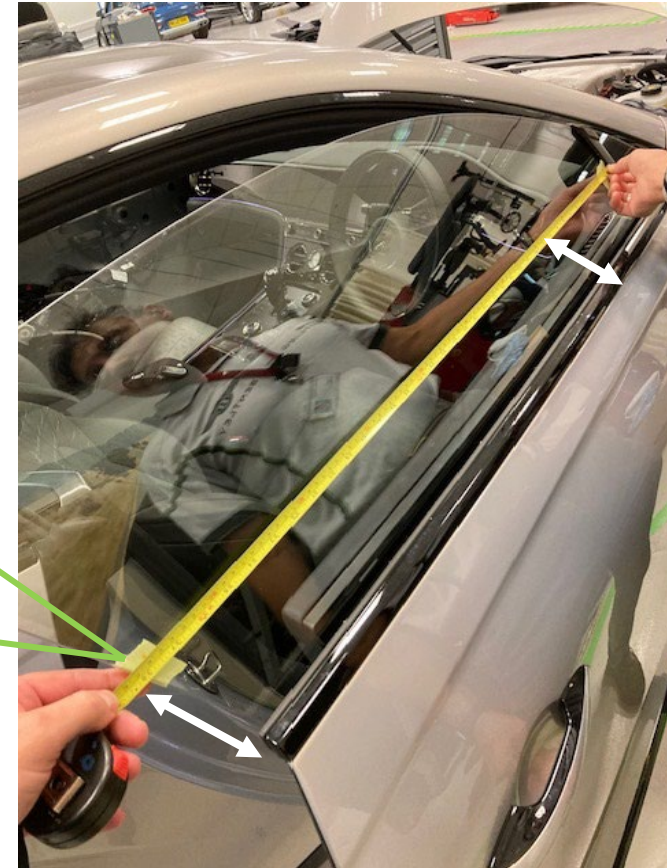
Measure 100mm up from  
the waist rail

**Specification**  
971mm +2mm

If out of specification, refer to the next  
slide to adjust the glass position
