| Topic | Window Drop Glass Operation Continental GT/GTC 25-26MY |
| Transaction No. | 2080372/2 |

Window Drop Glass Operation | Continental GT/GTC | 25-26MY

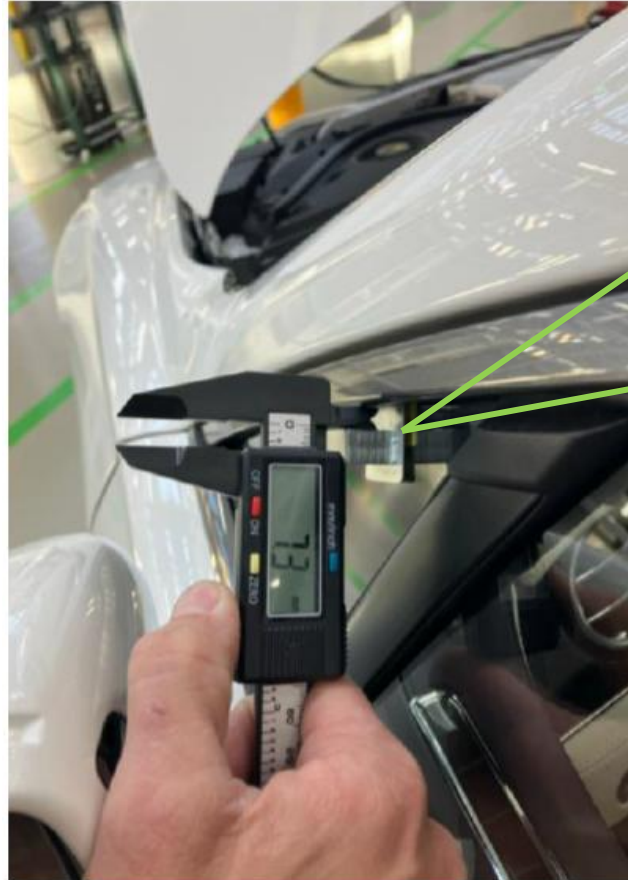
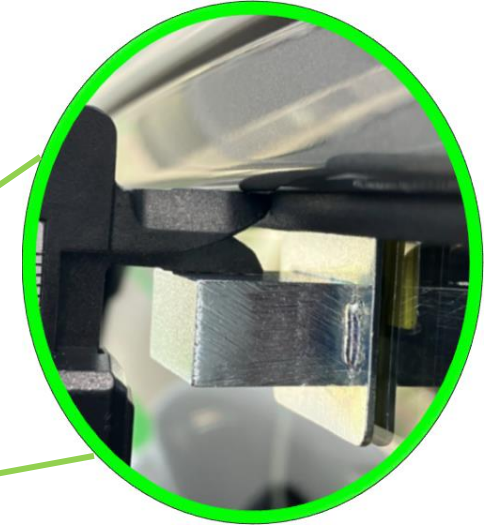
# INTERLOCK POINT 1

Place block 50mm in front of front div bar

Record measurement for all interlock points

From block to bright ware for all interlock points

If the measurement is out of specification refer to ElsaPro Repair Group 64 'Front door quarter glass – To adjust'

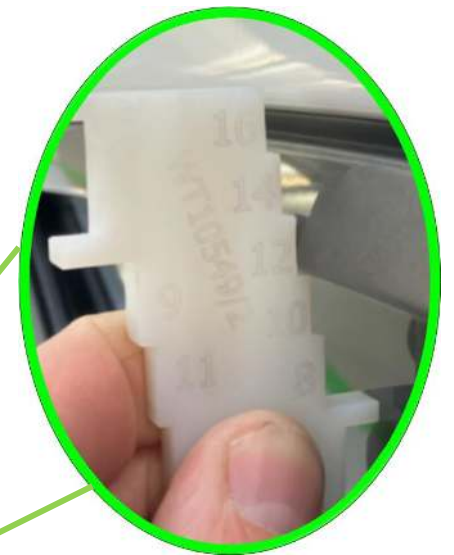
# PROFILE POINT 2, 3, 4

150mm behind front  
div bar

50mm in front of  
rear div bar

50mm behind  
rear div bar

Flat against glass to  
brightware

**Repair Group 64 'Slide  
glass checking and  
adjusting'**

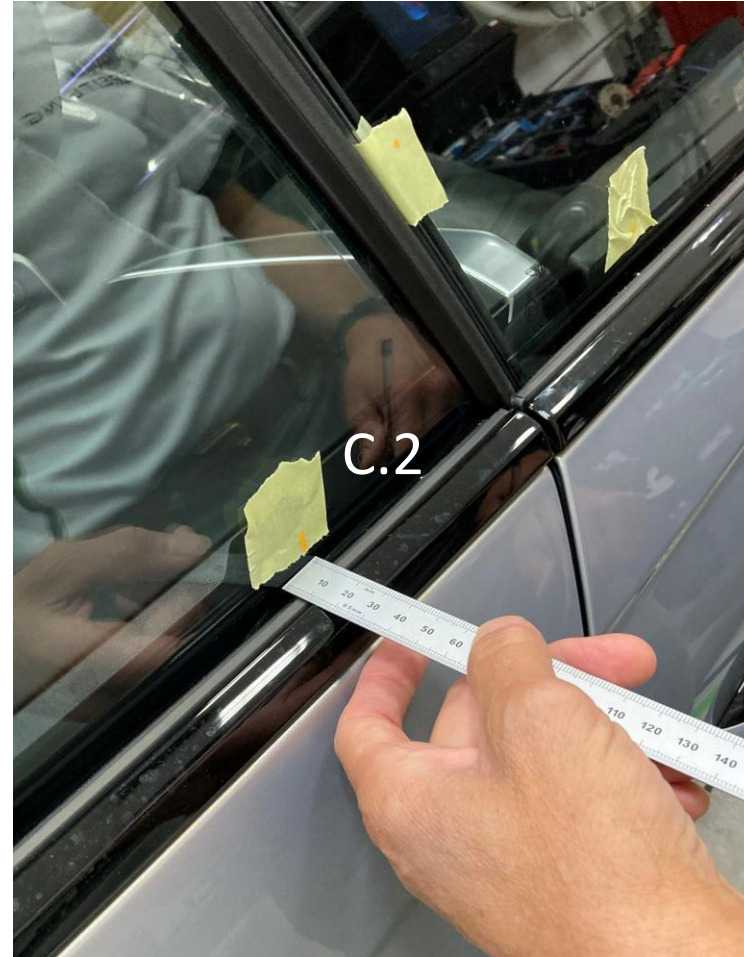
# WAIST SEAL MEASUREMENT POINT C

Mark on tape 100mm  
from div bar (C.1)

Measure seal to  
window gap (C.2)

**Repair Group 64 'Slide glass  
checking and adjusting'**

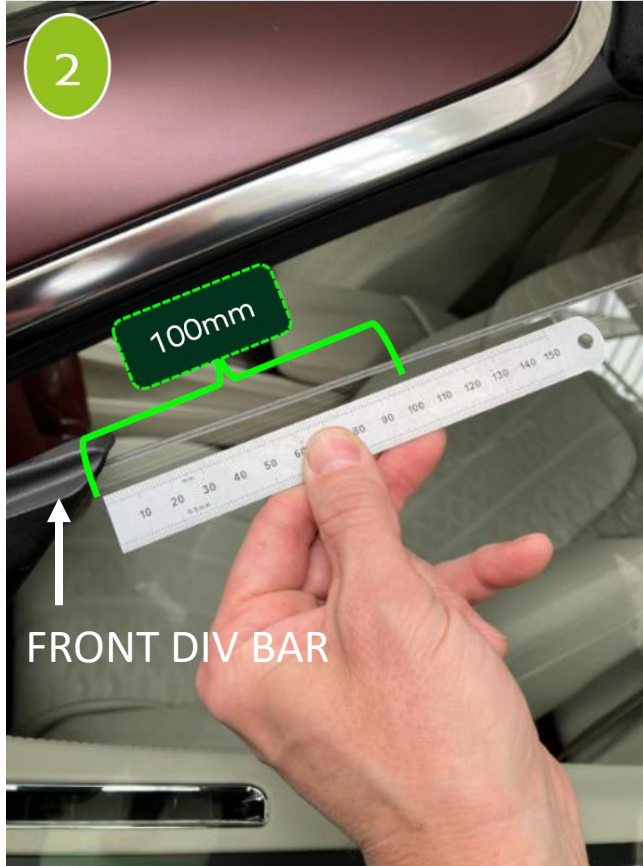
# INTERLOCK POINT 2

Place block 100mm in front of front div bar

Record measurement for all interlock points

From block to bright ware for all interlock points

**Repair Group 64 'Front door quarter glass – To adjust'**

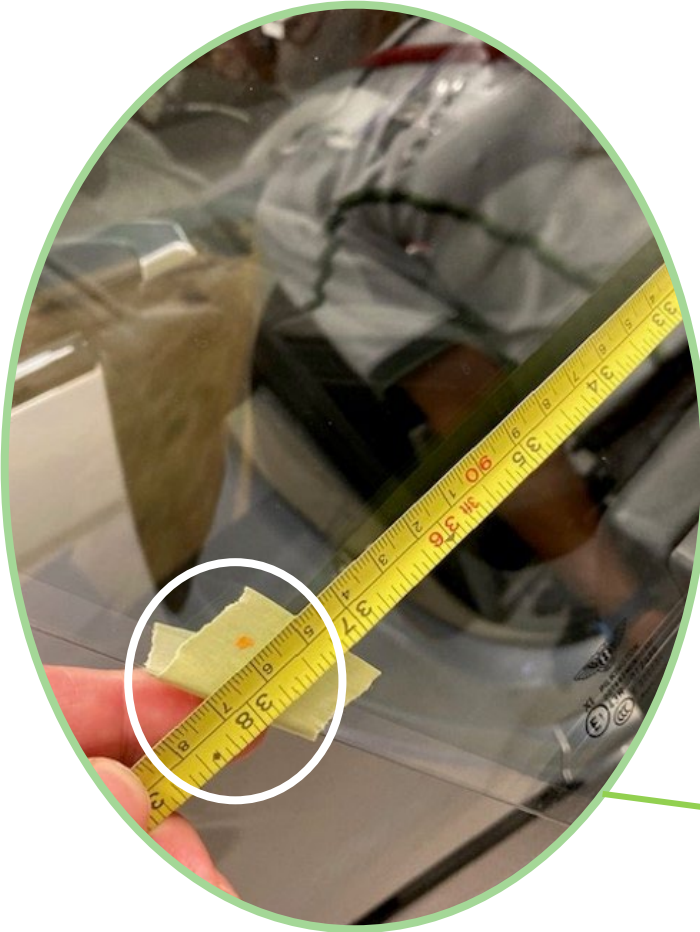
Measuring from front div bar to rear of  
the glass

**Specification**  
971mm +2mm

If out of specification, refer to the next  
slide to adjust the glass position
