## Technical product information

| <b>Topic</b> | Window Drop Glass Operation Continental GT/GTC 19-24MY |
| <b>Transaction No.</b> | 2080375/3 |

Window Drop Glass Operation | Continental GT/GTC |19-24MY

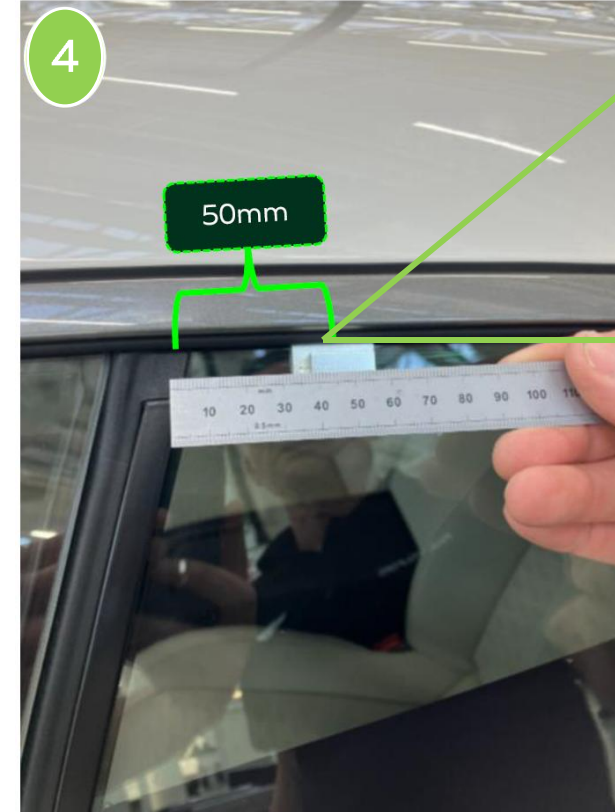
# INTERLOCK POINTS 2, 3, 4

Place block 150mm  
behind corner of  
front div bar

Place block 50mm  
in front of rear div  
bar

Place block 50mm  
to rear of rear div  
bar

**Specification**  
8mm ± 1mm  
(Interlock Tool WT10549)

If the measurement is  
out of specification  
refer to ElsaPro

**Repair Group 64 'Slide  
glass checking and  
adjusting'**

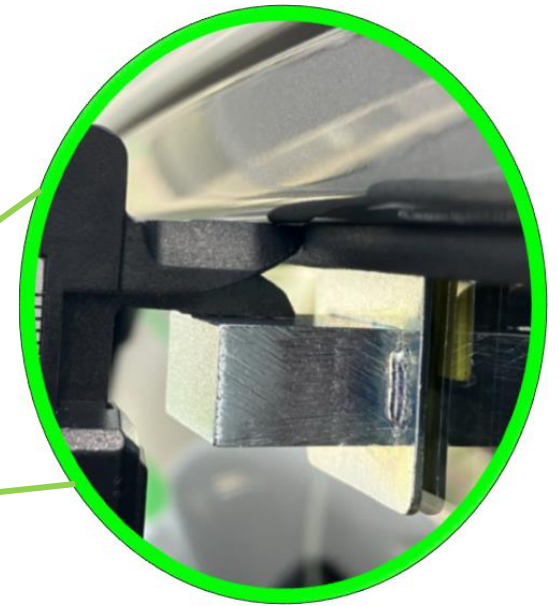
# INTERLOCK POINT 6

Place block 50mm from corner point of bright ware

Record measurement for all interlock points

**Specification**  
8mm  $\pm$  1mm  
(Interlock Tool WT10549/1)

If the measurement is out of specification refer to ElsaPro

**Repair Group 64 'Slide glass checking and adjusting'**

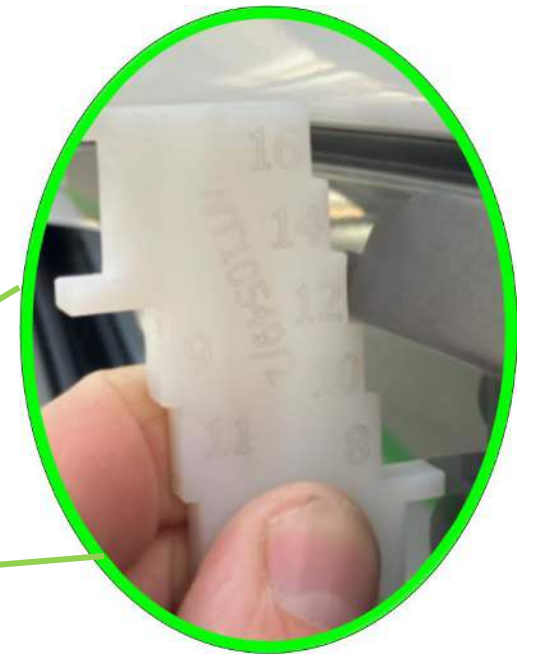
# PROFILE POINT 1

50mm in front of front div  
bar

Flat against glass to  
brightware

**Specification**  
10mm  $\pm$  1mm  
(Profile Tool WT10549/2)

If the measurement is  
out of specification refer  
to ElsaPro

**Repair Group 64 'Slide  
glass checking and  
adjusting'**

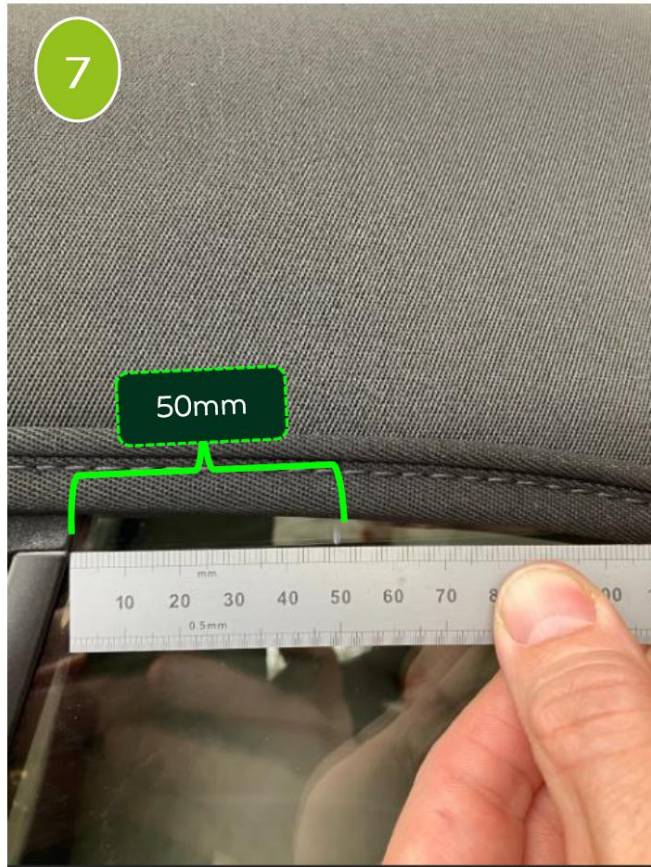
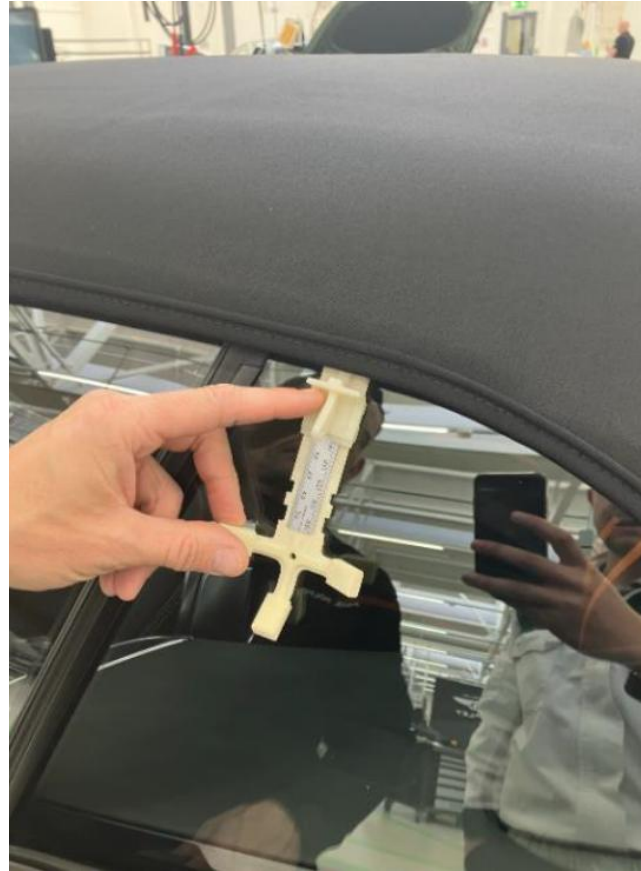
# INTERLOCK POINT 7

50mm behind rear div bar

**Specification**  
8.5mm  $\pm$  1mm  
(Interlock Tool WT10554)

1. Hook onto glass with door open at measured point
2. Close door and allow glass to close
3. Lightly push gauge to top and take measurement at indicated point. Do not deform the seal.

If the measurement is out of specification refer to ElsaPro Repair Group 64 'Front door quarter glass – To adjust'

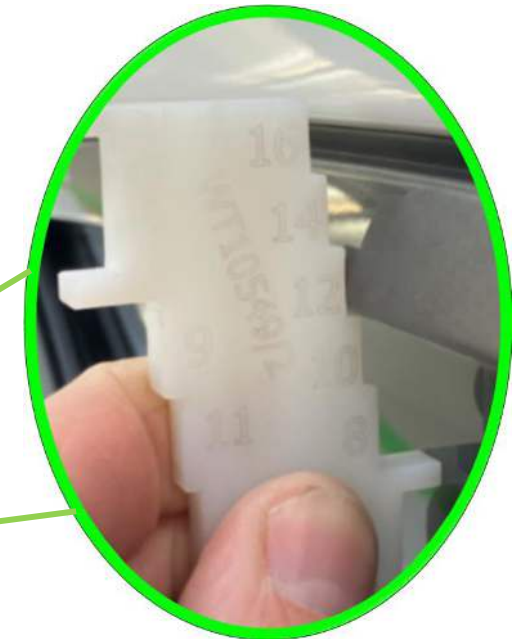
# PROFILE POINT 1

50mm in front of front div  
bar

Flat against glass to  
brightware

**Specification**  
10mm  $\pm$  1mm  
(Profile Tool WT10549/2)

If the measurement is out of  
specification refer to ElsaPro  
**Repair Group 64 'Slide glass  
checking and adjusting'**

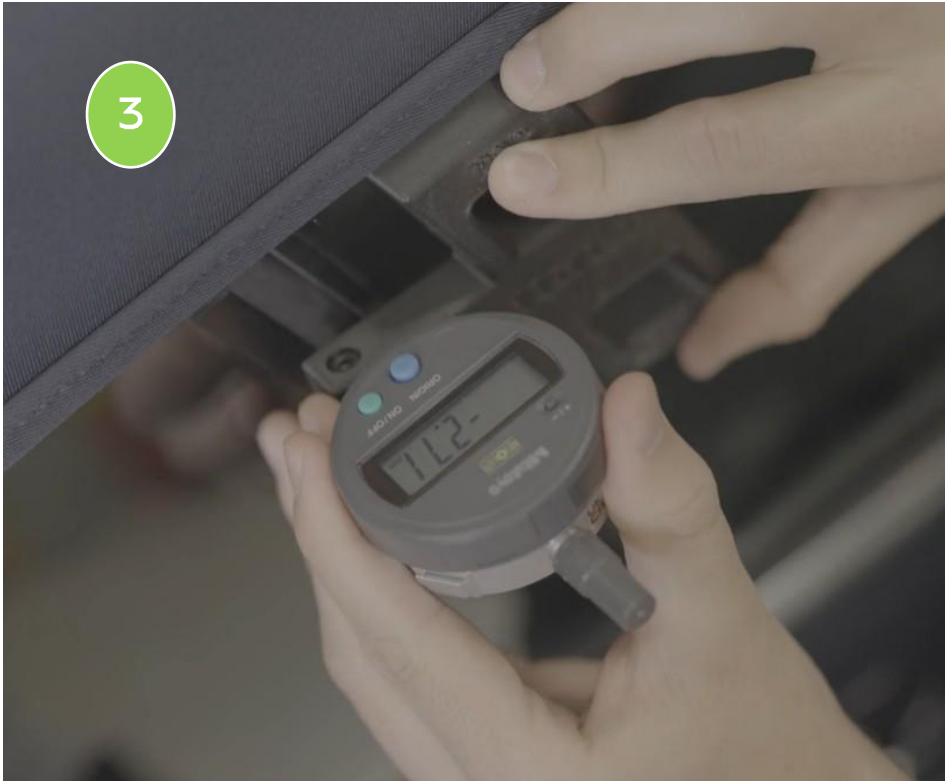
# PROFILE POINT 3 ROOF UP (DIGITAL DTI GAUGE - LATEST TOOL)

Align and position the tool on the front window so that its contact face rests flat against the roof trim, zero the tool.

Then slide it along the surface until it makes full, even contact with the rear glass. Record the measurement.

**Specification**  
0mm +0 / -3mm

**Repair Group 64**  
**'Slide glass checking and adjusting'**

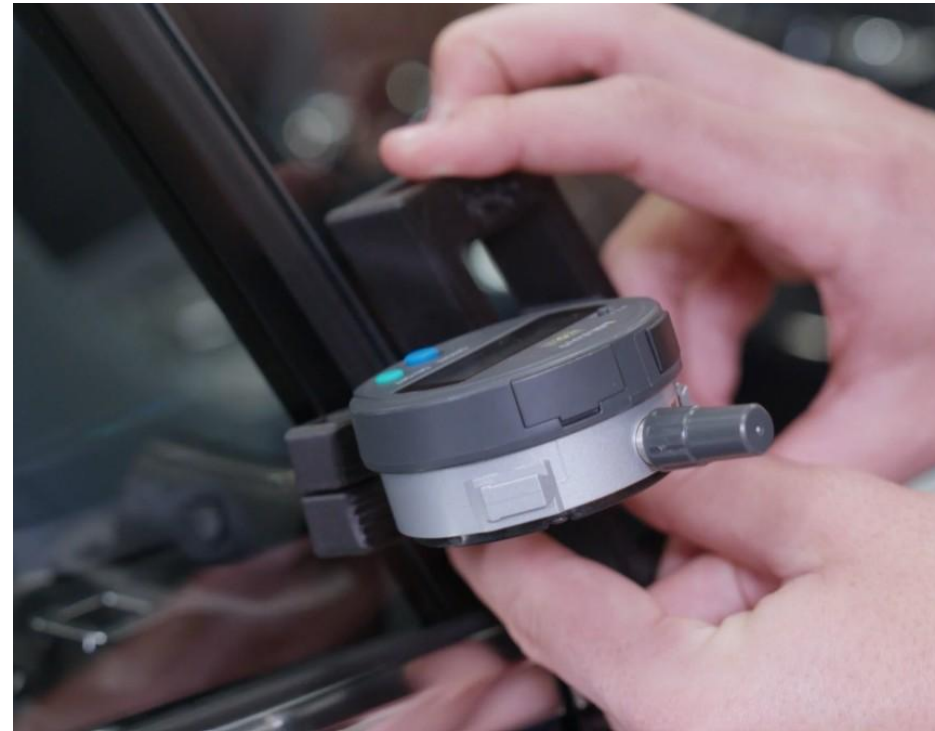
## PROFILE POINT 4 ROOF UP (DIGITAL DTI GAUGE - LATEST TOOL)

Align and position the tool on the front window so that its contact face rests flat against the lower bright ware trim, zero the tool.

Then slide it along the surface until it makes full, even contact with the rear glass.  
Record the measurement.

**Specification**  
0mm +0 / -3.5mm

**Repair Group 64**  
**'Slide glass**  
**checking and**  
**adjusting'**

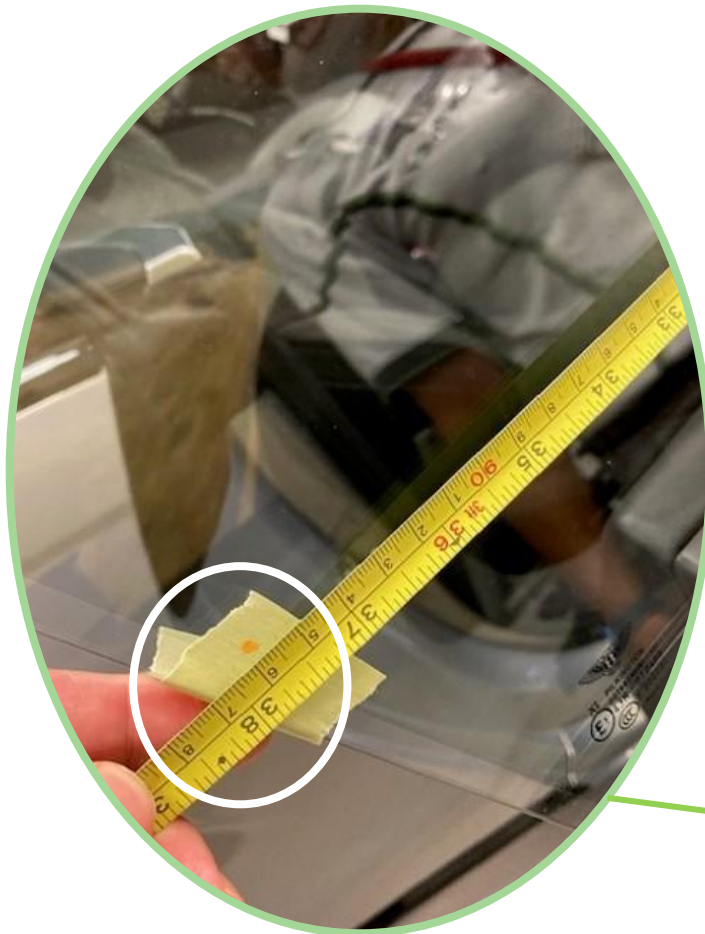
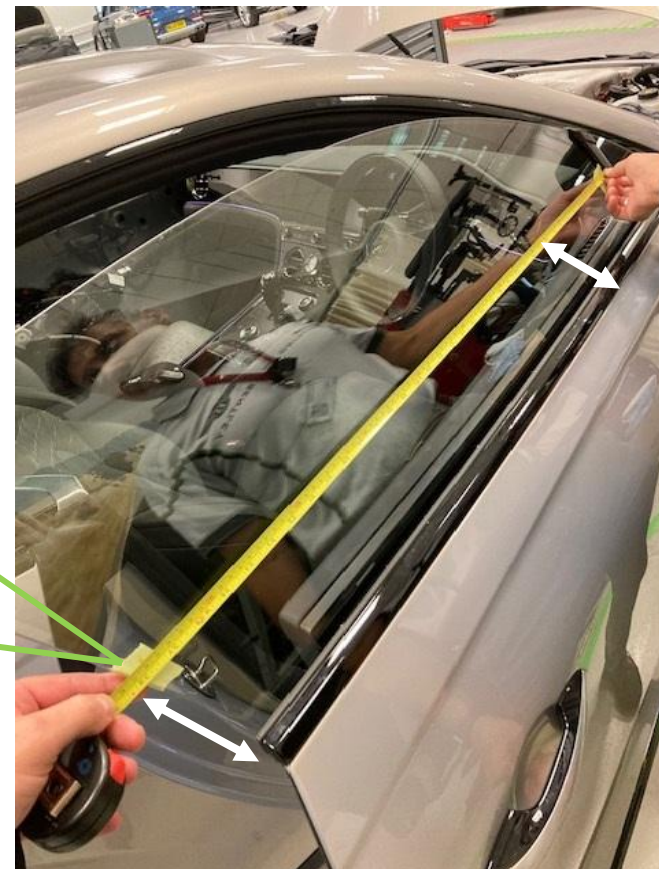
## Measuring from front div bar to rear of the glass

**NOTE:** Ensure the window is fully raised with the door closed, or fully closed in the latched position, before performing this measurement.

**Specification**  
971mm +2mm

Measure 100mm up from  
the waist rail

If out of specification, refer to the next slide to adjust the glass position

Then loosen the two purple bolts (-3- & -4-) in figure 3, raise the glass evenly as required, and re-secure the two purple bolts. Finally, return to the allen key (ratchet) adjustment to set interlock points 2, 3 and 4 to specification. Check the 971mm measurement has not altered, if so, re-adjust as required.

**NOTE:** If the 971 mm  $\pm$  1mm specification shown on the previous slide is incorrect, these bolts must be loosened to adjust the glass forward or backward as needed to meet the correct specification.
