## Technical product information

| <b>Topic</b> | Window Drop Glass Operation Continental GT/GTC 25-26MY |

Transaction No.: **2080372/3**

Window Drop Glass Operation | Continental GT/GTC | 25-26MY

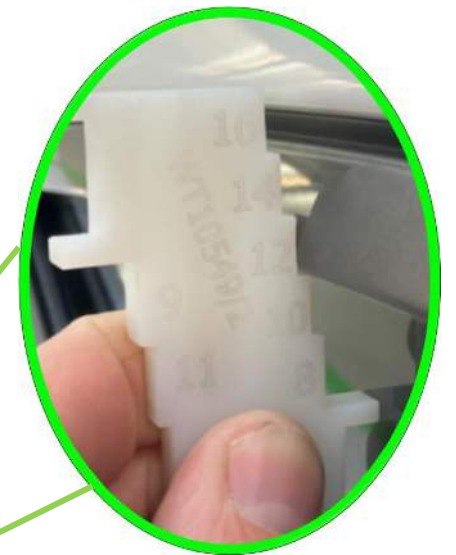
# PROFILE POINT 2, 3, 4

150mm behind front  
div bar

50mm in front of  
rear div bar

50mm behind  
rear div bar

Flat against glass to  
brightware

**Repair Group 64 'Slide  
glass checking and  
adjusting'**

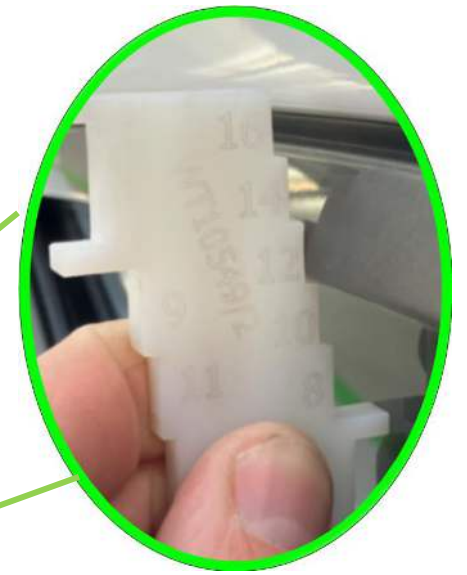
# PROFILE POINT 5

50mm from corner  
point of bright ware

**Specification**  
10mm  $\pm$  2mm  
(Profile Tool WT10549/2)

**Repair Group 64 'Slide glass  
checking and adjusting'**

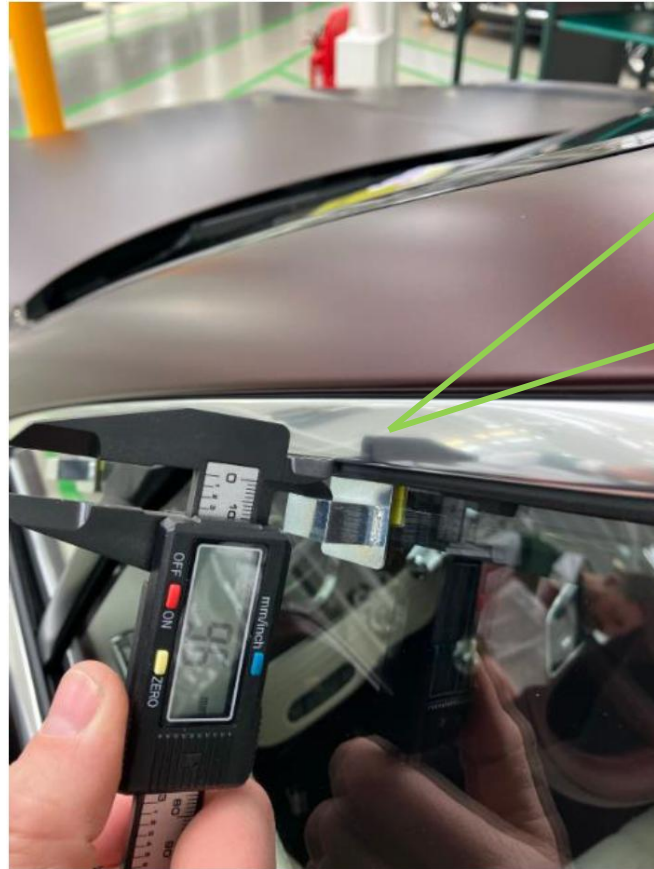
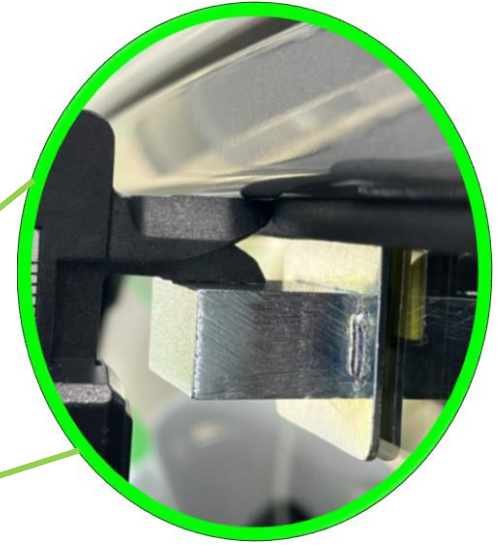
# INTERLOCK POINT 2

Place block 100mm in front of front div bar

Record measurement for all interlock points

From block to bright ware for all interlock points

**Repair Group 64 'Front door quarter glass – To adjust'**

*If the specification for interlock points 2, 3 or 4 cannot be achieved through normal adjustment, refer to page 6 of the glass reset procedure.*

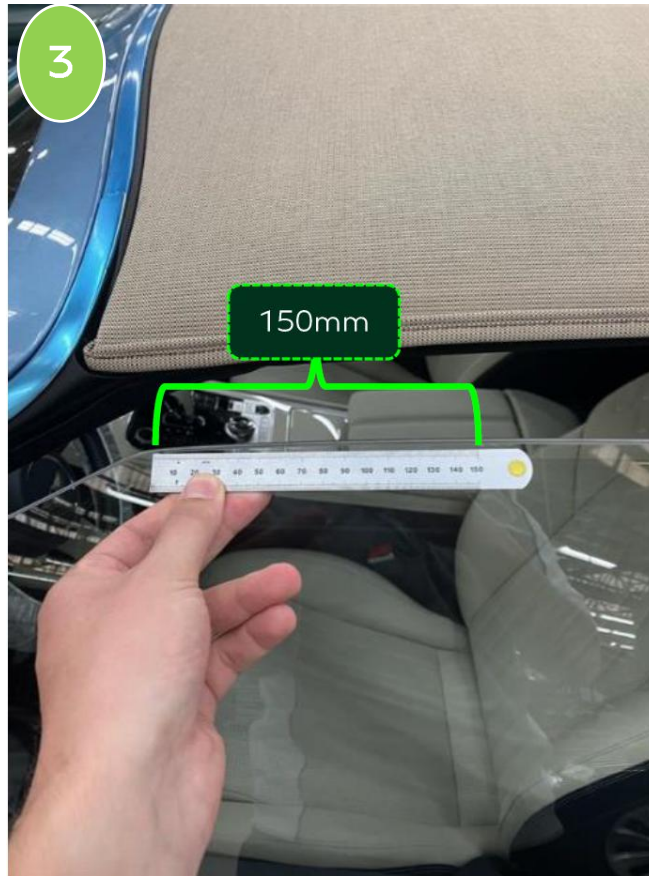
# INTERLOCK POINT 3

150mm from front corner of window glass as shown

If the measurement is out of specification refer to ElsaPro Repair Group 64 'Front door quarter glass – To adjust'

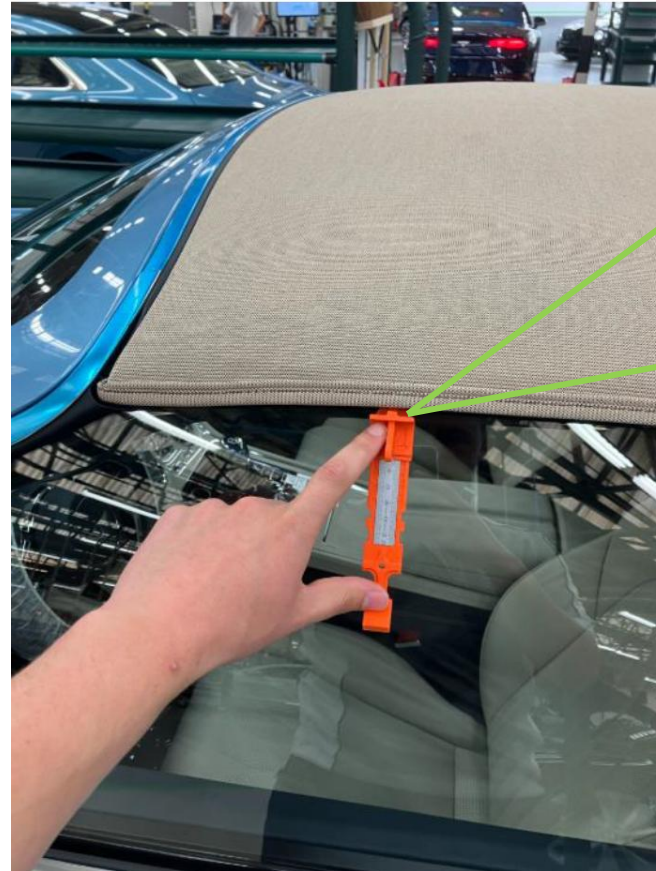
**Specification**  
7mm  $\pm$  1mm  
(Interlock Tool WT10554)

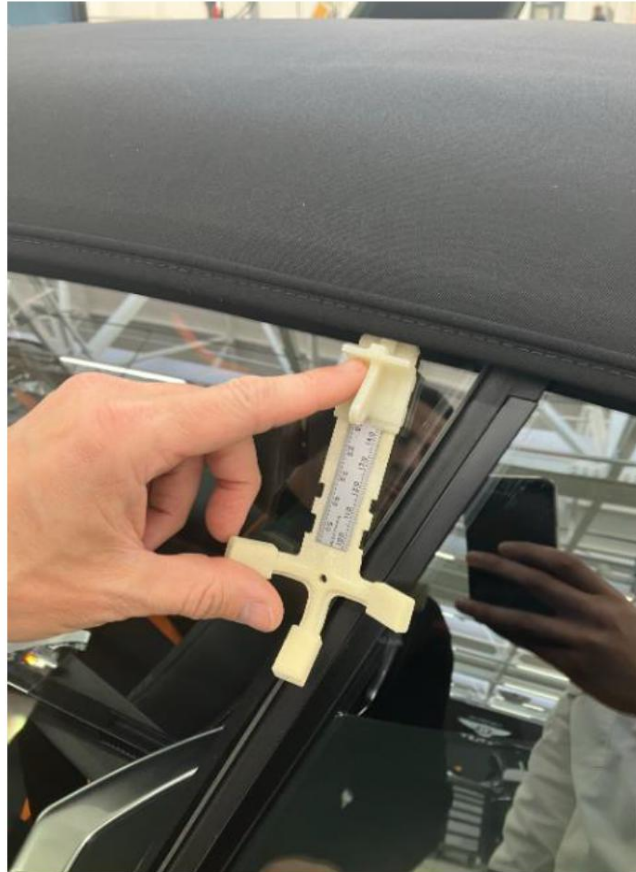
# INTERLOCK POINT 4

50mm from rear edge of the front door glass as shown

**Specification**  
8.5mm  $\pm$  1mm  
(Interlock Tool WT10554)

If the measurement is out of specification refer to ElsaPro Repair Group 64 'Front door quarter glass – To adjust'

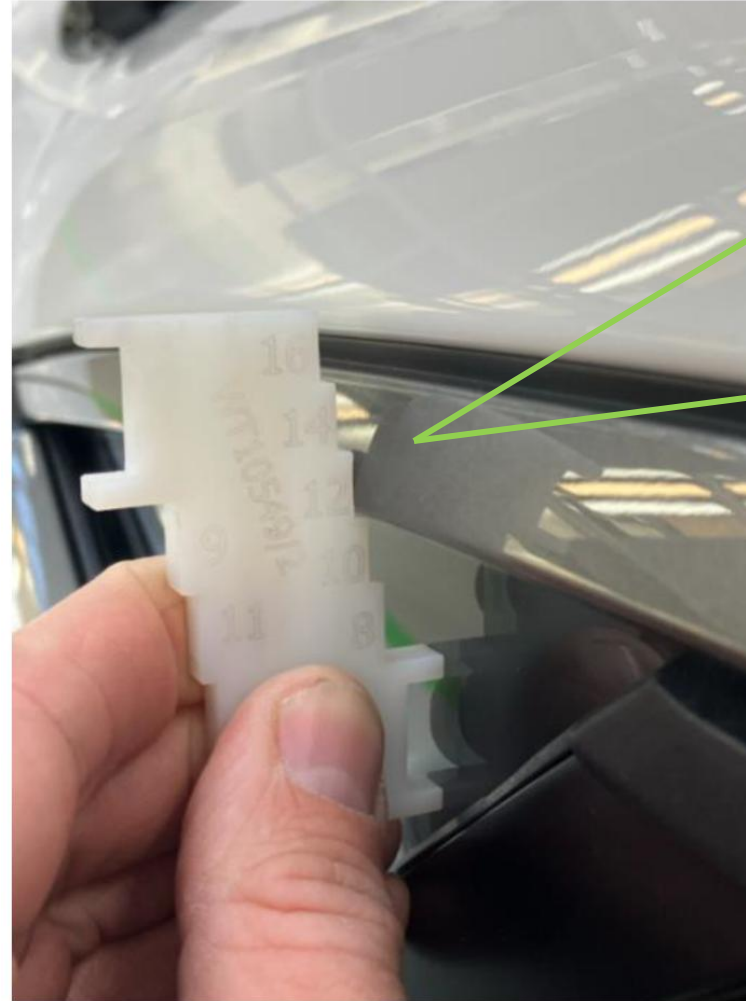
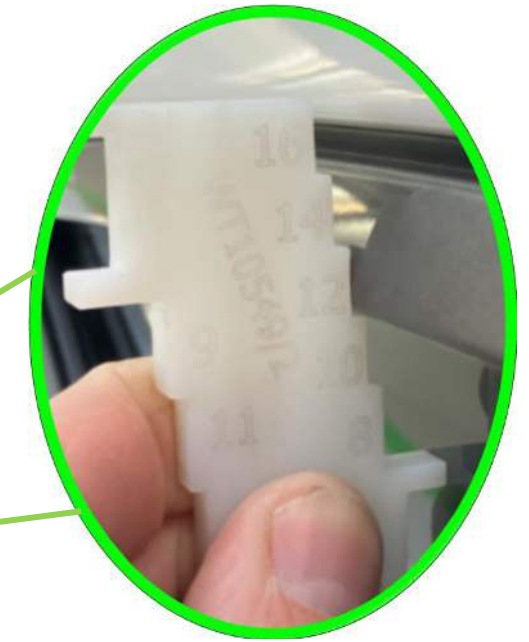
# PROFILE POINT 1

50mm in front of front div  
bar

Flat against glass to  
brightware

**Specification**  
10mm  $\pm$  1mm  
(Profile Tool WT10549/2)

If the measurement is out of  
specification refer to ElsaPro  
**Repair Group 64 'Slide glass  
checking and adjusting'**

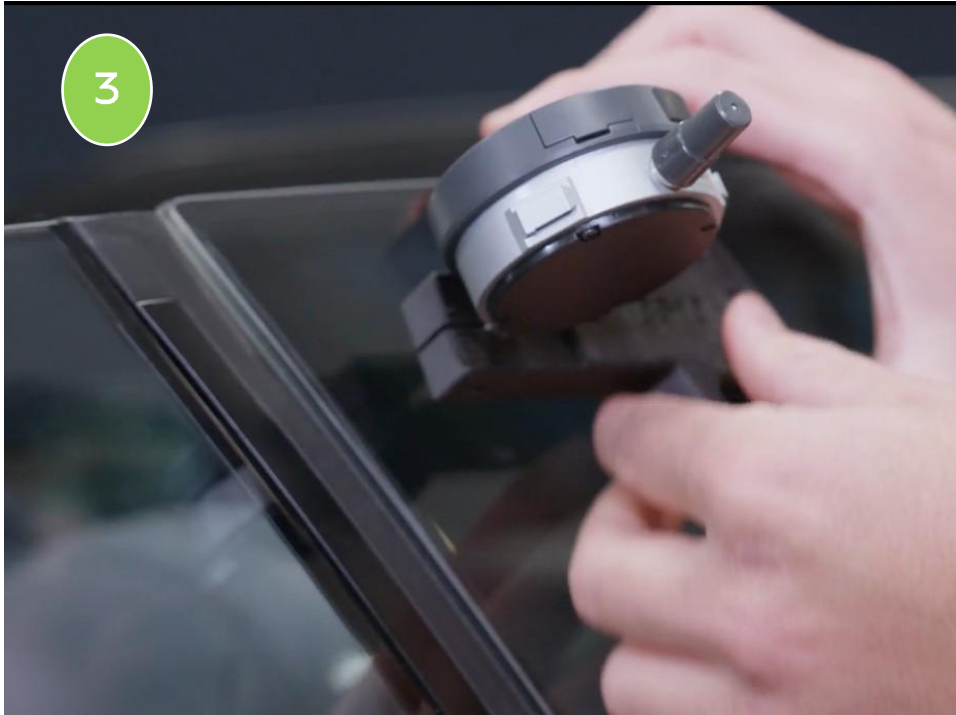
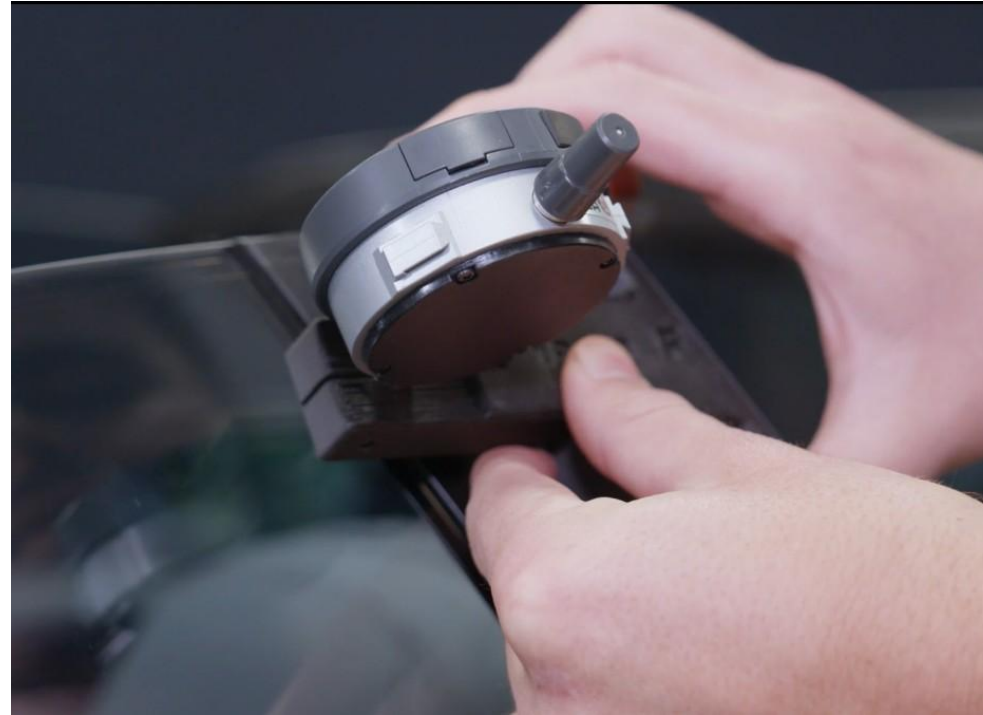
## PROFILE POINT 3 ROOF DOWN (DIGITAL DTI GAUGE - LATEST TOOL)

**Specification**  
0mm +0 / -3.5mm

**Repair Group**  
**64 'Slide glass**  
**checking and**  
**adjusting'**

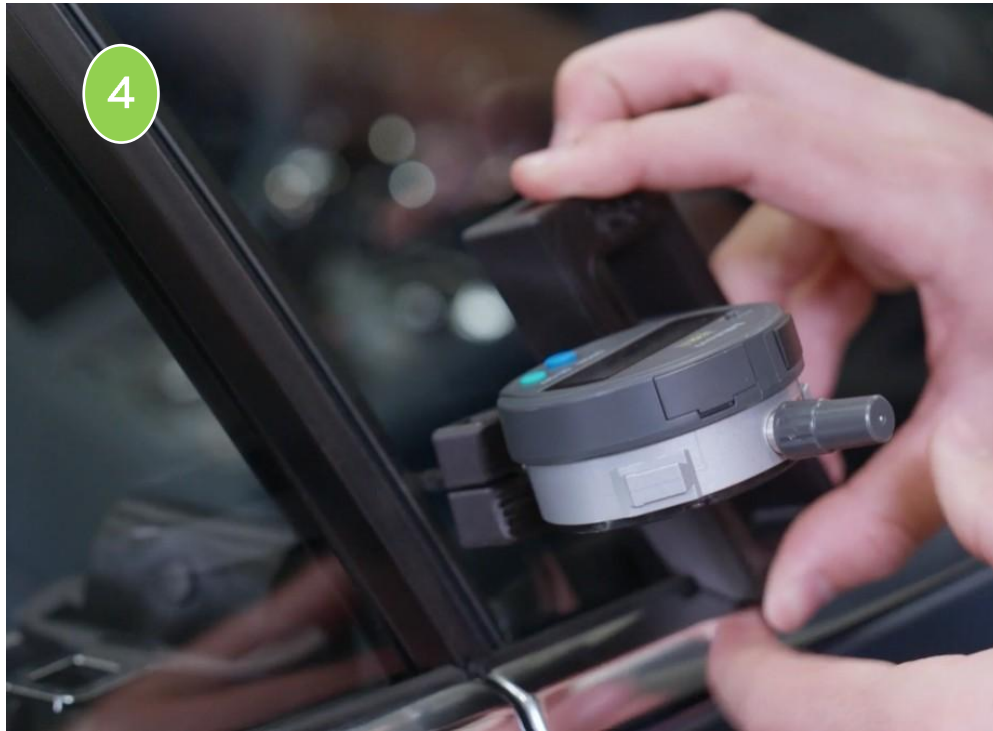
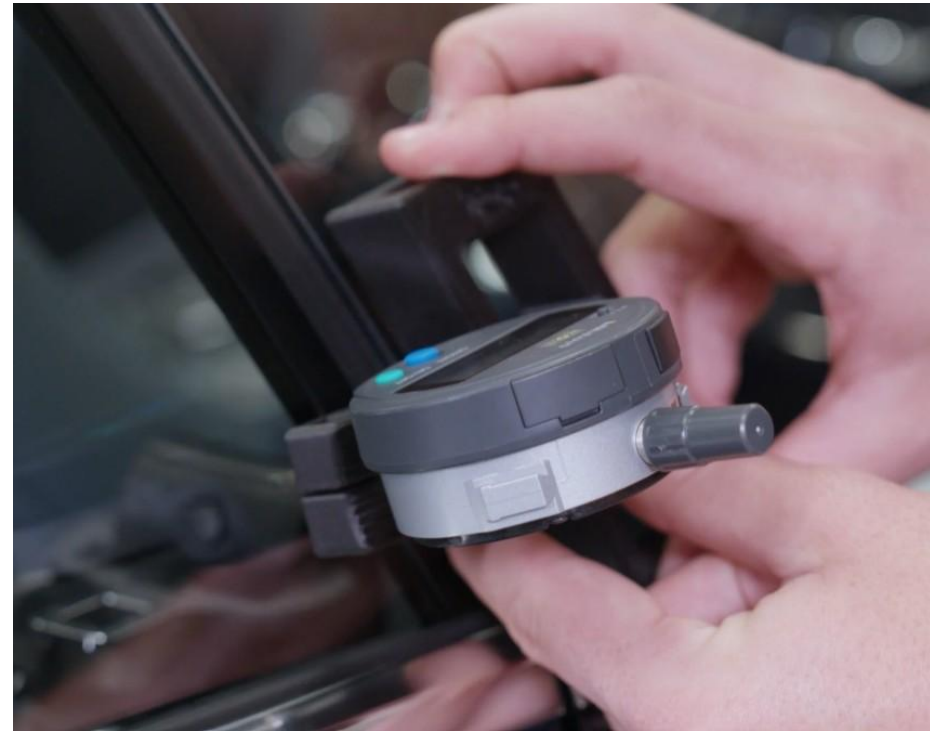
## PROFILE POINT 4 ROOF UP (DIGITAL DTI GAUGE - LATEST TOOL)

**Specification**  
0mm +0 / -3.5mm

**Repair Group 64**  
**'Slide glass**  
**checking and**  
**adjusting'**

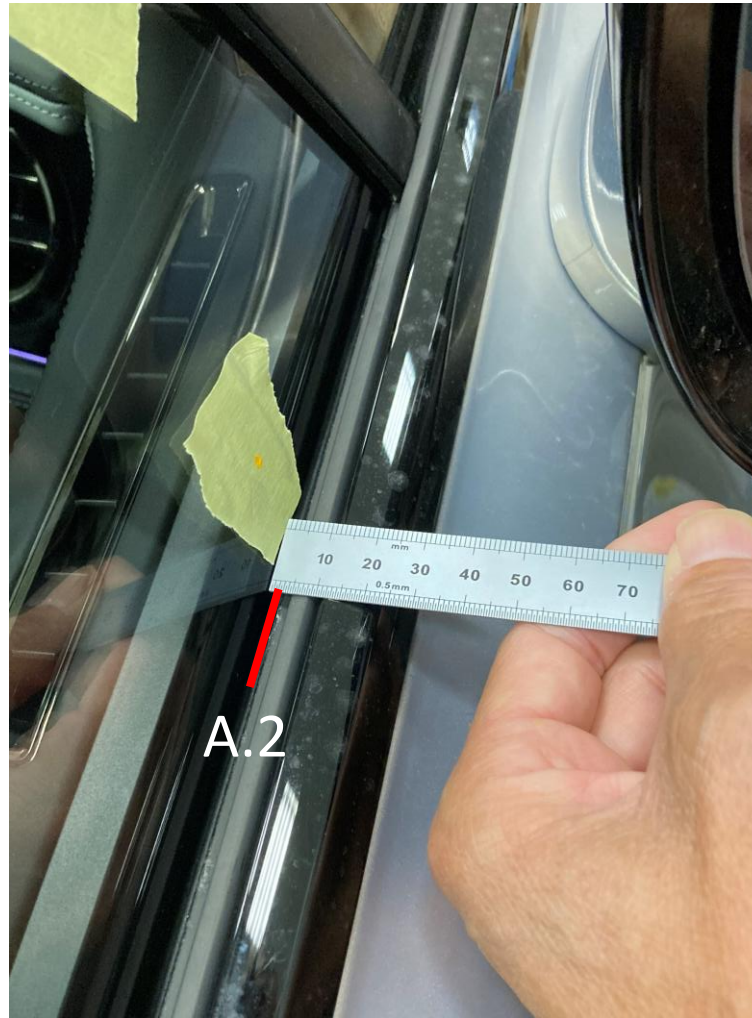
# WAIST SEAL MEASUREMENT POINT A

Mark on tape 100mm from div bar (A.1)

Measure from first lip rubber seal to window glass (A.2)

**Repair Group 64 'Slide glass checking and adjusting'**
