| <b>HYUNDAI</b><br><b>Technical Service Bulletin</b> | GROUP<br><b>FUEL SYSTEM</b> | NUMBER<br><b>26-FL-003H</b> |
| | DATE<br><b>JUNE 2026</b> | MODEL(S)<br><b>KONA (SX2)</b> |
| <b>SUBJECT:</b> FALSE “ENGINE LEFT IDLING” MYHYUNDAI NOTIFICATIONS - ECM SOFTWARE UPDATE - DTC P223700 | | |

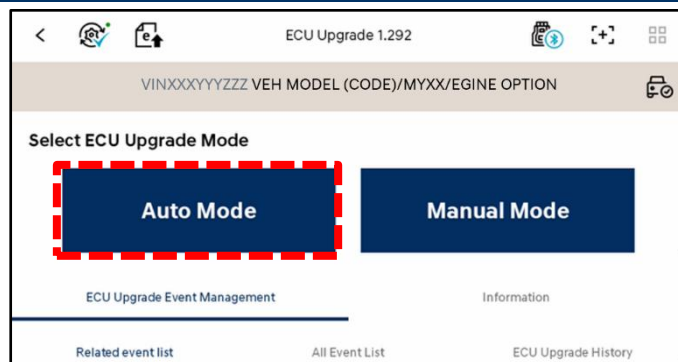
2. Verify the ROM ID by selecting the **Engine** system to scan the vehicle's current ROM ID.

Check the current ROM ID version and compare it to the ROM ID Information table before attempting to perform the software update.

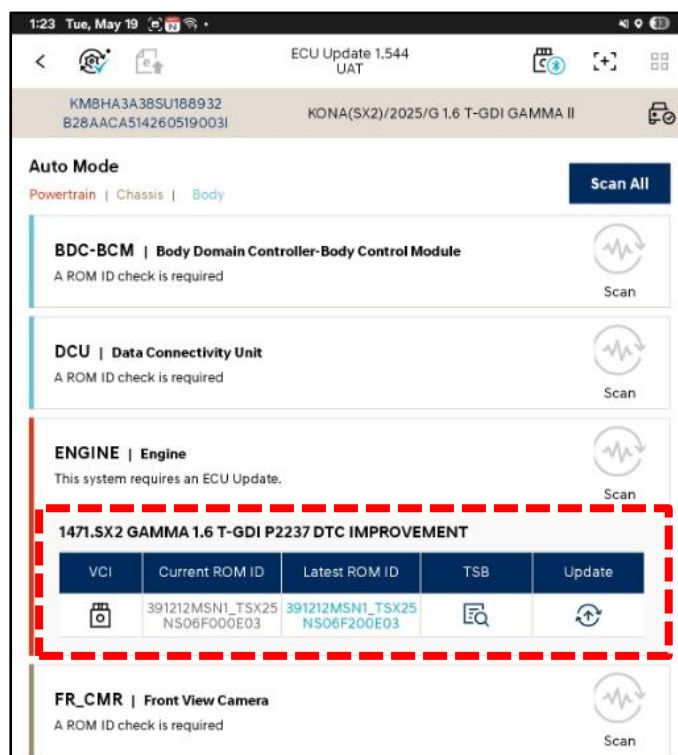
3. After the ECU update process shows 100% complete, follow the prompts on the screen to cycle the ignition **OFF** for at least **10 seconds** to reset the control unit (certain models may take up to **30 seconds**).

If the update fails, remove the power connector from the in-cabin fuse box for at least **5 seconds**. Alternatively, disconnect the negative (–) **12V** battery terminal and wait at least **5 seconds**. Reassemble and retry the update.

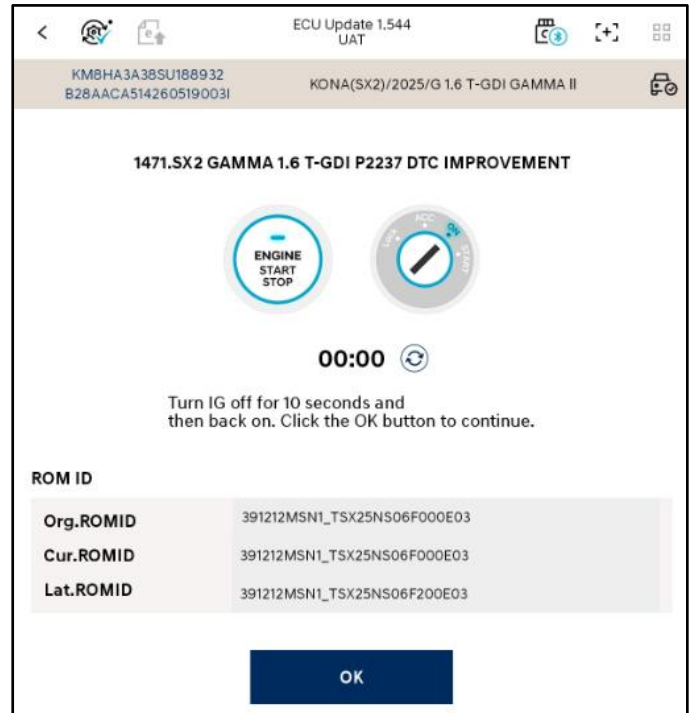
Use the **Refresh** button to reset the timer.

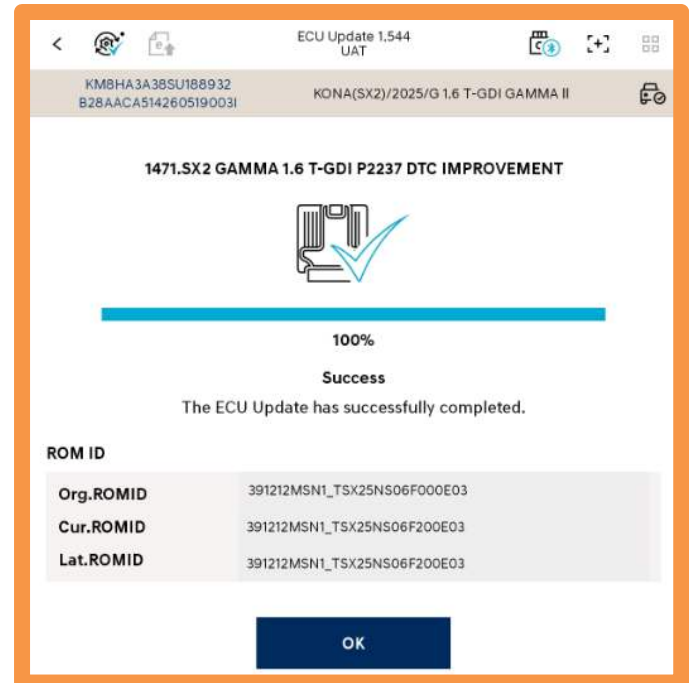
- 4.

Using the tablet or GDS screen capture function, take a screenshot of the ECU Update "Success" result screen.

Upload the photo to STUI.

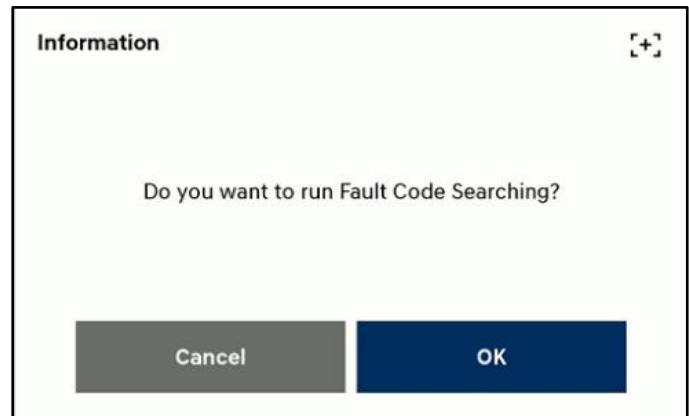
5. Perform an **All Systems Fault Code** search and erase DTC history that had incidentally occurred from the ECU update.

6. Start the engine to confirm proper operation of the vehicle.
7. The service procedure is now complete.
