## Technical product information

| <b>Topic</b> | Window Drop Glass Operation Continental GT/GTC 19-24MY |
| <b>Transaction No.</b> | 2080375/4 |

Window Drop Glass Operation | Continental GT/GTC |19-24MY

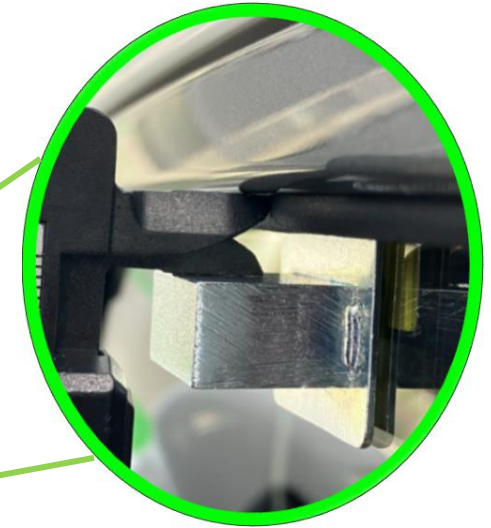
# INTERLOCK POINT 1

Place block 50mm in front of front div bar

Record measurement for all interlock points

From block to bright ware for all interlock points

**Specification**  
7.5mm  $\pm$  1mm  
(Interlock Tool WT10549/1)  
If the measurement is out of specification refer to ElsaPro  
**Repair Group 64 'Front door quarter glass – To adjust'**

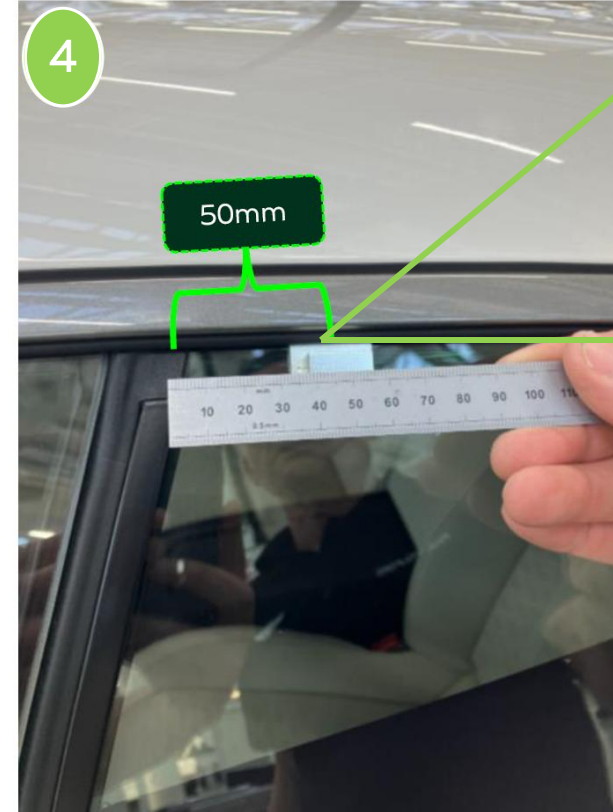
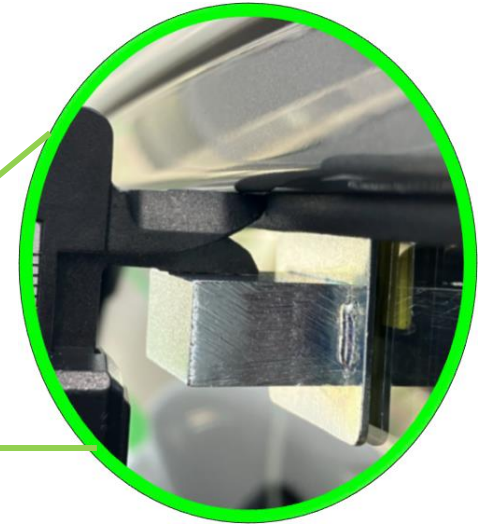
# INTERLOCK POINTS 2, 3, 4

Place block 150mm  
behind corner of  
front div bar

Place block 50mm  
in front of rear div  
bar

Place block 50mm  
to rear of rear div  
bar

**Specification**  
8mm ± 1mm  
(Interlock Tool WT10549)

If the measurement is  
out of specification  
refer to ElsaPro

**Repair Group 64 'Slide  
glass checking and  
adjusting'**

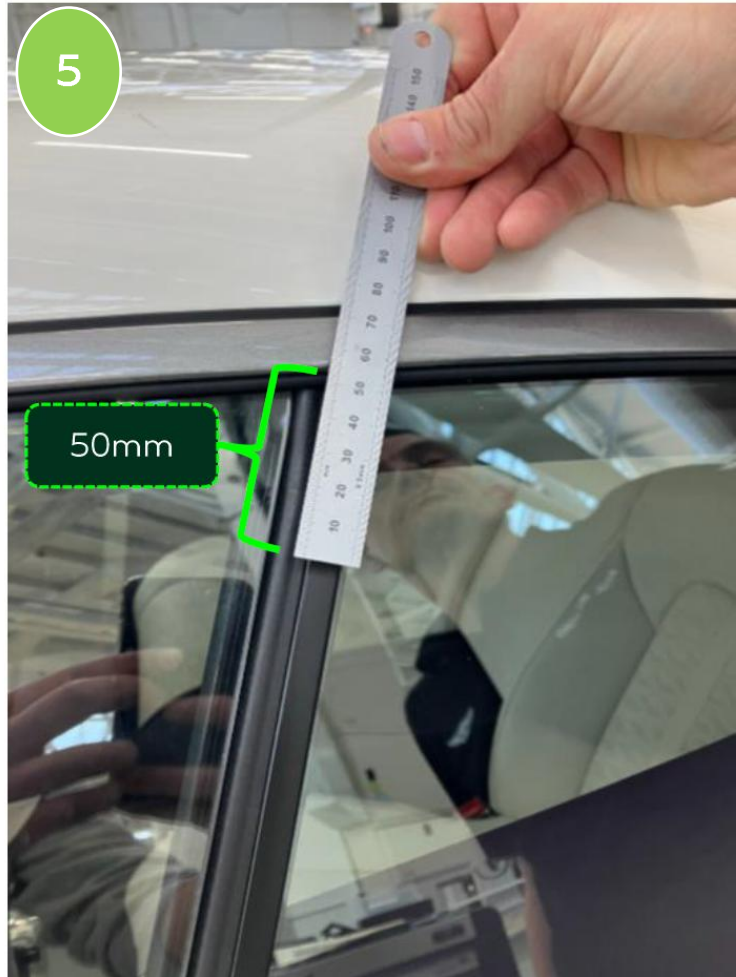
# INTERLOCK POINT 5

50mm from seal

Record measurement

**Specification**  
11mm  $\pm$  1mm  
(Ruler/vernier)

**Repair Group 64 'Slide  
glass checking and  
adjusting'**

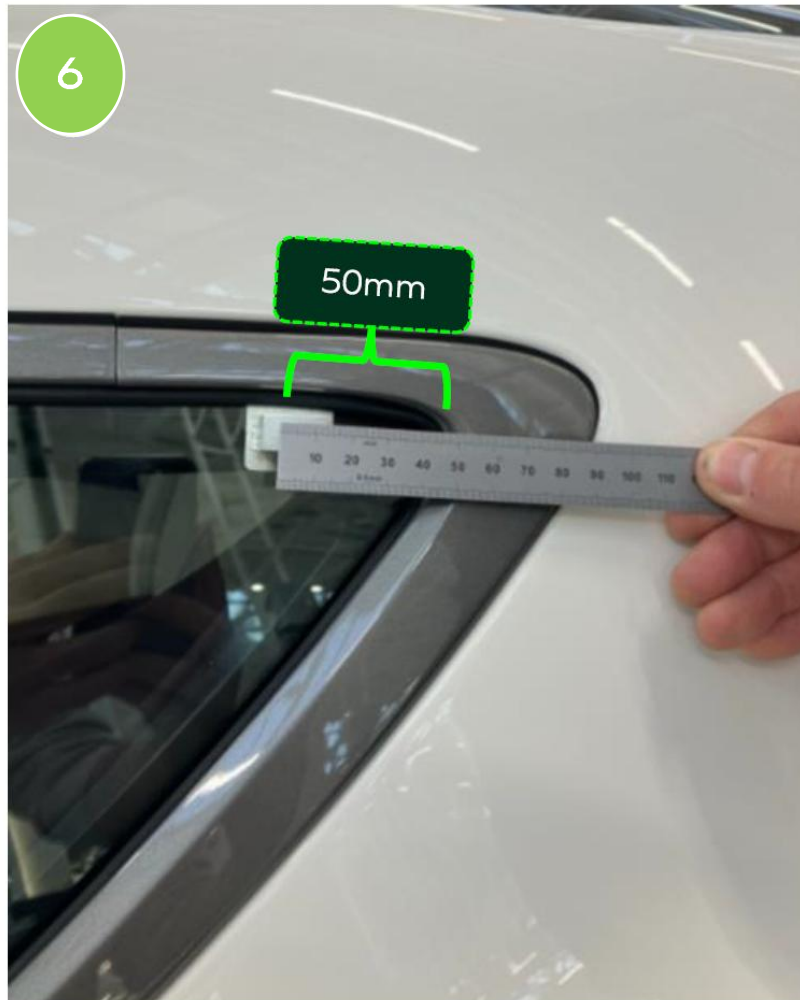
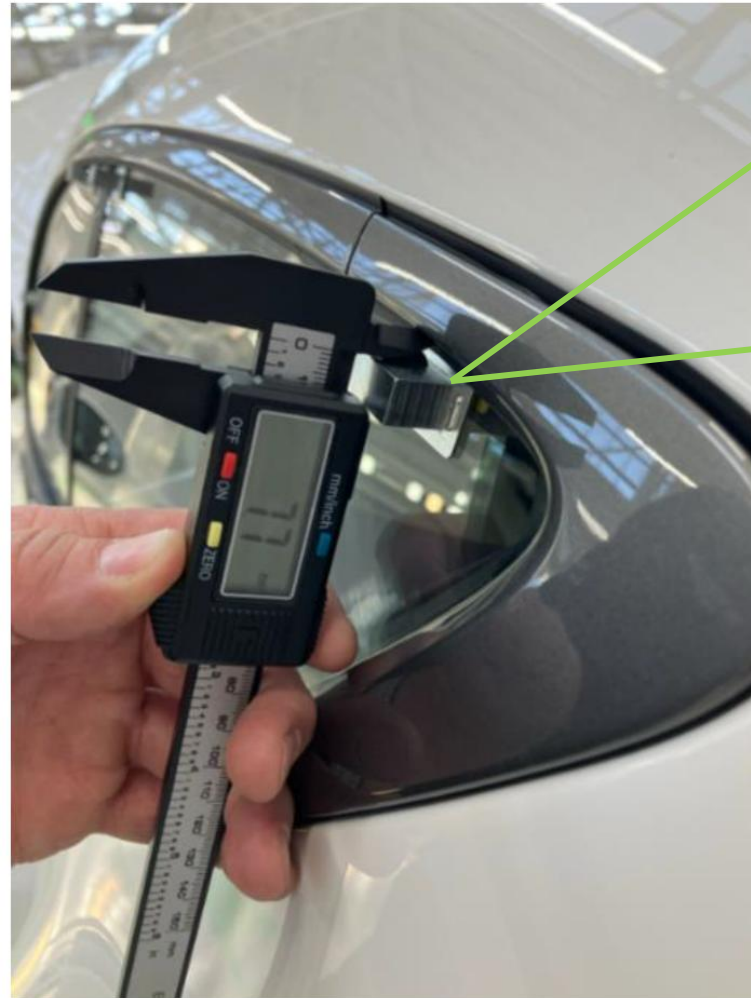
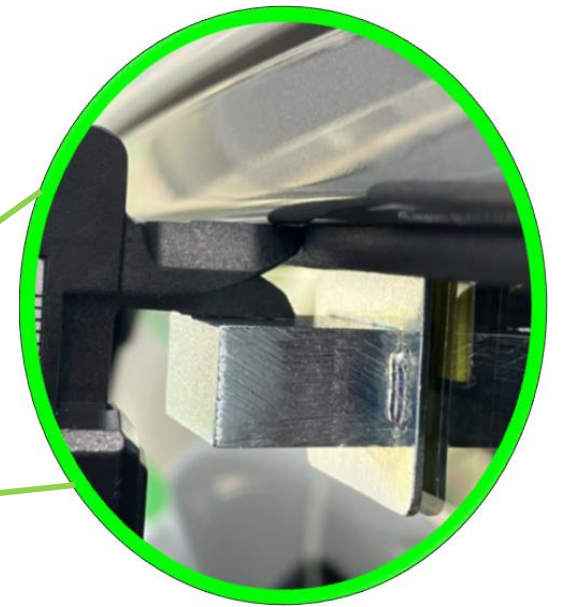
# INTERLOCK POINT 6

Place block 50mm from corner point of bright ware

Record measurement for all interlock points

**Specification**  
8mm  $\pm$  1mm  
(Interlock Tool WT10549/1)

If the measurement is out of specification refer to ElsaPro

**Repair Group 64 'Slide glass checking and adjusting'**

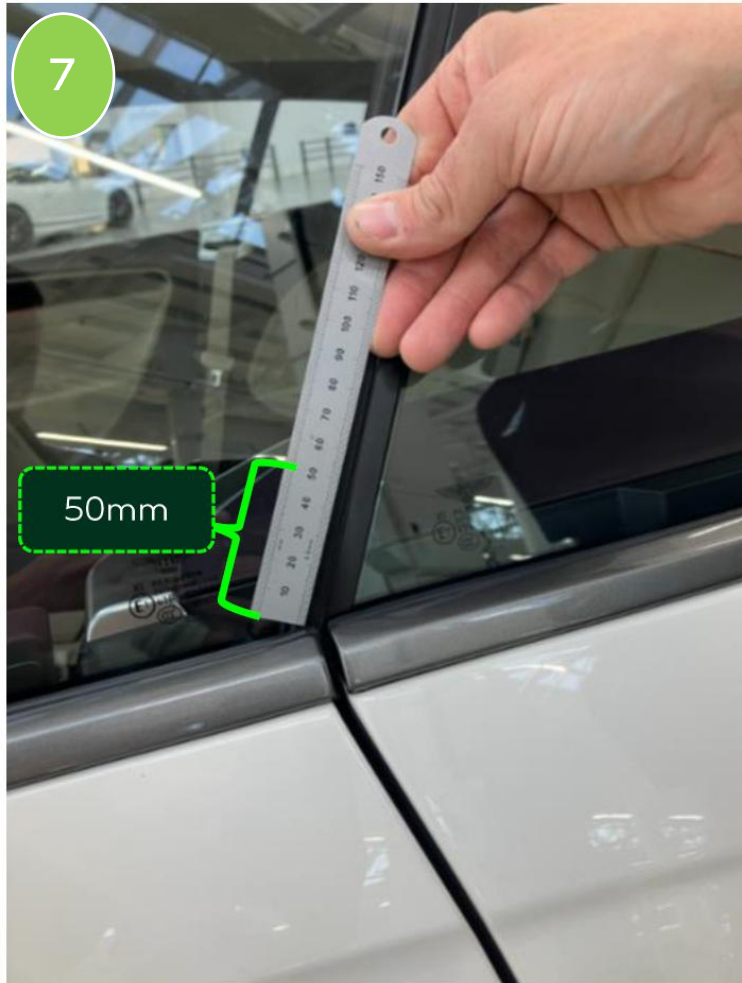
# INTERLOCK POINT 7

50mm from seal

Record measurement

**Repair Group 64 'Slide  
glass checking and  
adjusting'**

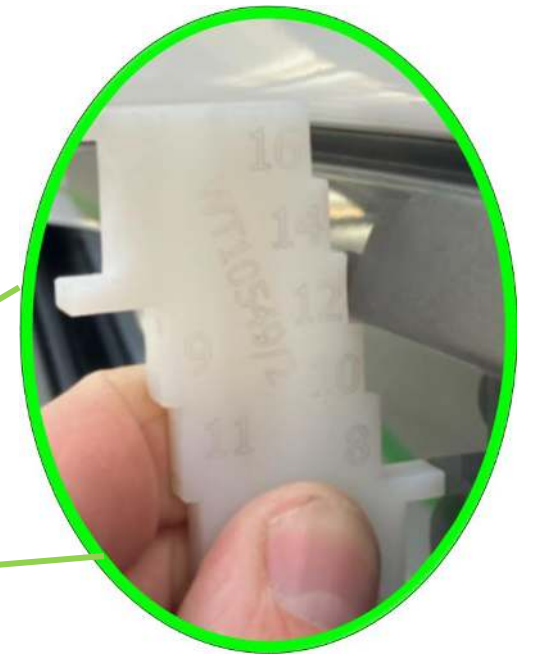
# PROFILE POINT 1

50mm in front of front div  
bar

Flat against glass to  
brightware

**Specification**  
10mm  $\pm$  1mm  
(Profile Tool WT10549/2)

If the measurement is  
out of specification refer  
to ElsaPro

**Repair Group 64 'Slide  
glass checking and  
adjusting'**

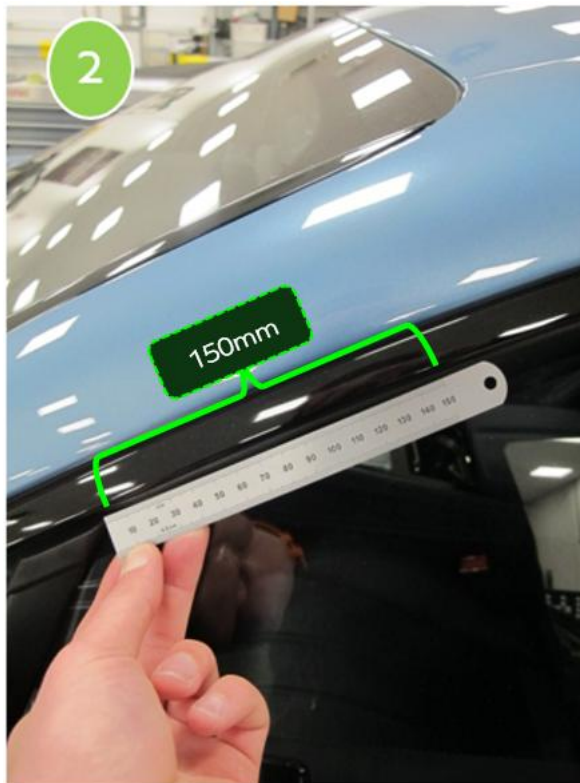
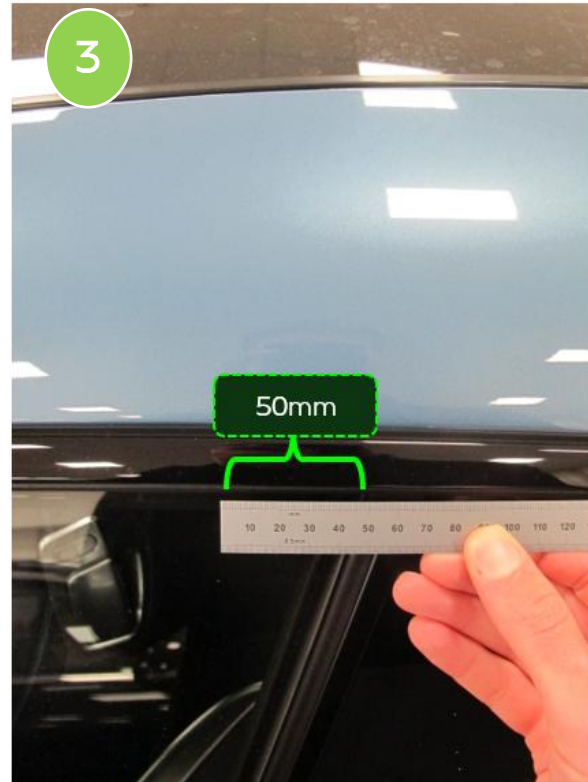
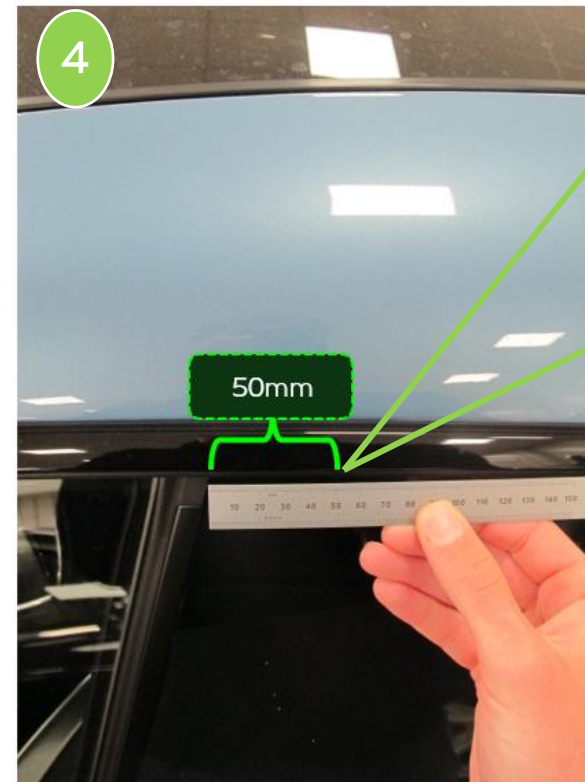
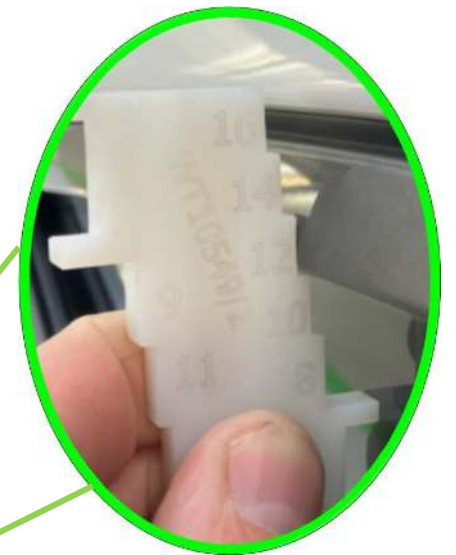
# PROFILE POINT 2, 3, 4

150mm behind front  
div bar

50mm in front of  
rear div bar

50mm behind  
rear div bar

Flat against glass to  
brightware

**Repair Group 64 'Slide  
glass checking and  
adjusting'**

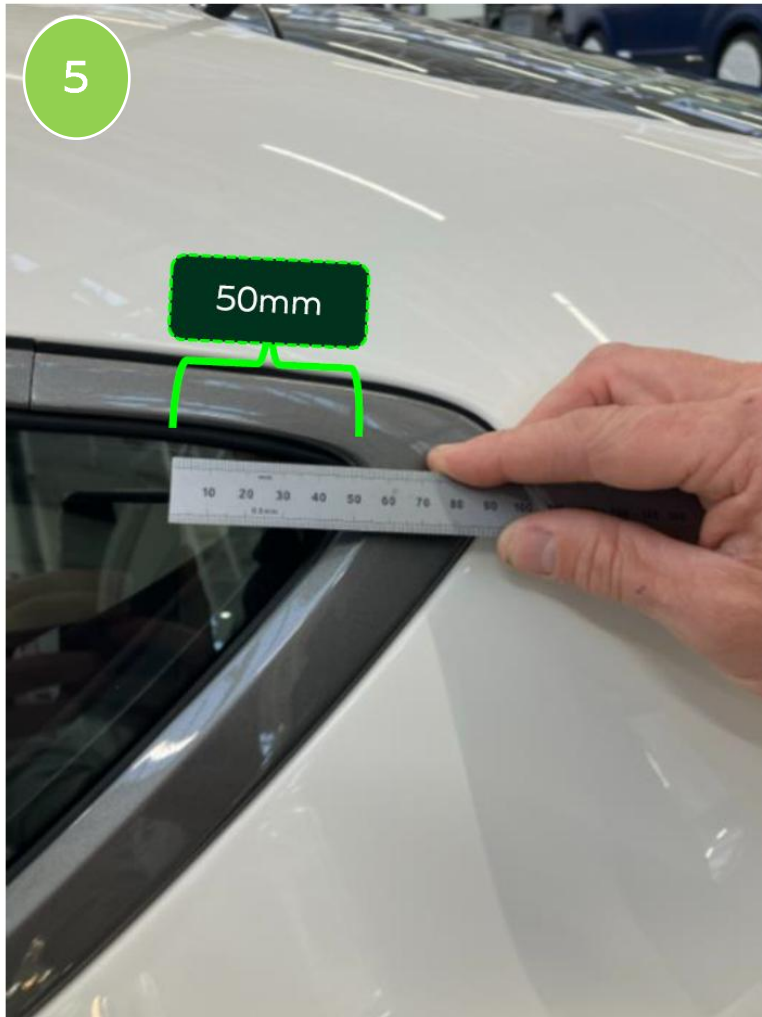
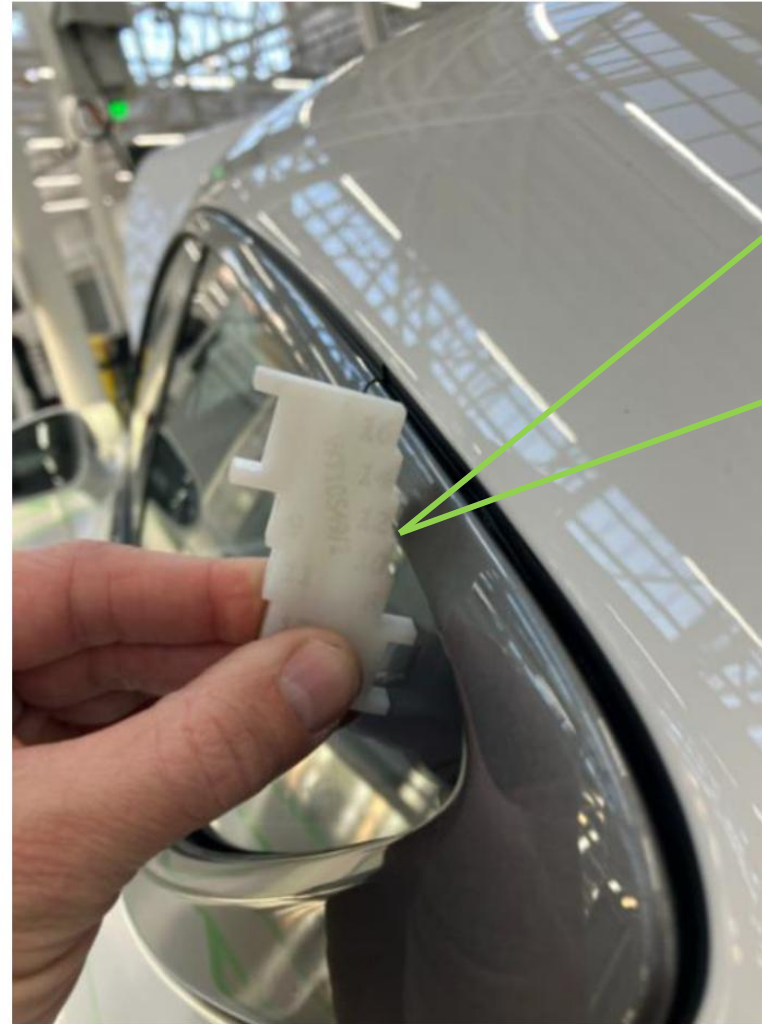
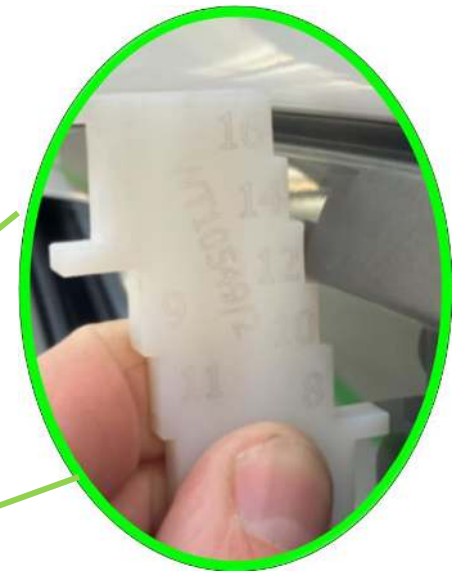
# PROFILE POINT 5

50mm from corner  
point of bright ware

Flat against glass to  
brightware

**Specification**  
10mm  $\pm$  2mm  
(Profile Tool WT10549/2)

**Repair Group 64 'Slide glass  
checking and adjusting'**

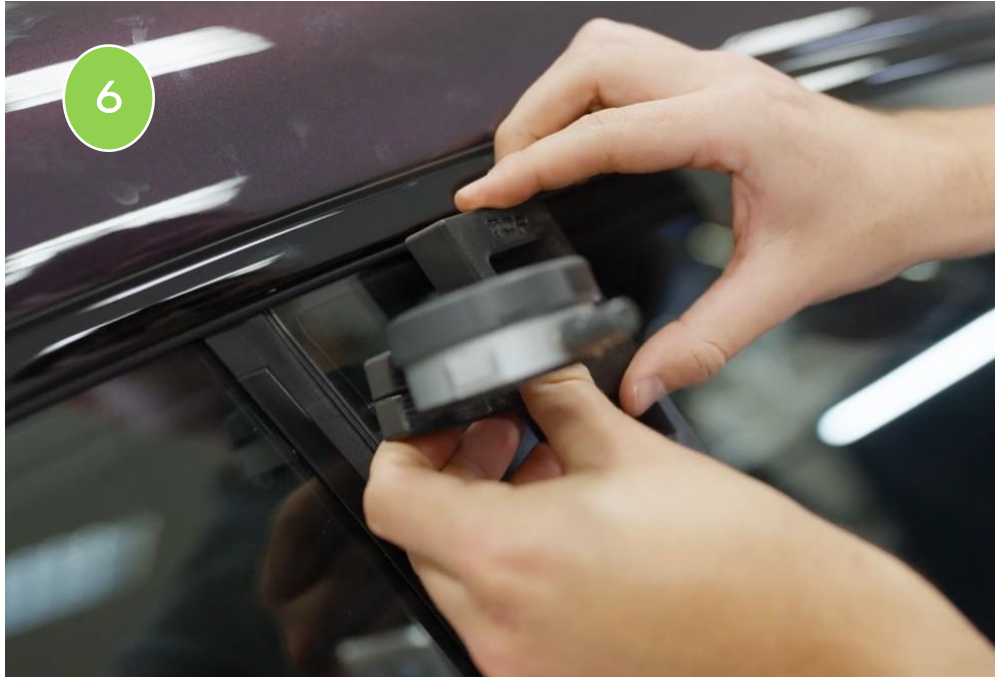
# PROFILE POINT 6 (DIGITAL DTI GAUGE - LATEST TOOL)

Align and position the tool on the front window so that its contact face rests flat against the upper bright ware trim, zero the tool.

Then slide it along the surface until it makes full, even contact with the rear glass.  
Record the measurement.

**Specification**  
0mm +0 / -3mm

**Repair Group 64**  
**'Slide glass checking and adjusting'**

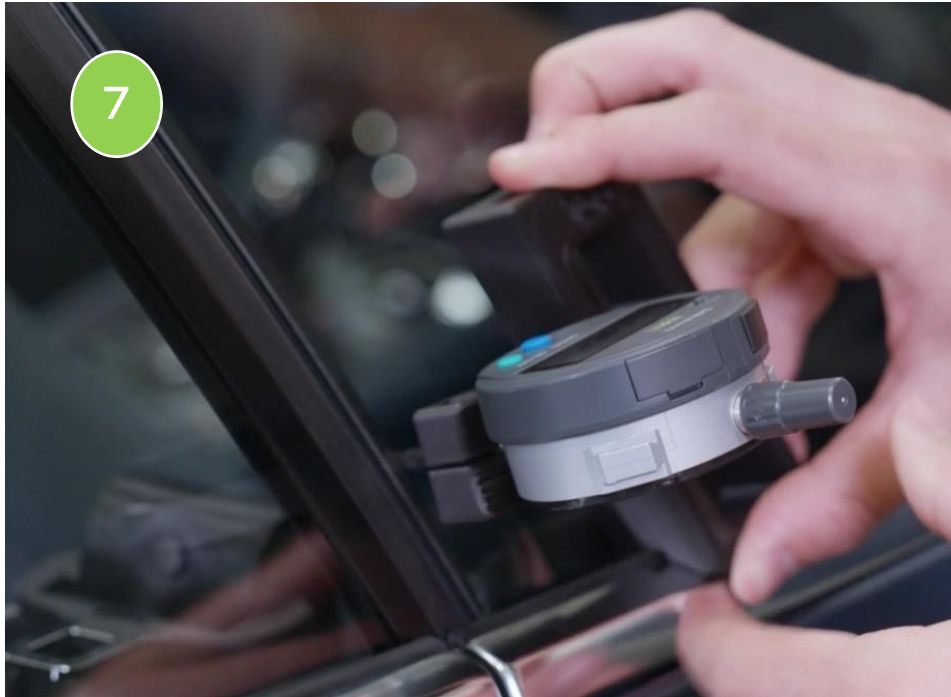
# PROFILE POINT 7 (DIGITAL DTI GAUGE - LATEST TOOL)

Align and position the tool on the front window so that its contact face rests flat against the lower bright ware trim, zero the tool.

Then slide it along the surface until it makes full, even contact with the rear glass.  
Record the measurement.

**Specification**  
0mm +0 / -3mm

**Repair Group 64**  
**'Slide glass checking and adjusting'**

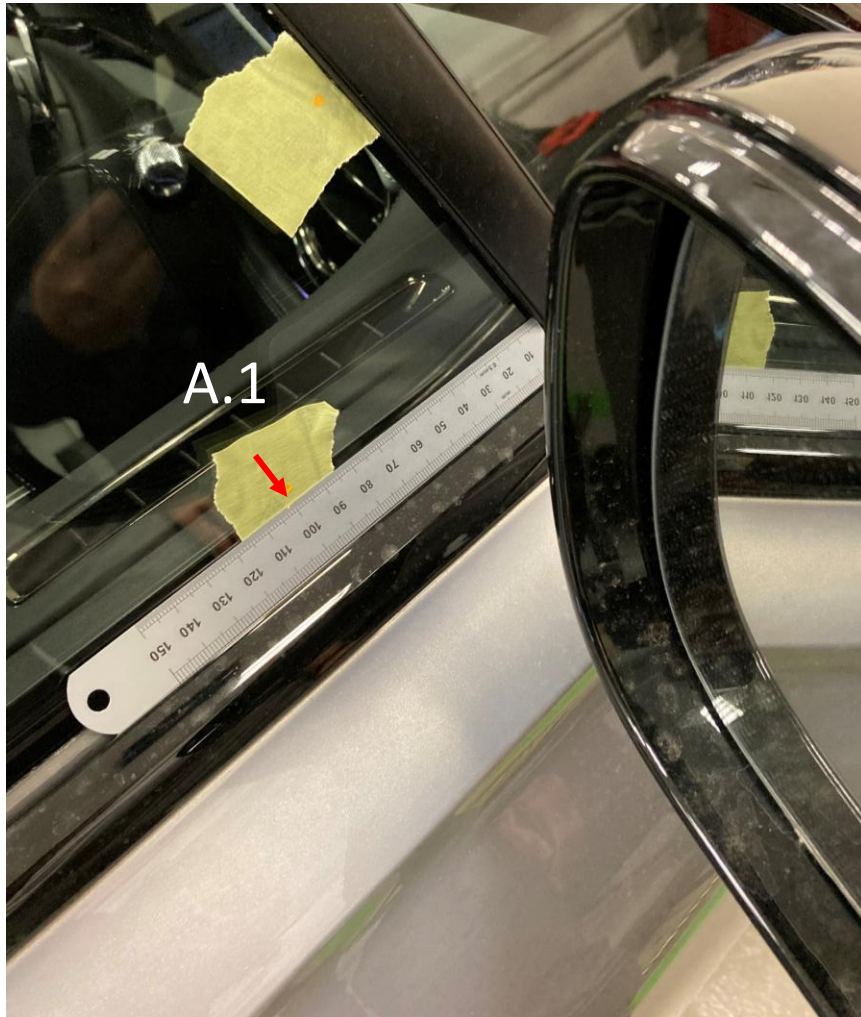
# WAIST SEAL MEASUREMENT POINT A

Mark on tape 100mm  
from div bar (A.1)

Measure from first lip rubber  
seal to window glass (A.2)

**Repair Group 64 'Slide  
glass checking and  
adjusting'**

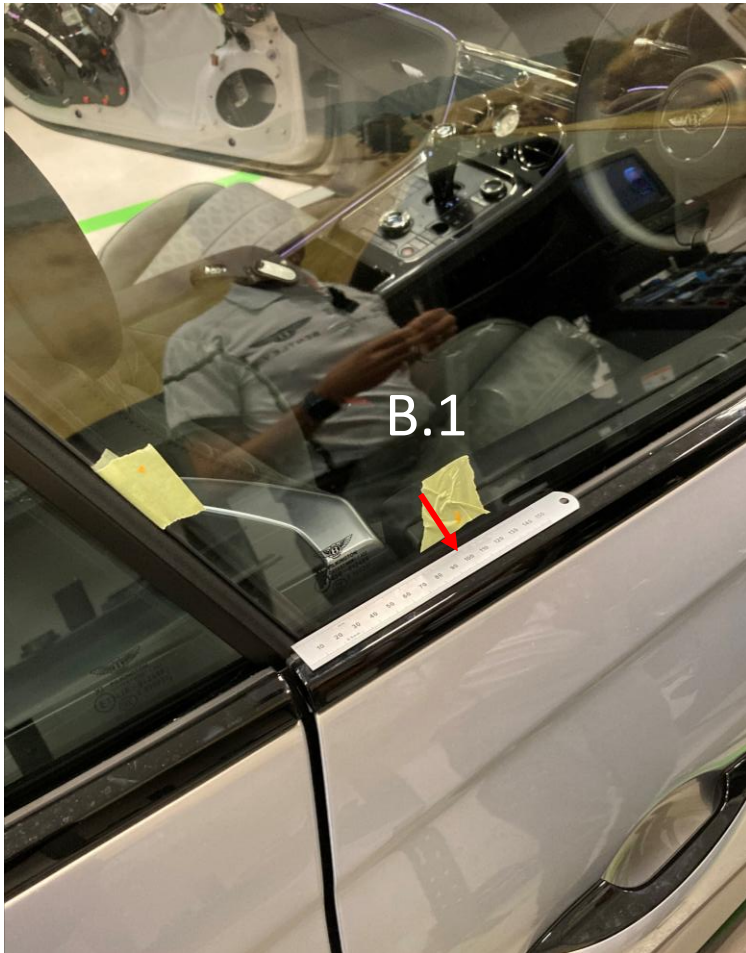
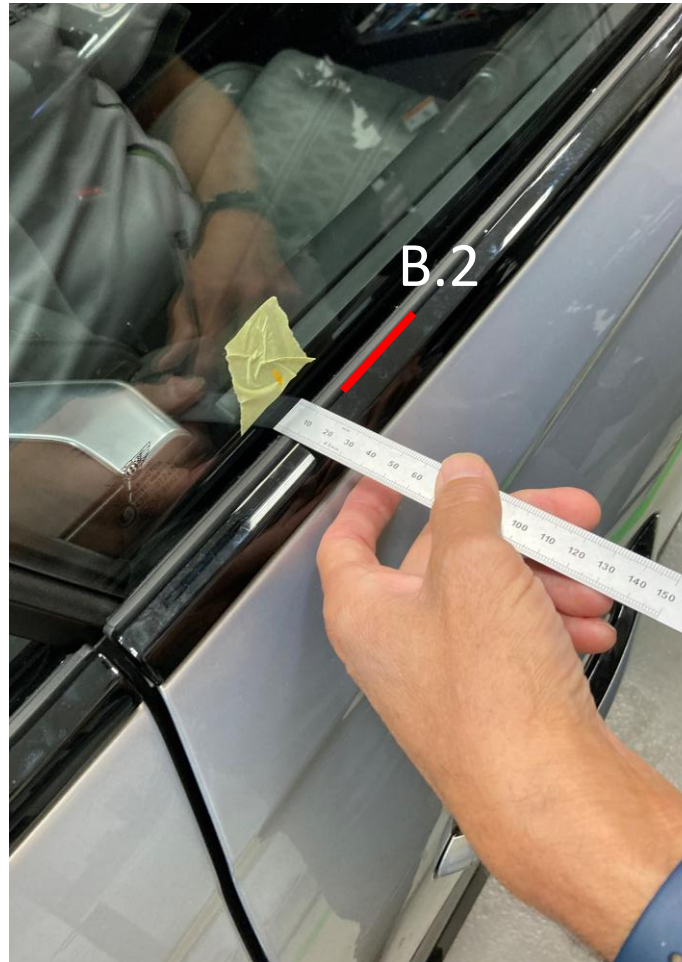
# WAIST SEAL MEASUREMENT POINT B

Mark on tape 100mm from  
div bar (B.1)

Measure from first lip rubber  
seal to window glass (B.2)

**Repair Group 64 'Slide glass  
checking and adjusting'**

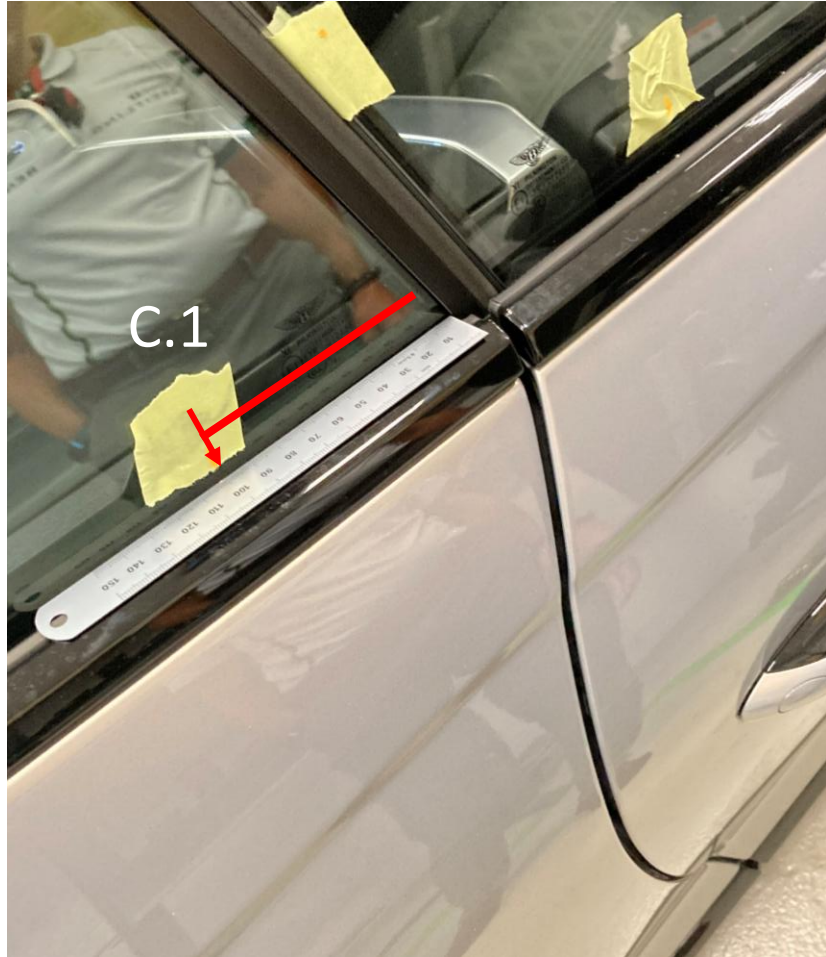
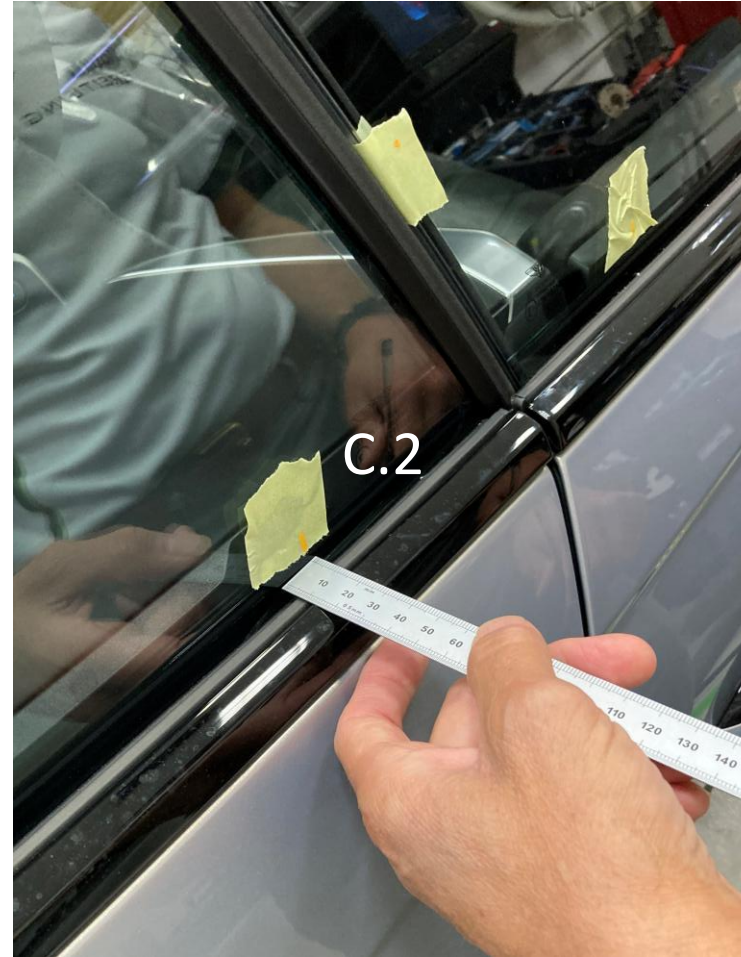
# WAIST SEAL MEASUREMENT POINT C

Mark on tape 100mm  
from div bar (C.1)

Measure seal to  
window gap (C.2)

**Repair Group 64 'Slide glass  
checking and adjusting'**

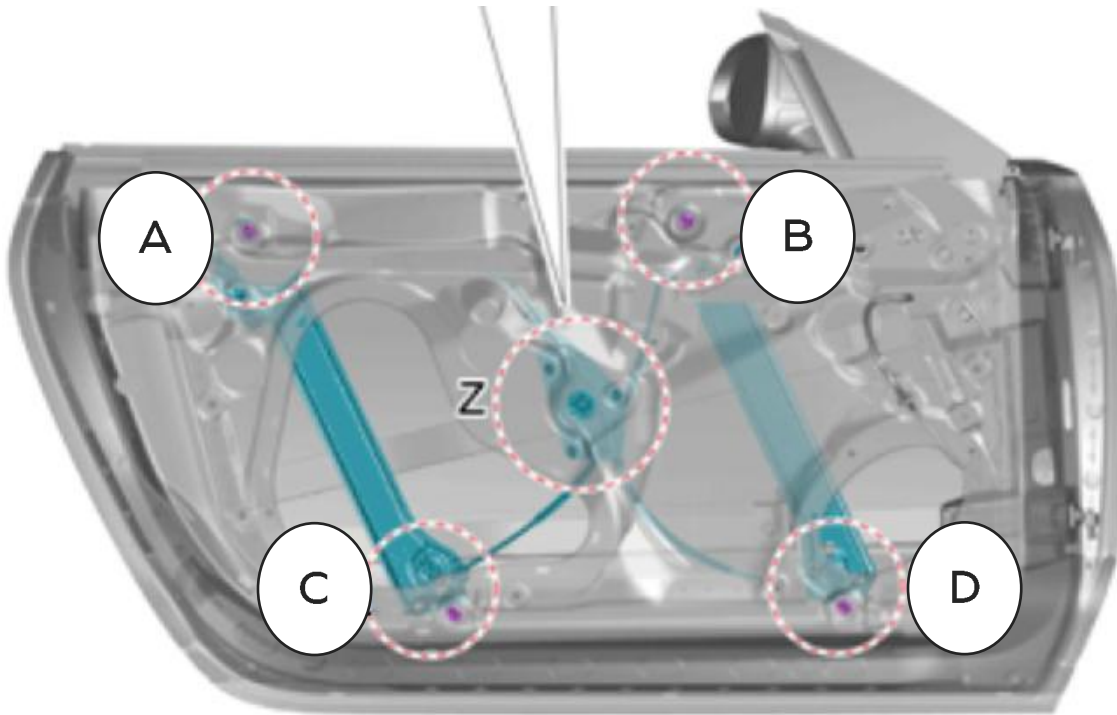
*Figure 2*

### **Regulator adjusters A, B**

1. loosen the lock nut.
2. Screw the adjuster fully clockwise until it bottoms out on the frame.
3. Unscrew the adjuster counterclockwise by four complete turns.
4. Resecure the lock nut.

Finally, set the height and profile to the TPI specification before proceeding to the next step.

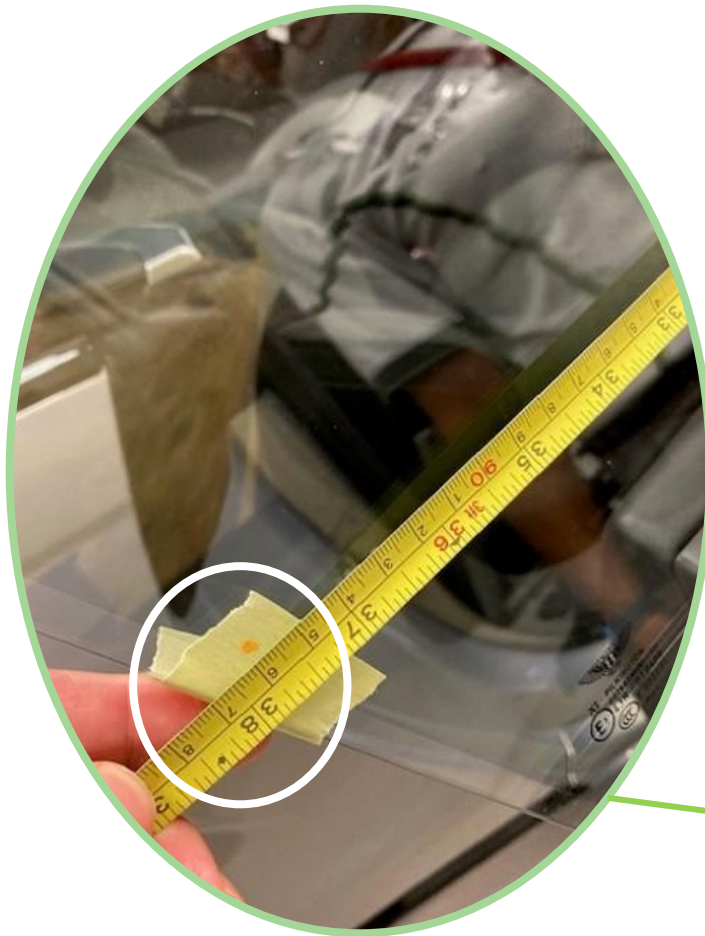
## Measuring from front div bar to rear of the glass

**NOTE:** Ensure the window is fully raised with the door closed, or fully closed in the latched position, before performing this measurement.

**Specification**  
971mm +2mm

If out of specification, refer to the next slide to adjust the glass position

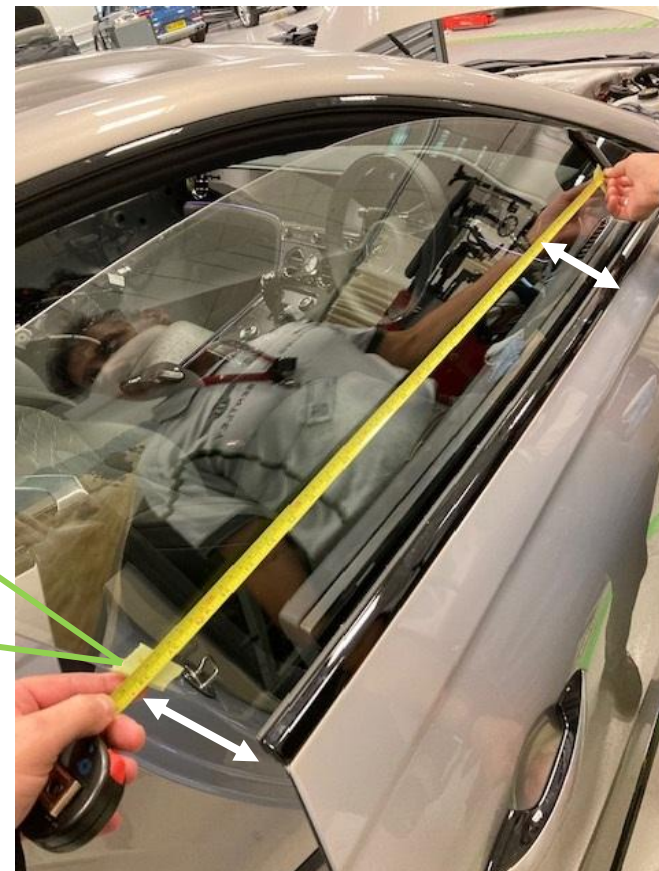
Measure 100mm up from  
the waist rail
