| | GROUP<br><b>Product Improvement</b> | MODEL<br><b>See Model List on Page 1</b> |
| | NUMBER<br><b>PI1802W/X (Rev 6, 11/07/2019)</b> | DATE<br><b>October 2018</b> |
| <b>SUBJECT:</b> ENGINE REPLACEMENT INSTRUCTIONS<br>FOR DTC P1326 (PI1802W/X) | | |

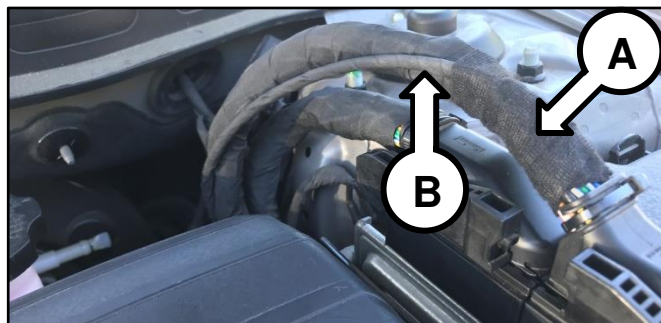
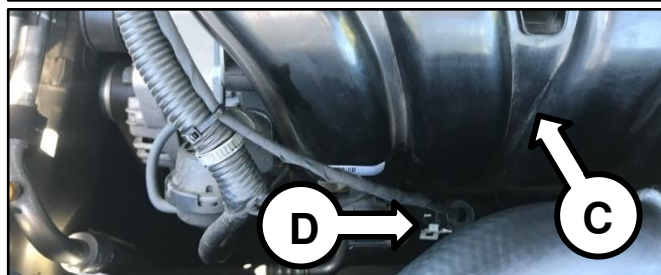
**NOTE:** To identify the extension harness (B), look for an external harness (B) which should be cable-tied to the existing wiring harness (A) leading by the intake manifold (C) to the knock sensor (D), as shown.

- If the extension harness (B) has been installed, open a Techline case online.
- If the extension harness (B) has not been installed, proceed to the next step.

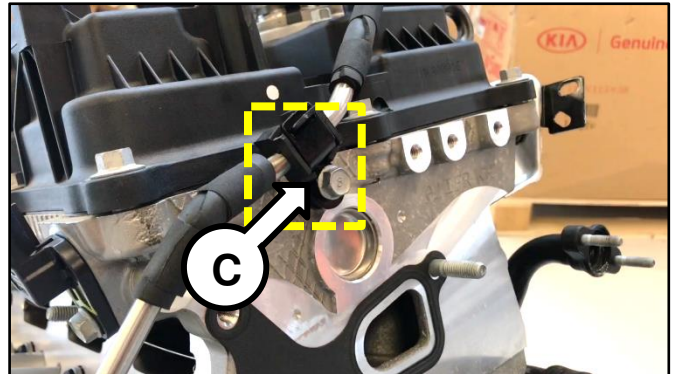
If the bracket and bolt are missing, order and install a new bracket and bolt.

2. Install the pipe retaining bracket and bolt (C) and torque to specifications.

**Tightening torque (bracket bolt):**  
5.8 – 8.7 lb.ft (7.8 – 11.8 N.m,  
0.8 – 1.2 kgf.m)
