| <b>HYUNDAI</b><br><b>Technical Service Bulletin</b> | GROUP<br><b>Campaign</b> | NUMBER<br><b>19-01-036H</b> |
| | DATE<br><b>November, 2019</b> | MODEL(S)<br><b>Ioniq (AE)<br/>HEV/PHEV/EV,<br/>Kona (OS) EV</b> |
| <b>SUBJECT</b> ELECTRIC WATER PUMP (EWP) CAN CASE REPLACEMENT<br>- (CAMPAIGN T4G) | | |

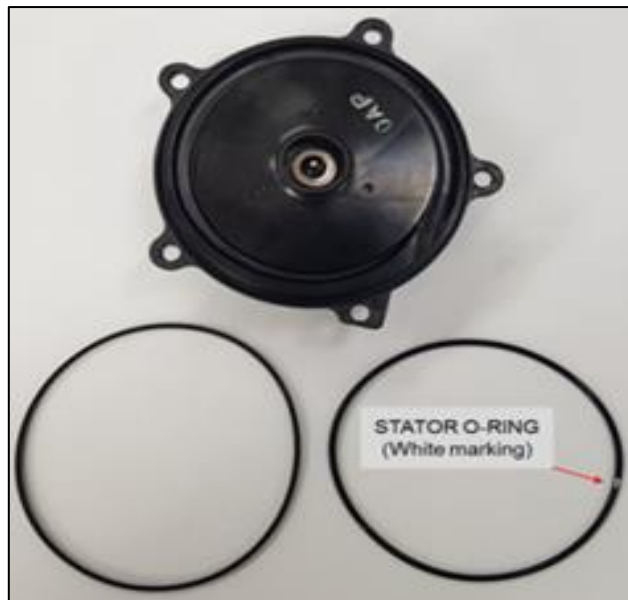
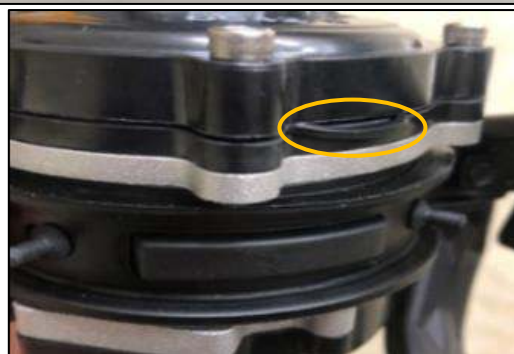
Prevent any interference between the O-ring and the pump cover as shown.

2. Reinstall EWP disassembled parts in reverse order of removal.
3. Reinstall the EWP back on the vehicle.
4. Go to section **(G)** (page-11) – Fill and Bleed the Hybrid/Plug-In/EV system coolant.
