| <b>HYUNDAI</b><br><b>Technical Service Bulletin</b> | <b>GROUP</b><br><b>AUTOMATIC TRANSMISSION</b> | <b>NUMBER</b><br><b>19-AT-024H</b> |
| <b>SUBJECT:</b> AUTOMATIC TRANSAXLE DIAGNOSIS (6-SPEED)<br>INHIBITOR/RANGE SWITCH DTC P0705, P0706, P0707 & P0708 | | |

***This TSB supersedes TSB 17-AT-005 to update the Service Procedure and applicable vehicles.***

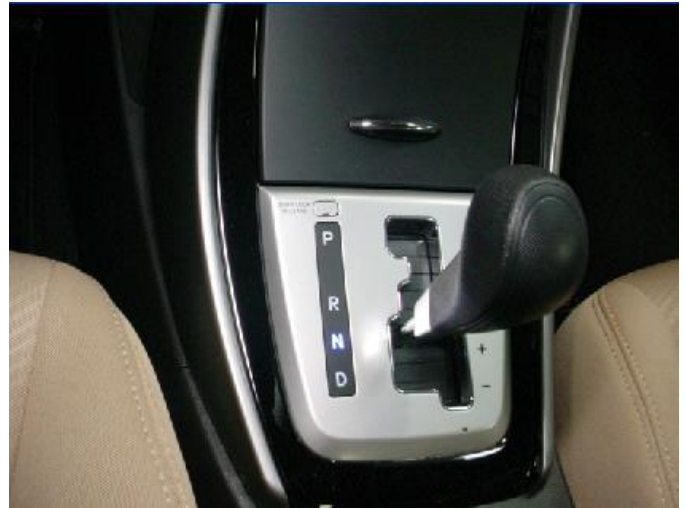
9. Apply the parking brake. Move the shift lever to the “N” position.

Turn the ignition switch to the **OFF** position.

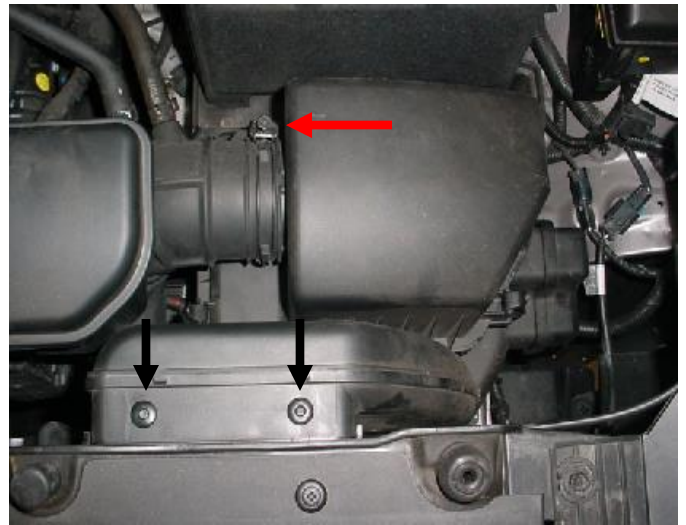
10. Remove the air duct and air cleaner to access the inhibitor switch.

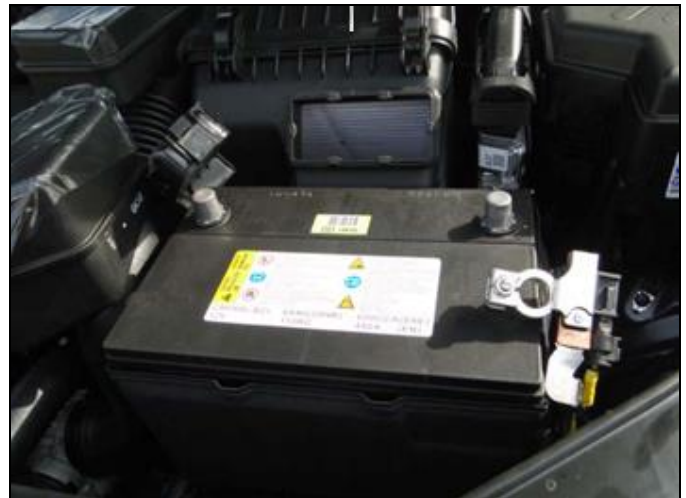
11. Remove the battery.

Record the preset radio stations and reset after repairs are completed.

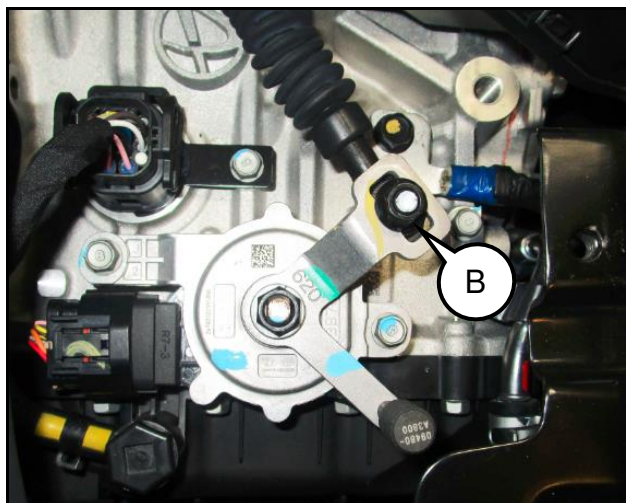
16. Confirm the shift lever is in the **N** position.

Install the shift cable nut and tighten the nut (B) to specification.

**Torque: 6~9 lb-ft (0.8~1.2 kgf.m, 8~12 N.m)**

Remove the SST or 5mm bolt from the alignment hole.
