# Service Alert

## DTC U2050:55 STORED AFTER BCM SOFTWARE UPDATE

**Service Alert No.: SA-055/19****Last Issued: 12/10/2019****APPLICABLE MODEL(S)/VINS**

2019 Mazda3

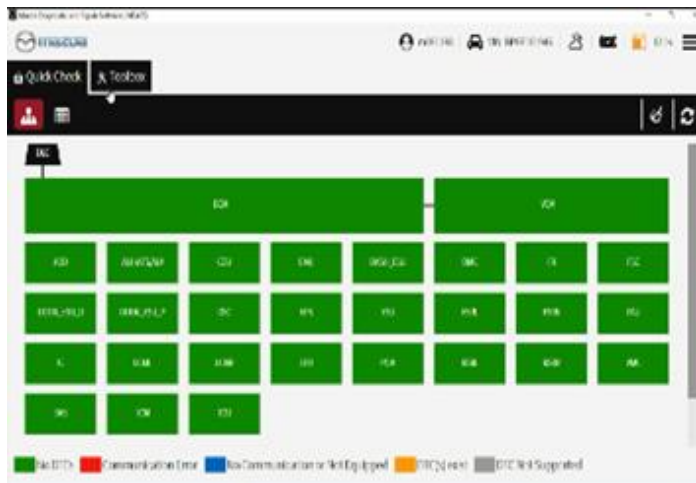
Some vehicles may store DTC U2050:55 (Activation of remote control not implemented) after a BCM software update.

1. Are there any warning lights and/or warning messages?
  - Yes - Go to next step.
  - No - Ignore the DTC.
2. Connect MDARS.

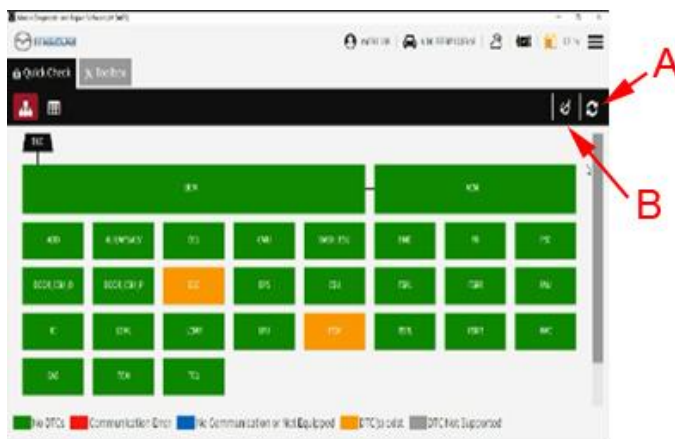
- If the engine is not started, DTC P2610 is stored and cannot be erased.
- If DTC U2050:55 is stored, ignore it. A TSB is pending.
