# Service Bulletin

Bulletin No.: 20-NA-021

Subject: Intermittent Service Steering Column Lock message displayed with U0155 Set

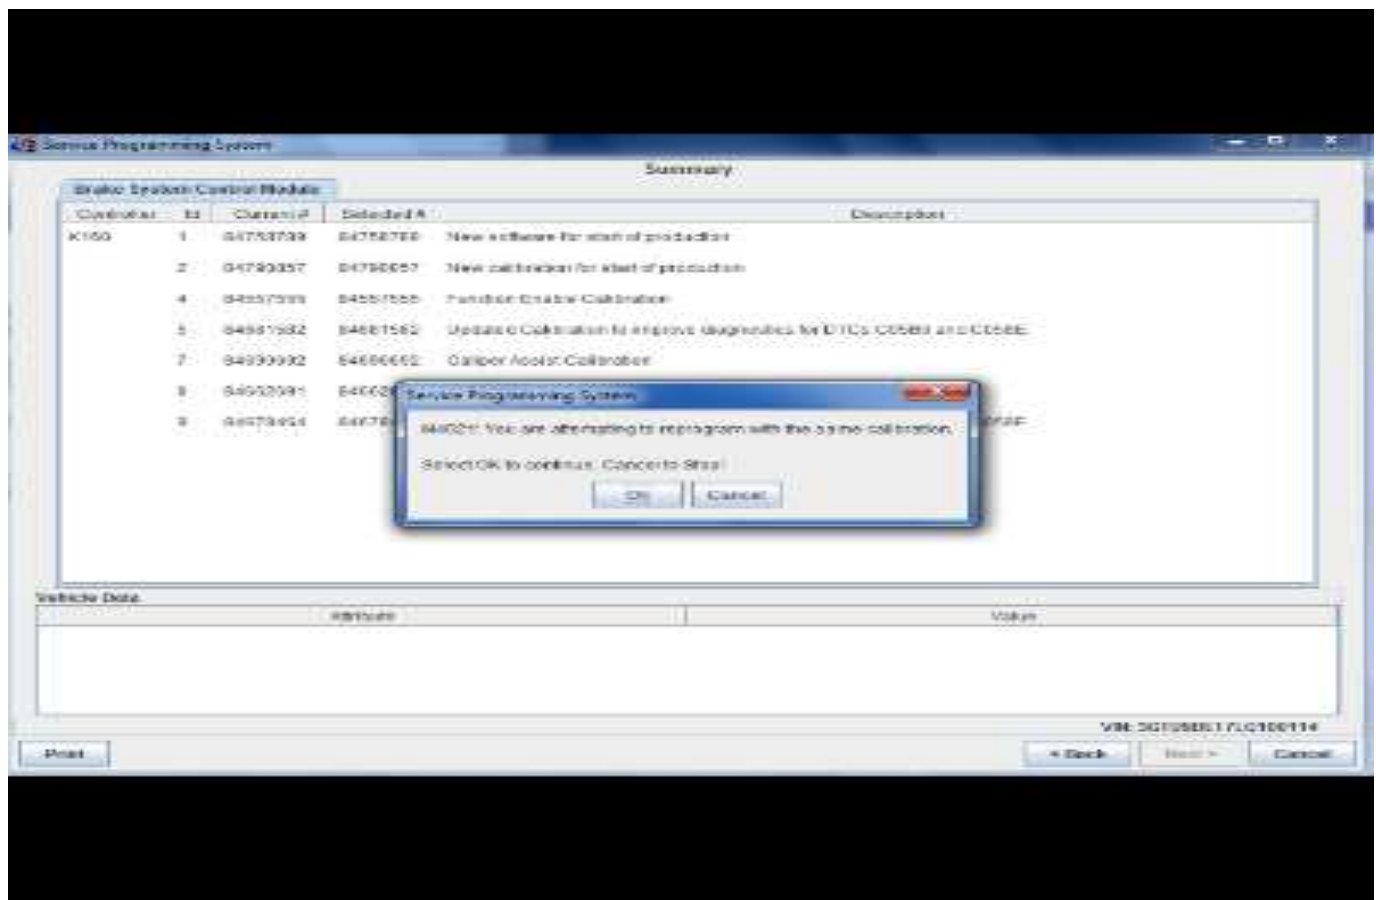
Important: If the Same Calibration/Software Warning is noted on the SPS screen, select OK and follow screen instructions. After a successful programming event, the WCC is located in the Service Programming System dialogue box of the SPS Summary screen. No further action is required. Refer to the Warranty section of the bulletin.

1. Reprogram the Reprogram the Steering Column Lock Module. Refer to K60 Steering Column Lock Module: Programming and Setup in SI. Modify as required (e.g., select x module from the controller screen. Then provide step-by-step instructions or refer to SI procedure.
