## SERVICE BULLETIN

| EC16-034c | NTB17-082c | June 29, 2020 |

### DTC P0456 CAUSED BY EVAP LEAK AT VENT CONTROL VALVE O-RING

**APPLIED VEHICLES:** All model year 2008 and newer Nissan vehicles  
except LEAF and Titan XD with V8 diesel engine

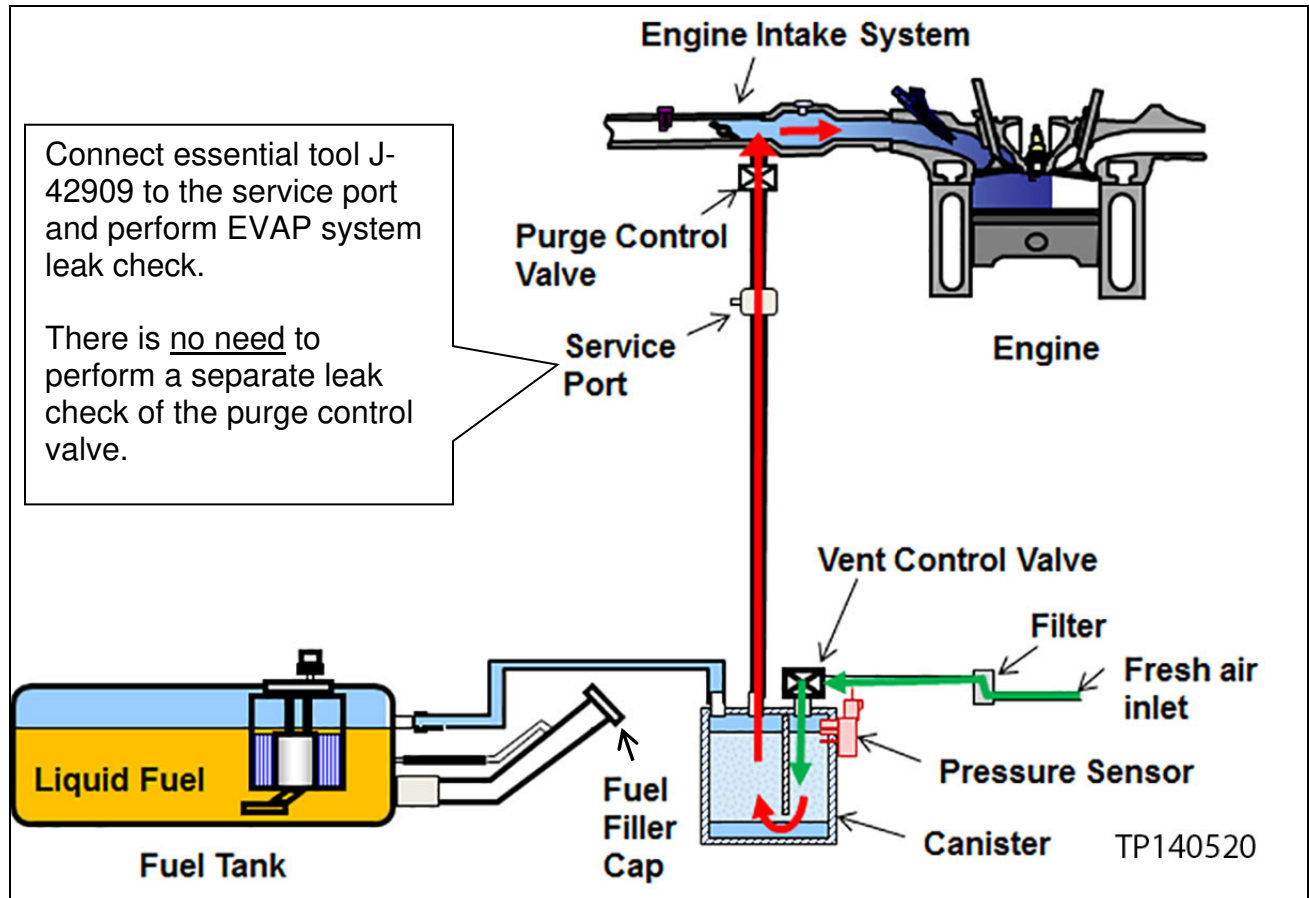
Figure 8

## Models with a Service Port (2017 and older)

- Fuel vapor flows from fuel tank into canister (light blue area)
- Vapor flows from canister through purge control valve (red line)
- Fresh air flows into canister (green line)

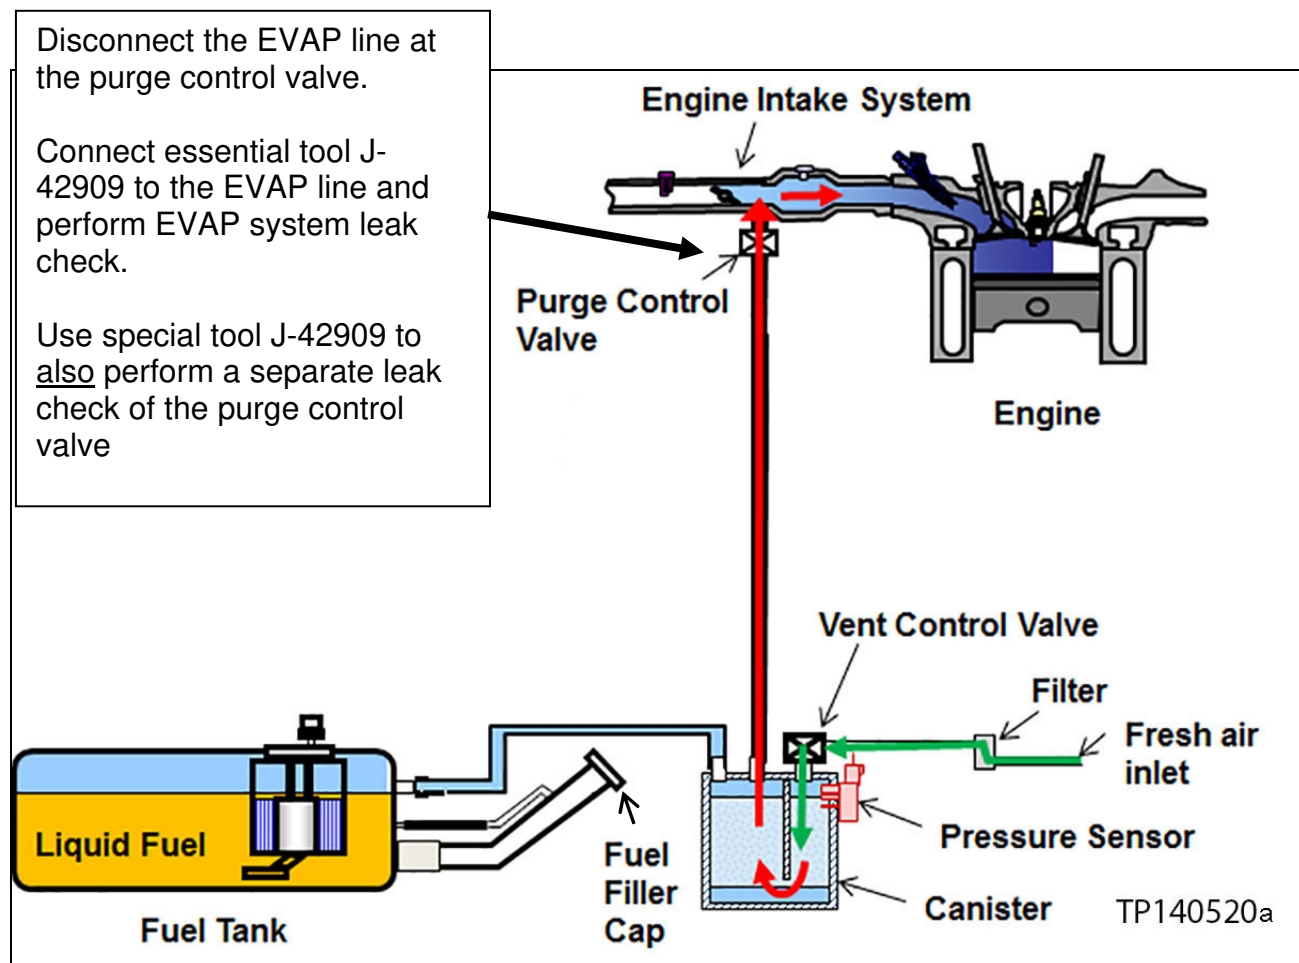
Figure 9

## Models without a Service Port (2018 and Newer)
