EC13-016a

ITB13-053a

July 18, 2014

## 2011 – 2012 QX56; MIL “ON” WITH DTC P0420 AND/OR P0430

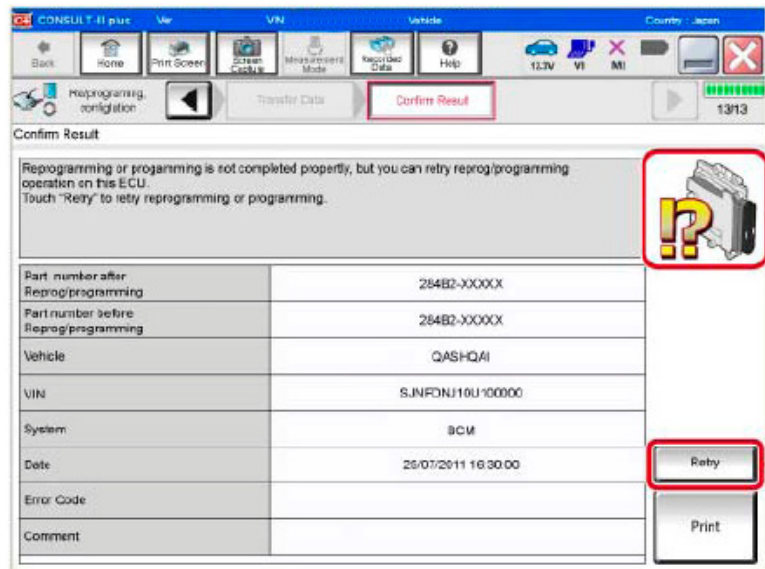
Figure 5

If reprogramming does not complete and the “!” icon displays as shown in Figure 5:

- Check battery voltage (12.0 - 15.5 V).
- Ignition is ON, engine OFF.
- External Bluetooth® devices are OFF.
- All electrical loads are OFF.
- Select retry and follow the on screen instructions.
- “Retry” may not go through on first attempt and can be selected more than once.

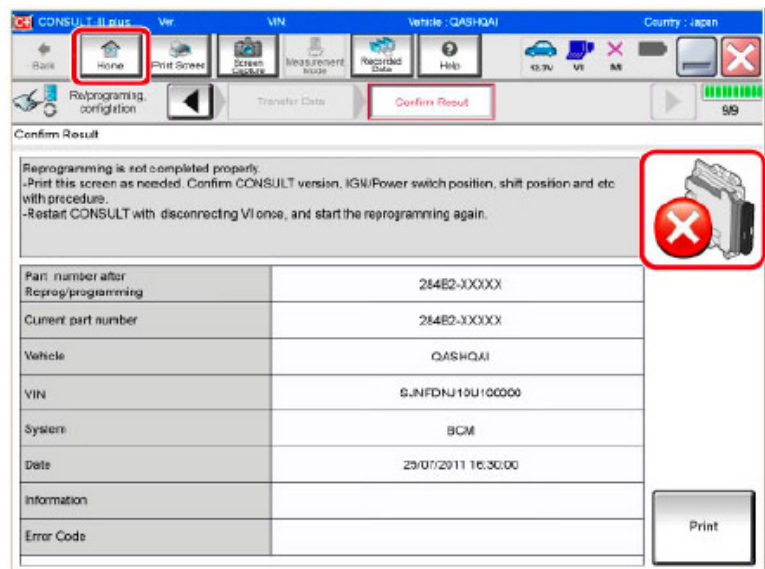
Figure 6

If reprogramming does not complete and the “X” icon displays as shown in Figure 6:

- Check battery voltage (12.0 - 15.5 V).
- CONSULT A/C adapter is plugged in.
- Ignition is ON, engine OFF.
- Transmission is in Park.
- All C-III plus / VI cables are securely connected.
- All C-III plus updates are installed.
- Select Home, and restart the reprogram procedure from the beginning.
