BR14-006a

ITB14-051a

July 29, 2015

## JX35, QX60, AND Q50; FCW MALFUNCTION AND DTC C1A27 STORED

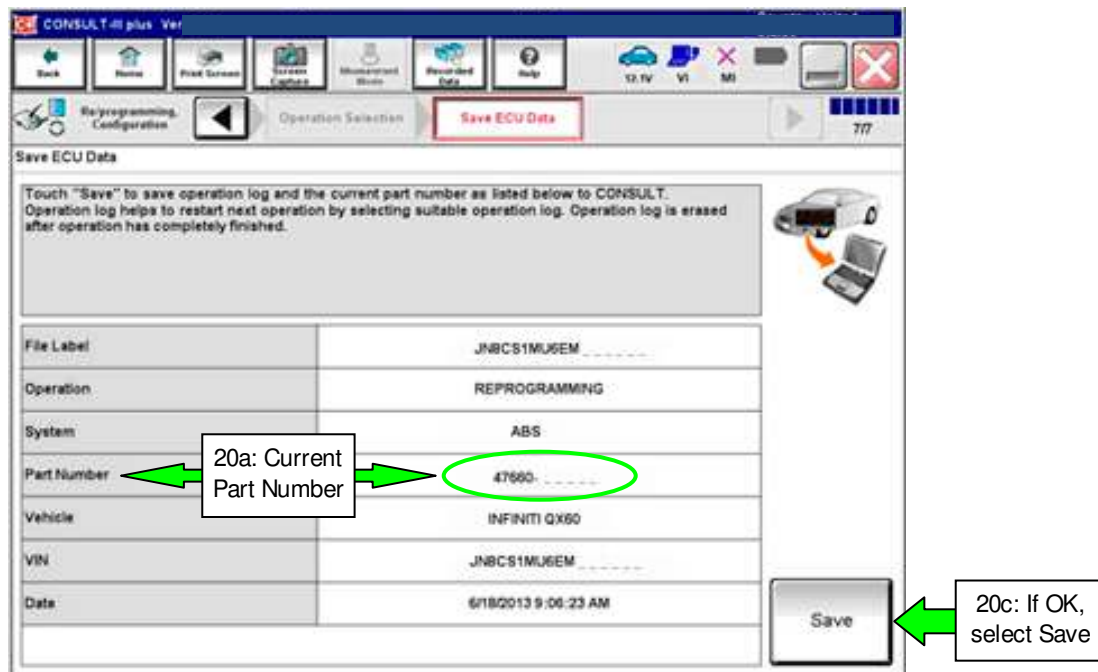
Figure 9

20. When you get to the screen shown in Figure 9, confirm reprogramming applies as follows:

- a. Find the ABS Part Number and write it on the repair order.

NOTE: This is the current ABS Control Unit Part Number.

- b. Compare the P/N you wrote down to the numbers in the Current Part Number column of Table A below:
  - If there is a match, this bulletin applies. Continue with the reprogramming procedure on the next page.
  - If there is not a match, this bulletin does not apply. Close C-III plus and check ASIST for further diagnostic and repair information.
- c. If there is a part number match as specified below, select Save and then continue with the reprogramming procedure on the next page.

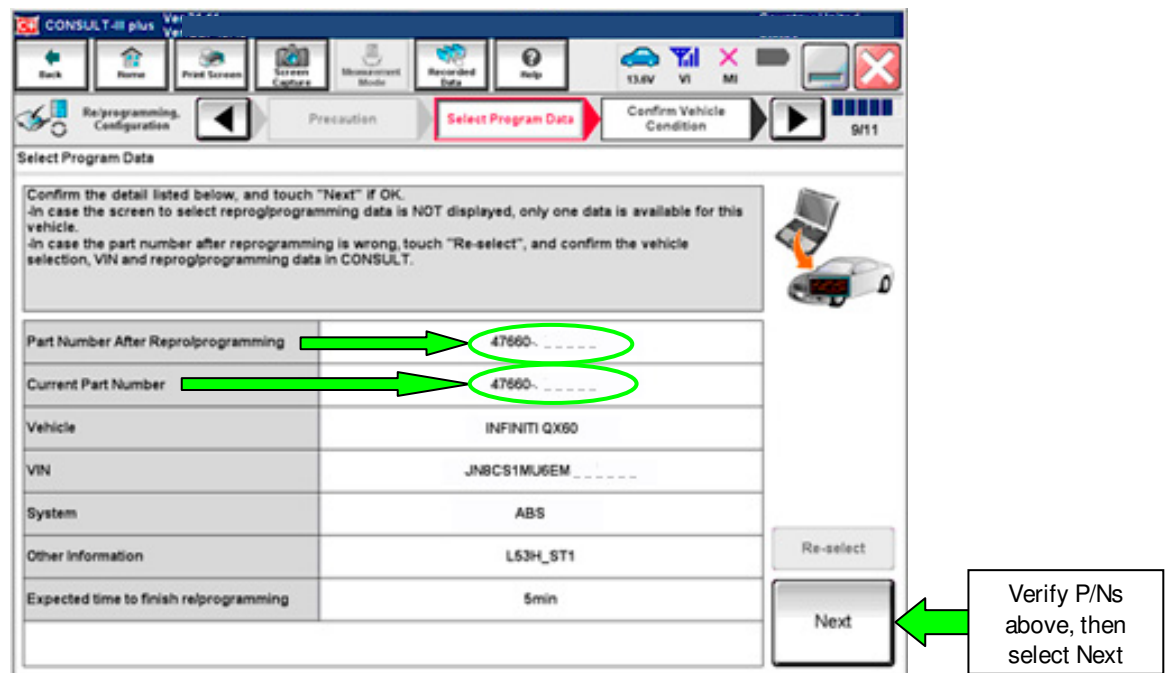
Figure 11

24. Read the Current Part Number and Part Number After Reprogramming. They should be different.
25. Select Next.

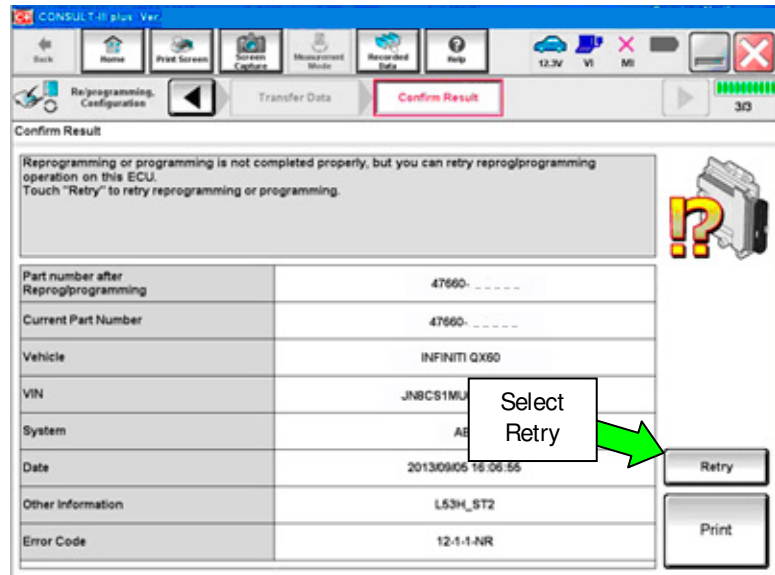
Figure 16

If reprogramming does not complete and the “!?” icon displays as shown in Figure 16:

- Check battery voltage (12.0–15.5 V).
- Ignition is ON, engine OFF.
- External Bluetooth® devices are OFF.
- All electrical loads are OFF.
- Select retry and follow the on screen instructions.
- “Retry” may not go through on the first attempt and can be selected more than once.

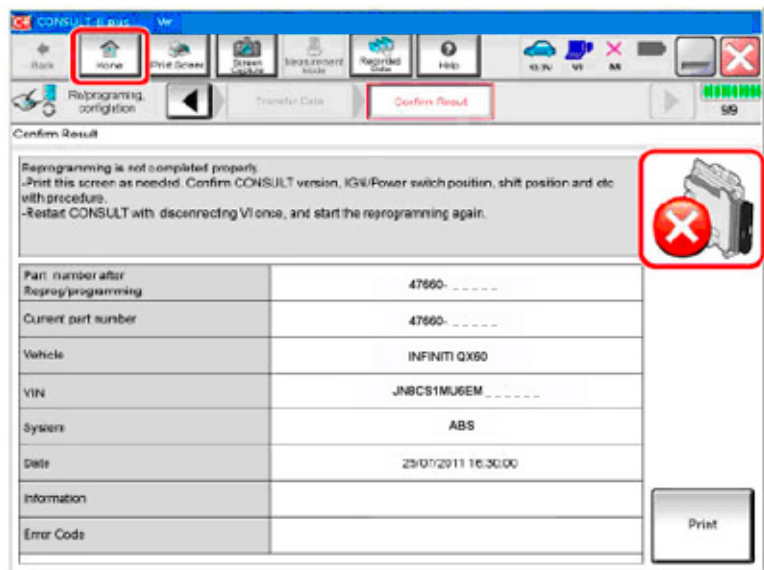
Figure 17

If reprogramming does not complete and the “X” icon displays as shown in Figure 17:

- Check battery voltage (12.0 – 15.5 V).
- CONSULT A/C adapter is plugged in.
- Ignition is ON, engine OFF.
- Transmission is in Park.
- All C-III plus / VI cables are securely connected.
- All C-III plus updates are installed.
- Select Home, and restart the reprogram procedure from the beginning.

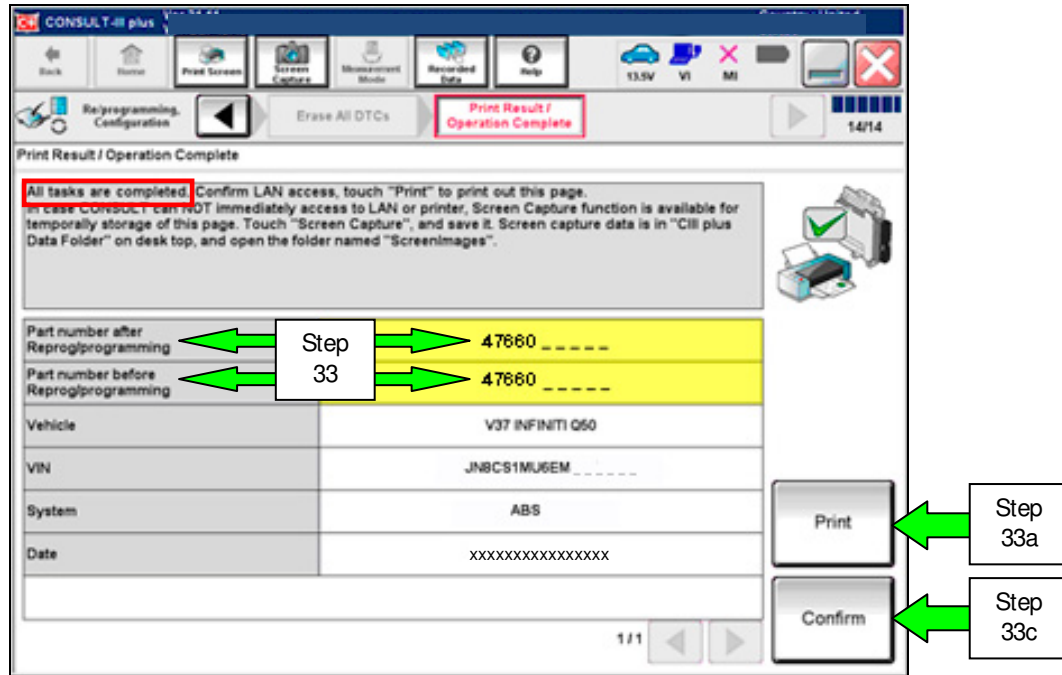
33. Verify the part number has changed (before and after reprogramming part numbers should be different).
  - a. Print a copy of the screen in Figure 19 by selecting Print.
  - b. Attach the copy to the repair order.
  - c. Once a copy has been printed, select Confirm.
