**01-18-13 - MIL ON DTC P0401 Exhaust Gas Recirculation Flow  
Insufficient**

Release date: 6/29/2021

High soot loads prior to regeneration can cause possible restrictions in the Exhaust Gas Recirculation (EGR) filter.

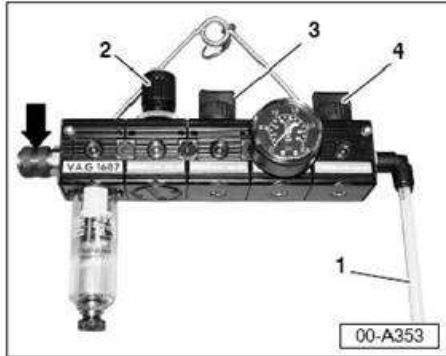
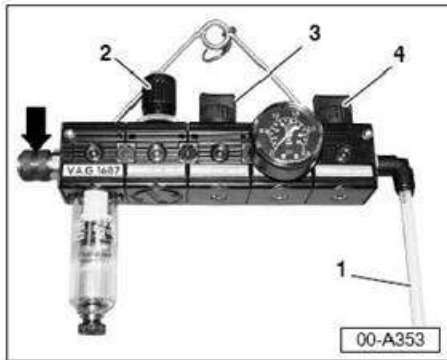
**Performing pressure Test:**

- With outlet hose -1- of VAG 1687 connected to air pressure adapter.
- Attach shop air supply line to previously installed male fitting.

- Open valve -3- between regulator valve and gauge.
- Adjust test pressure up to 0.5 bar (see Note below) by turning the regulator valve -2-.

- Repair any leaks found.
- Remove tester.
- Remove plug from crankcase ventilation hose.
- Remove air pressure adapter.
- With VAS diagnostic tool connected:
  - Erase DTC memory.
