| GROUP | MODEL |
|---|---|
| ELE | 2017-2018MY<br>Sedona (YP) |
| 259 | August 2022 |

## TECHNICAL SERVICE BULLETIN

### SIDE AIRBAG (SAB) WARNING LIGHT ON WITH DTC(S) B1378/B1382

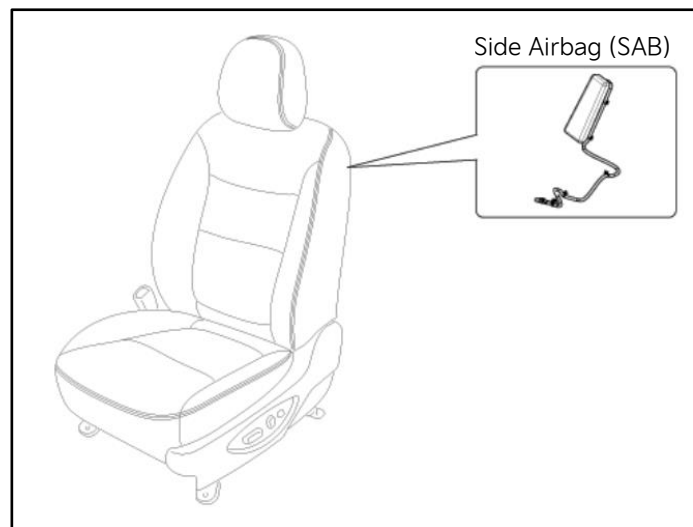
This bulletin provides information associated with the 'Warranty Extension Program' (WTY025) to diagnose and repair certain airbag warning light 'ON' conditions for 2017-2018MY Sedona (YP) vehicles produced from March 16, 2016 through December 6, 2017. The affected vehicles may exhibit an airbag warning light 'ON' with DTC B1378 and/or B1382 due to the front seat Side Airbag (SAB) connector experiencing higher than normal resistance. Follow the procedure outlined in this publication to inspect for DTCs and reconnect the side airbag connector of the affected front seat depending on the DTC defined below.

- B1378 - Side Airbag Front Driver Resistance Too High
- B1382 - Side Airbag Front Passenger Resistance Too High
